MODEL  
Sedona (VQ)  
2006-2012MY

NUMBER  
PS238

SUBJECT: AUDIBLE TONE FROM BACK-UP ASSIST ALWAYS ON

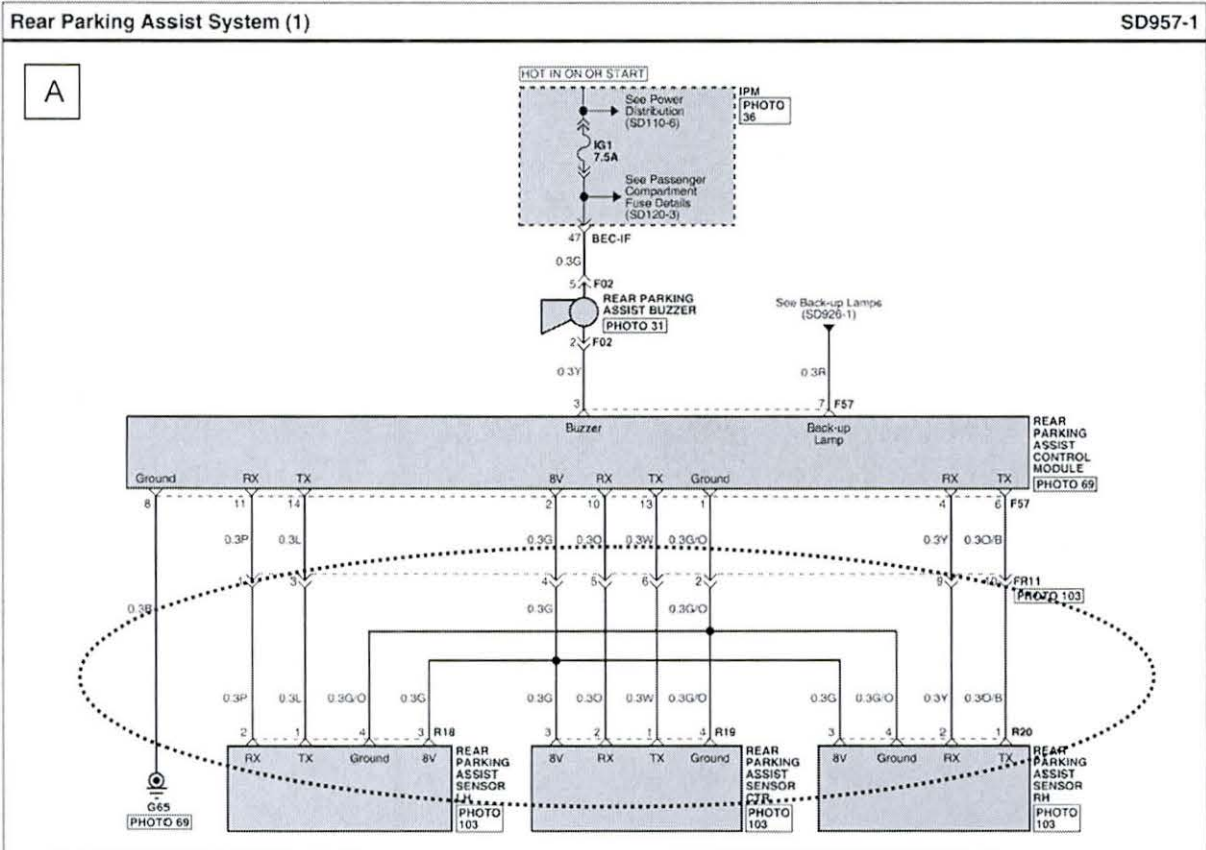
If you encounter a customer complaint relating to the audible tone from the back-up assist feature remaining on at all times, inspect the sensors in the rear bumper for possible collision damage causing a short in the sensor. Also, make sure to check the harnesses feeding the sensors for continuity to ground. Refer to the schematic diagram (A) below or to the Body Electrical section of the service manual for detailed repair information.
