Technical Service Bulletin

GROUP	NUMBER	
CAMPAIGN	13-01-012	
DATE	MODEL(S)	
MARCH 2013	BK GENESIS

MANUAL TRANSMISSION SHIFT LEVER KNOB INSPECTION (SERVICE CAMPAIGN TN2)

THIS TSB SUPERSEDES TSB 12-01-045 TO INCLUDE RETAIL VEHICLES.

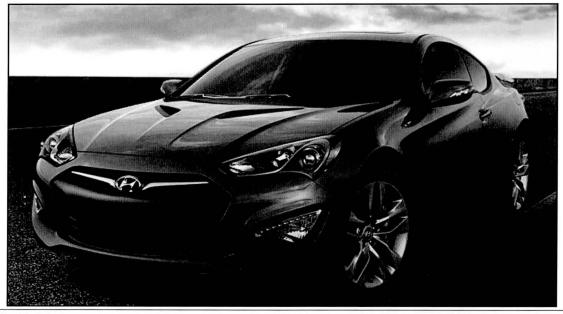
Description: This bulletin describes the procedure to inspect and reinstall the shift knob on some BK Genesis Coupe vehicles equipped with a manual transmission.

Applicable Vehicles: (BK) Genesis Coupe vehicles equipped with a manual transmission, produced from July 03, 2012 to Nov. 07, 2012

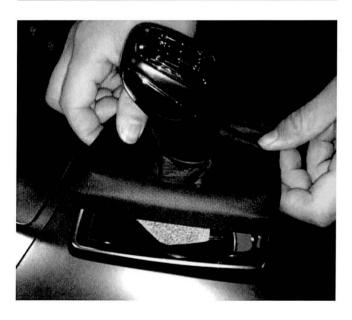
2. Grasp the driver's side of the boot base and pull towards the passenger side to disengage the clips. Then pull upwards to remove the boot from the shifter trim.
