# Rear Sunshade Binding on Package Tray

YEAR(S)	MODEL(S)	ADDITIONAL INFORMATION
2013	Avalon, Avalon HV

Some 2013 model year Avalon and Avalon HV vehicles may exhibit a condition where the rear sunshade is inoperative and appears to be binding in the package tray. Please follow the process below to address this condition.

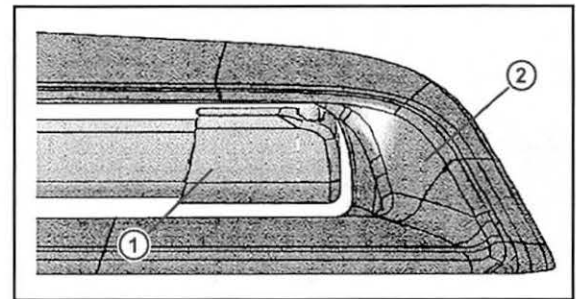
Figure 1.

1. Verify condition is present by cycling the rear sunshade and confirming interference with the package tray.

1	Sunshade
2	Package Tray

2. Replace the package tray according to Repair Manual instructions.

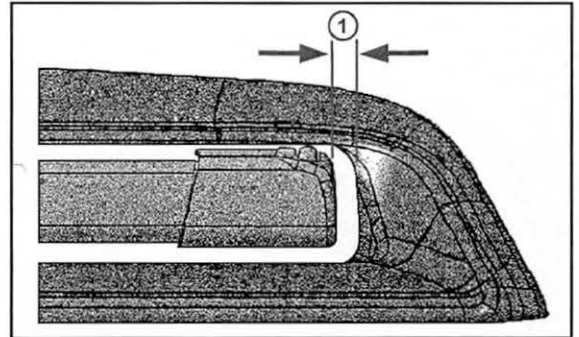
Figure 2.

4. Check that there is clearance between the sunshade and package tray. Verify operation by cycling the rear sunshade.

1	Clearance
---	-----------
