Loose Windshield Dam at Lower Right Corner of Windshield

Service Category Vehicle Interior

Section Interior Panels/Trim

YEAR(S)	MODEL(S)	ADDITIONAL INFORMATION
2012 – 2013	Yaris	Body Type(s): 3Dr. Hatch Back, 5Dr. Hatch Back

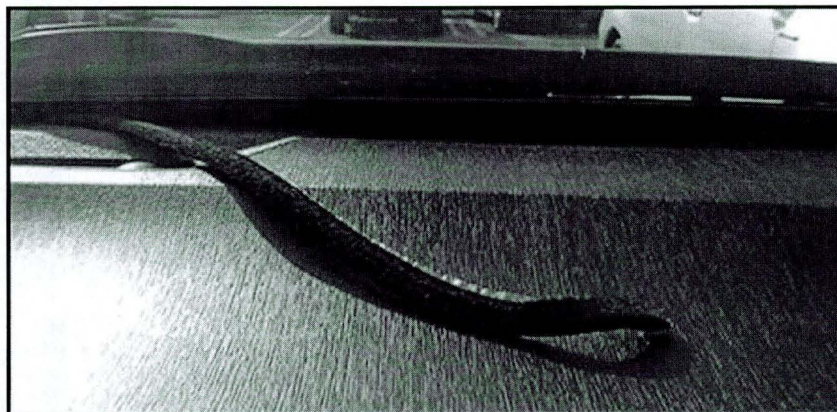
Figure 1.

Some 2012 – 2013 model year Yaris Hatchback vehicles may exhibit a condition where a piece of foam that fits between the instrument panel and the windshield may come loose. Parts have been revised to address this condition.

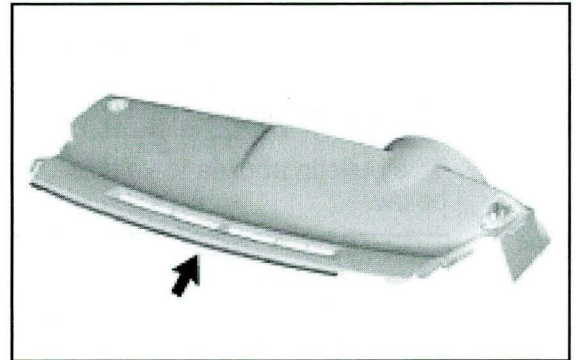
Figure 2.

2. Remove the Instrument Panel Cushion.

HINT
Remove excess glue that remains.

3. Install the NEW Instrument Panel Cushion.
