NUMBER: 07-002-13

Coolant Weepage At EGR Hose

Chrysler 300 (International Only)

NOTE: This bulletin applies to vehicles with the 3.0L V6 Turbo Diesel Engine (sales code EXF) built on or before June 03, 2013 (MDH 0603XX)

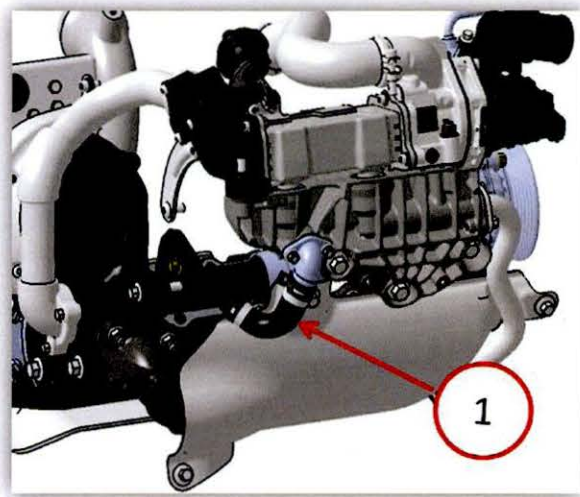
Fig. 1 EGR

The EGR hose may weep coolant.

1 - EGR Coolant Hose

1. Drain the cooling system. Follow the detailed procedures available in DealerCONNECT/TECHCONNECT, Refer To 07 - Cooling - Standard Procedure.
2. Lower the belly pan splash shield.
3. Lower the rear transmission splash shield.
4. Replace the EGR coolant hose.
