Service Bulletin

Bulletin No.: PIT4551E

Subject: Back Up Alarm Inoperative And Needs To Be Connected During PDI

Models: 2008-2013 Chevrolet Silverado
2008-2013 GMC Sierra
Equipped with Back Up Alarm (RPO 8S3)

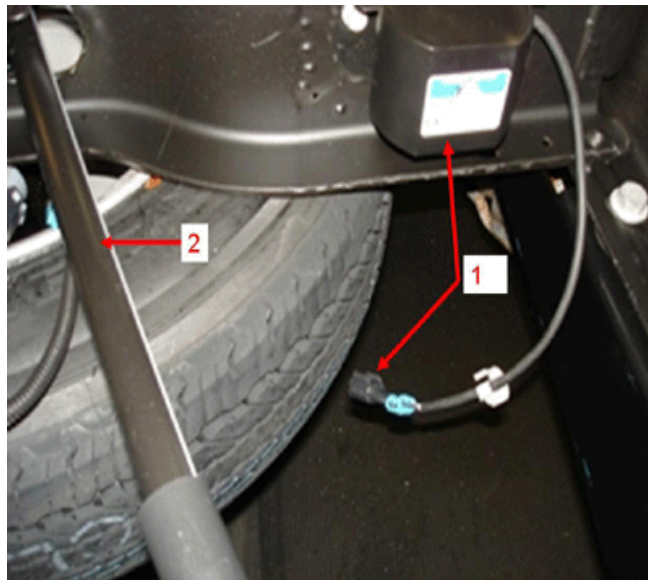
During the PDI it may be noticed that the backup alarm is inoperative. On trucks equipped with the Back Up Alarm (RPO 8S3), the alarm will be intentionally left disconnected from the assembly plant.

1. Back Up Alarm/Connector
2. Spare Tire Hoist Tube

The alarm is located on the right rear of the frame, and the chassis harness alarm connector is located on the left rear of the frame. Route the harness up and over the spare tire hoist tube and connect to the backup alarm.
