**NUMBER:** 08-084-13 REV. A

**Decklid Opens Unintentionally**

This bulletin involves inspecting the decklid passive entry switch and replacing if necessary.

2011 - 2013	LD	Charger
2011 - 2013	LX	300

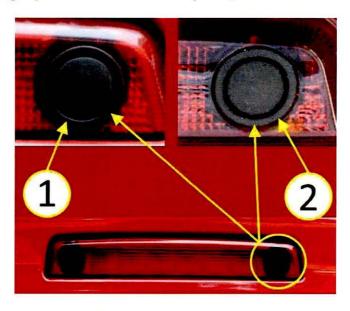
Fig. 1 Passive Entry Switch Button Surface

- Determine if the trunk passive entry switch button surface is plastic (slippery) or rubber (grippy) by rubbing a finger across the switch button surface to detect the surface material. Appearance is very similar and may require careful examination to detect which version of switch is installed (Fig. 1).
  - a. Plastic (1) (Fig. 1) replace the switch, perform the repair procedure.
  - b. Rubber (2) (Fig. 1) no further action is required, return the vehicle to the customer.

- 1 Plastic Button
- 2 Rubber Button

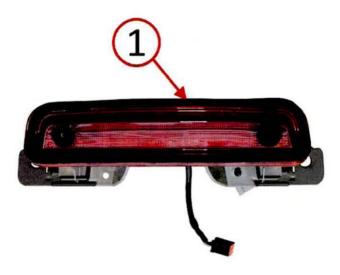
Fig. 2 CHMSL Seal

1 - CHMSL Seal

- Remove the center high mounted stop lamp (CHMSL) from the decklid. Refer to the
  detailed removal procedures available in DealerCONNECT>TechCONNECT> under:
  Service Info> 08 Electrical> 8L Lamps and Lighting> Lamps/Lighting Exterior>
  LAMP, Center High Mounted Stop> Removal.
- 3. Inspect the CHMSL to decklid seal for any damage and/or deterioration. Replace if necessary to prevent water intrusion (Fig. 2).

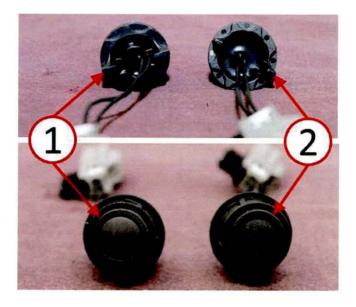
Fig. 4 Switch Version

- 1 Plastic Button Passive Entry Switch
- 2 Rubber Button Passive Entry Switch
- Install the NEW passive entry switch into the CHMSL housing. Refer to the detailed installation procedures available in DealerCONNECT>TechCONNECT> under: Service Info> 08 - Electrical> 8N - Power Systems> Power Locks> SWITCH, Deck Lid Release> Installation (Fig. 5).

5. Replace previous version plastic button passive entry switch (1) with new version rubber button passive entry switch (2) (Fig. 4).

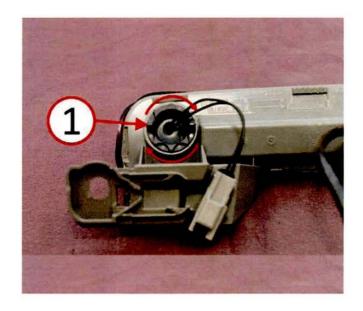
Fig. 5 Passive Entry Switch Installation

1 - Passive Entry Switch
