NUMBER: 23-009-13

GROUP: Body

Chipped Paint On Deck Lid At Spoiler

2012 (LX) 300

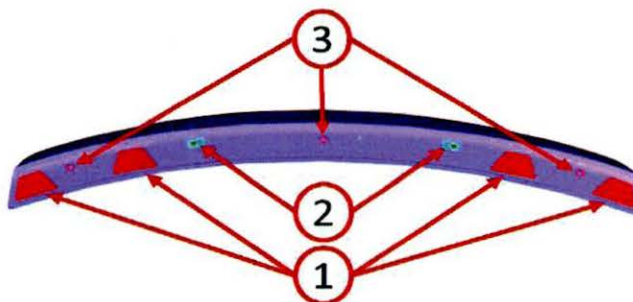
Fig. 1 Spoiler Modification

- 1 - Spoiler Tape (Location Area)
- 2 - Attachment Stud Clips
- 3 - Spoiler Molded Studs

2. Clean the mounting surface on the underside of the spoiler at the red tape locations (1) with isopropyl alcohol (Fig. 1).
3. Apply 3M #4298 Adhesion Promoter or equivalent to the same locations.
4. Install four pieces of double sided spoiler tape (1) part number 68213235AA to the locations in red (Fig. 1).

NOTE: Locate the outer tape approximately 2mm away from the lip on the forward curved edge and sides of the spoiler. Locate the inner tape 2mm away from the lip on the forward curved edge and centered between the mounting studs.

-
5. Remove the red liner from the tape and align the spoiler to the deck lid with the two attachment stud clips (2) and spoiler molded studs (3) (Fig. 1).
 6. Press the spoiler to the deck lid at all four tape locations (1) (Fig. 1).
 7. Tighten the studs to the deck lid using locking fastener 06510663AA if the spoiler is not already equipped with them.
