**NUMBER:** 23-010-13

Water Dripping Across Door Sill And/Or Damp Front Floor

- 2011 - 2012 (JK) Wrangler
- 2011 - 2012 (J3) Wrangler (Export)

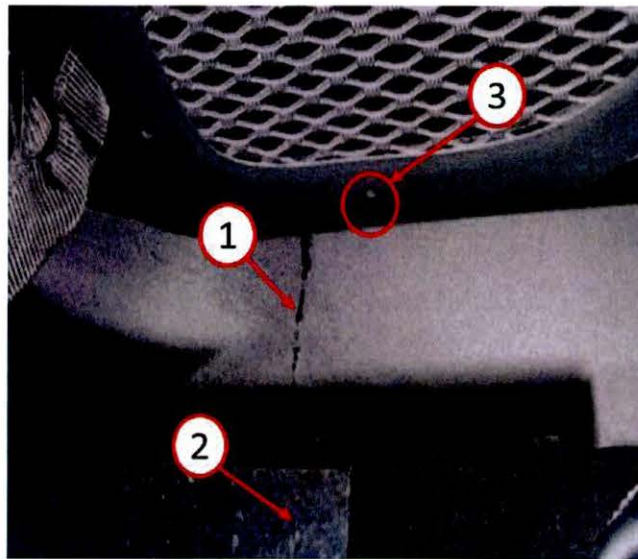
**Fig. 1 Water Leak Path**

The customer may experience water dripping across the door sill and/or a damp front floor.

- 1 - Front Door Sill (Waterleak)
- 2 - Front Floor
- 3 - Door Panel Front Lower Fastener

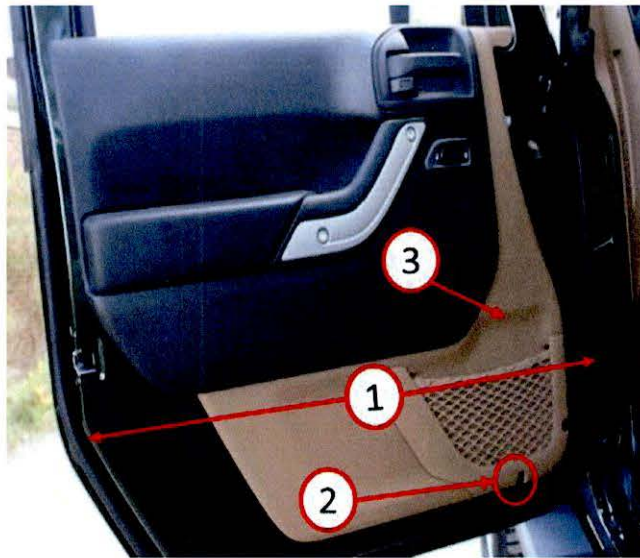
**Fig. 2 Door Seal Modification Location**

- 1 - Door Seal
- 2 - Door Panel Lower Fastener (Notch Location)
- 3 - Door Panel

1. Open the door on the side with leak present and mark the door seal (1) approximately below the lower door panel fastener (2) or the area where water is running across the sill(Fig. 2).
2. Remove the lower section of the door seal (1) from the door seal channel below the arrows indicated on either side of (1) in (Fig. 2).

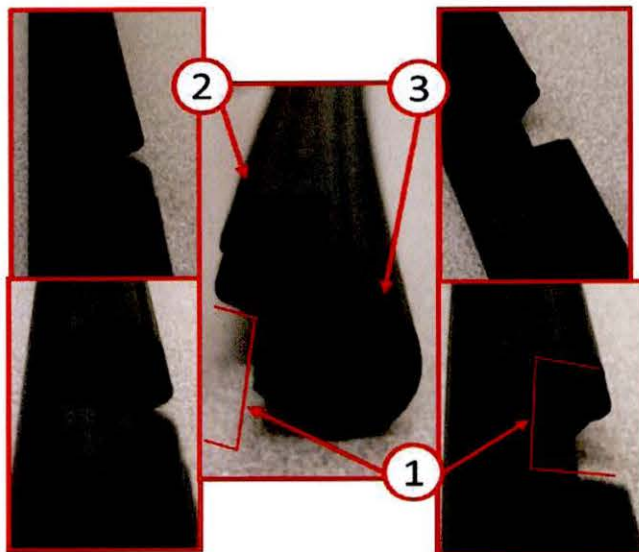
**Fig. 3 Seal Modification Desired Result**

- 1 - Seal Notch (Area to be Removed)
- 2 - Outer Door Side of Seal ("Wet Side")
- 3 - Inner Door Side of Seal/Bulb ("Dry/Body Side")

**NOTE:** Be careful when notching the door seal so that the inside wall of the bulb seal (3) is not cut when the notch (1) is cut into the outer “wet side” (2) of the door seal. (Fig. 3) shows the desired result of the door seal notch procedure outlined in **Step #3** with relation to the structure of the seal and the layout of the notch on the seal relative to the door.

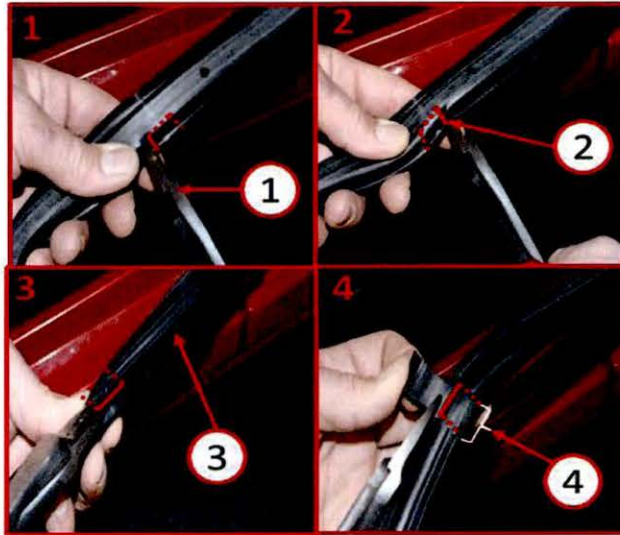
**Fig. 4 Seal Modification**

- 1 - Door Seal Notch Mark (Center of Notch)
- 2 - Diagonal Cutters
- 3 - Door Seal Notch
- 4 - Door Seal
- 5 - Seal Notch Width (5/8"/16mm)

- 
3. Locate the mark (1) made in [Step #1](#) on the door seal, below the lower door panel fastener, and designate it as the center of the notch (3) which should be approximately 5/8"/(16mm) wide (4) ([Fig. 4](#)).
  4. Using diagonal cutters, (2) cut approximately 1/4"(6mm) into the outer door/"wet side" of the seal on either side of the seal center mark (1) outlined in top pictures 1 & 2 of ([Fig. 4](#)).
  5. Connect the two cuts from [Step #4](#) by cutting along the bottom side/door bulb side of the seal as outlined in picture 3 of ([Fig. 4](#))
  6. Connect the two cuts from [Step #4](#) by cutting along the top side/door channel "flat side" of the seal as outlined in picture 4 of ([Fig. 4](#))

**NOTE: Use caution not to cut into the bulb seal portion of the seal while performing the notch procedure.**

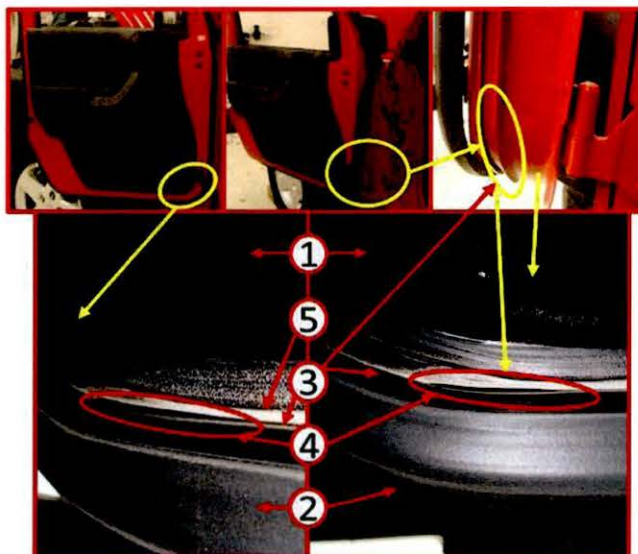
**Fig. 5 Sealer Skip Inspection**

- 1 - Door (Bottom Side)
- 2 - Door Seal (Bottom of Door)
- 3 - Door Seal Channel
- 4 - Seam Sealer Skip
- 5 - Seam Sealer (Correctly Applied)

- 
- 7. Inspect the sealer (5) applied along the inboard lower edge of the door seal channel (3).
  - 8. Were any sealer skips present?
    - a. Yes >>> Proceed to [Step #9](#).
    - b. No >>> Proceed to [Step #10](#).
  - 9. Seal any skips (4) where there may be a void between the door seal channel (3) and the bottom of the door (1) with Kent Hi-Tech clear seam sealer.

**NOTE: Follow the manufacturer's recommendations for surface preparation and curing times.**

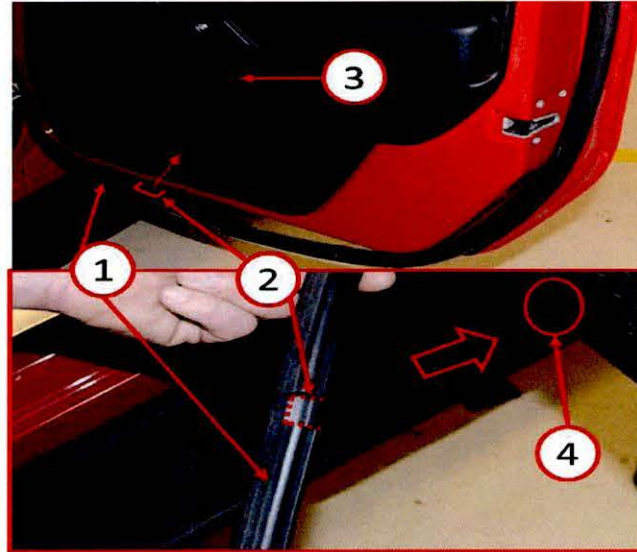
**Fig. 6 Reinstall Door Seal**

- 1 - Door Seal
- 2 - Door Seal Notch
- 3 - Door Panel
- 4 - Door Panel Lower Fastener (Notch Location)

10. Reinstall the lower section of the door seal (1) back into the lower door seal channel so that the door seal notch (2) faces outward toward the “wet side” of the vehicle.

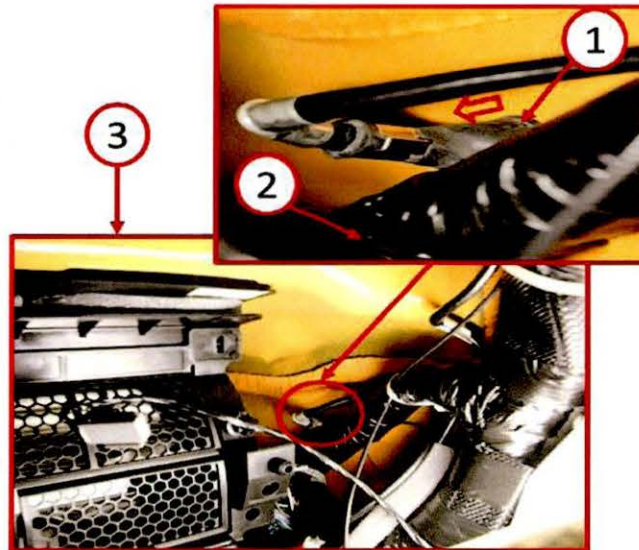
**Fig. 7 Antenna Grommet Inspection**

- 1 - Antenna Grommet
- 2 - Main Wire Harness
- 3 - Glove Box Opening View (Glove Box removed)

11. Was water still entering the vehicle onto the front floor?
  - a. Yes >>> Proceed to the next step.
  - b. No >>> Return the vehicle to the customer.
12. Was water dripping down the cowl-side inner body panel under the Instrument panel or dripping down the front of the door seal from the A-pillar area?
  - a. Cowl-side inner body panel >>> Proceed to [Step #13](#).
  - b. Door Seal from A-pillar area >>> Proceed to [Step #16](#).
13. Remove the passenger side front speaker. Refer to the detailed procedures available in DealerConnect>TechCONNECT> under: Service Info> 08-Electrical> SPEAKER> Removal> Instrument Panel - Passenger Side
14. Through the glove box opening (3) with the passenger side speaker and glove box removed verify that the antenna grommet (1) is properly seated to the inner body side (Fig. 7).

**NOTE:** The antenna grommet is a pull to seat type of grommet. If the grommet is not pulled through the cowl-side inner body panel enough to be properly seated, it must be pulled gently toward the vehicle interior in order to seat it. If the grommet has been over-pulled through the cowl-side inner panel, push it outboard and seat it properly. Make sure that the main wire harness (2) is not pushing on the antenna grommet causing it to be pushed out of the inner body side panel.

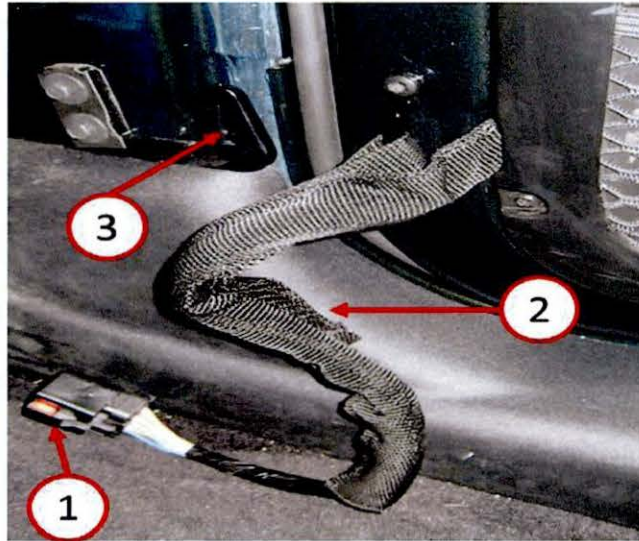
**Fig. 8 Disconnect Door Harness and Check Strap**

- 1 - Check Strap Harness
- 2 - Check Strap
- 3 - Check Strap Hook

- 
15. Was water also dripping down the front of the door seal from the A-pillar area?
    - a. Yes >>> Proceed to [Step #16](#).
    - b. No >>> Proceed to [Step #30](#).
  16. Open the suspect front door and disconnect the door wiring harness (1) by pushing red lock and remove cloth check strap (2) from hook (3) ([Fig. 8](#)).

- 
- 28. Reinstall the door weatherstrip seal.
  - 29. Reconnect the cloth check strap and door wiring harness as shown in (Fig. 8)
  - 30. Water leak test the vehicle primarily along the top of the door seal and down the A-pillar area for leaks.

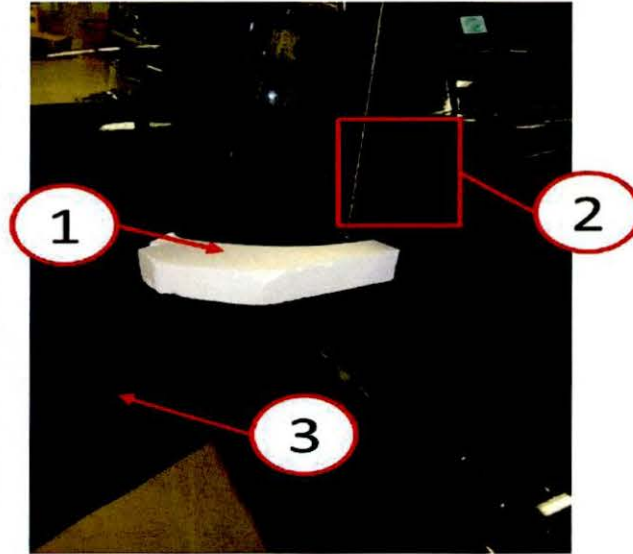
**Fig. 9 Prevent Door Contact**

- 1 - Foam
- 2 - Potential Damage Area
- 3 - Door

**NOTE: Use a foam block or equivalent to prevent the sideview mirror from hitting the vehicle when the door is full open (Fig. 9).**

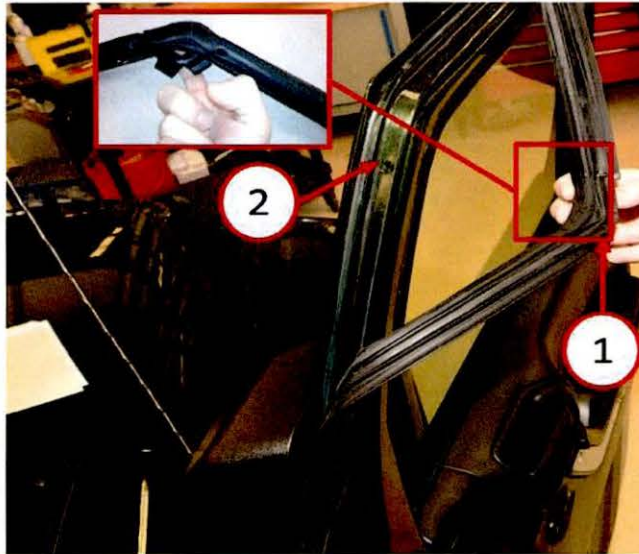
**Fig. 10 Door Weatherstrip Removal**

- 1 - Door Weatherstrip
- 2 - Metal Weatherstrip Channel

17. Remove the suspect door upper weatherstrip seal (1) at the A pillar upper corner, from metal channel (2) enough to gain access to stuffer access slot (Fig. 10).

**NOTE: Inspect the side upper door seal channel (2) for possible sealer skips**

19. Seal any skips where there may be a void between the door seal channel and the top of the door with Kent Hi-Tech clear seam sealer.

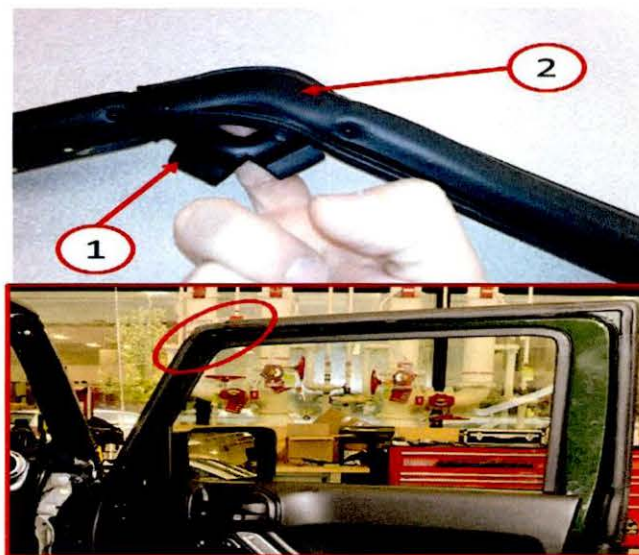
**Fig. 11 Door Stuffer Access**

- 1 - Door Stuffer
  - 2 - Door Weatherstrip
-

20. Pull out half of the existing stuffer that goes down the front A-pillar side of the door weatherstrip through the access slot in the backside of the weatherstrip (Fig. 11).

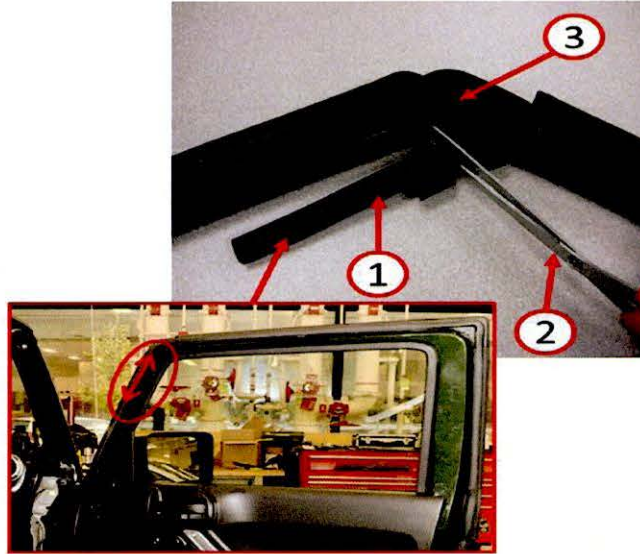
**Fig. 12 Door Stuffer Removal**

- 1 - Stuffer
- 2 - Scissors
- 3 - Door Weatherstrip

21. Remove half the existing stuffer (1) by cutting at the stuffer relief joint using scissors (Fig. 12).

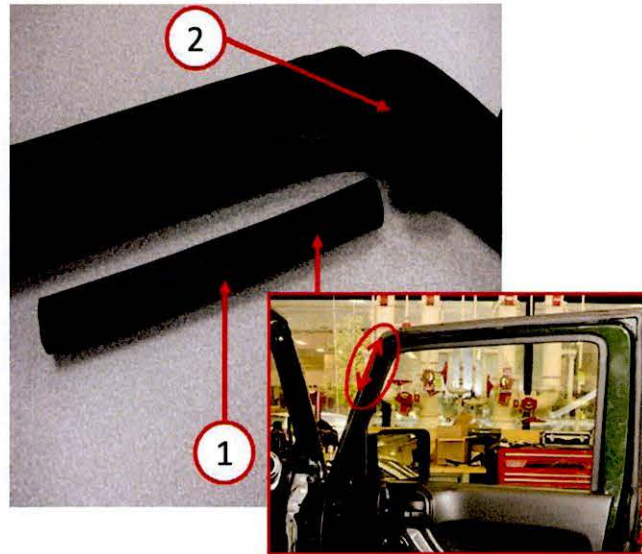
**Fig. 13 Install New Door Stuffer**

- 1 - New Stuffer
- 2 - Weatherstrip

- 
22. Insert the new stuffer (1) into the weather strip where existing was removed (Fig. 13).

**NOTE: For ease of installation lubricate the stuffer with soapy water.**

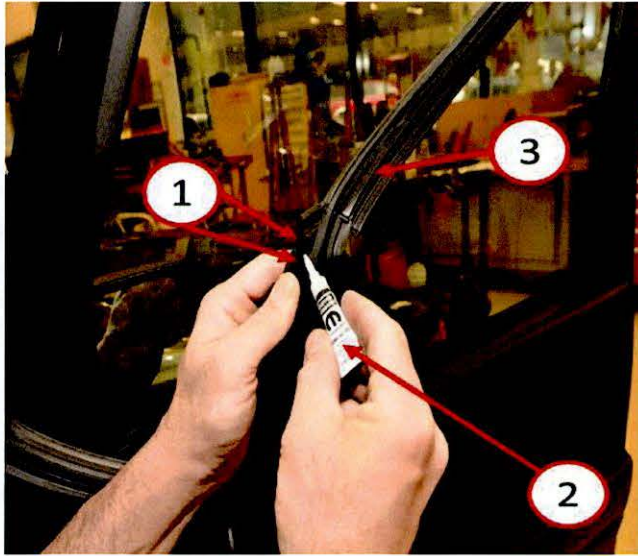
**Fig. 14 Door Stuffer Installation**

- 1 - Stuffers
- 2 - Mopar Bond All Gel
- 3 - Weatherstrip

- 23. Clean stuffer sections to be bonded with isopropyl alcohol and allow it to flash.
- 24. Bond both stuffer sections at the intersection (1) with Mopar Bond All Gel (2) and make sure there is no gap between stuffer sections as shown in (Fig. 14).

**NOTE: The glue is being used to keep the new a-pillar stuffer in position and to prevent it from moving down the weatherstrip over time.**

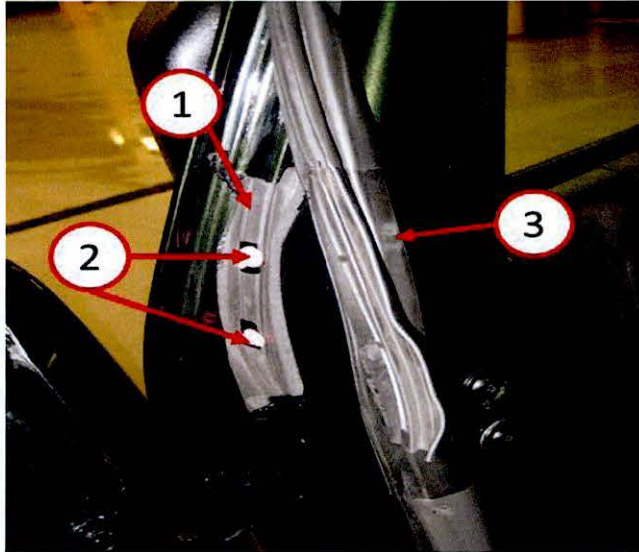
**Fig. 15 Foam Removal**

- 1 - Foam Patch (right side shown)
- 2 - Weatherstrip Retaining Clips
- 3 - Weatherstrip

25. Remove existing foam patch (1) and clean door surface with isopropyl alcohol (Fig. 15).

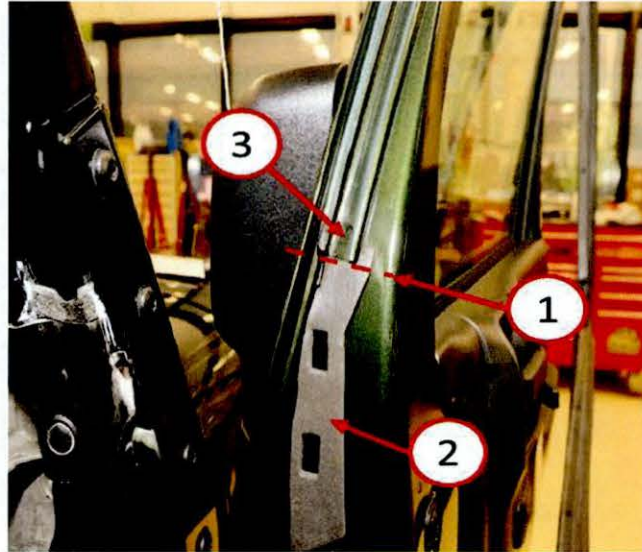
**Fig. 16 Foam Installation**

- 1 - Edge of Door Weatherstrip Channel
- 2 - Foam (right side shown)
- 3 - Upper Door Seal Channel

26. Wipe door surface with adhesion promoter and once flashed insert the new foam patch (Fig. 16).

**NOTE: Ensure foam patch is tight against upper door weatherstrip channel by beginning installation at the top of foam and finishing at the bottom. Make sure foam gasket is applied flat against the door with no creases or wrinkles.**

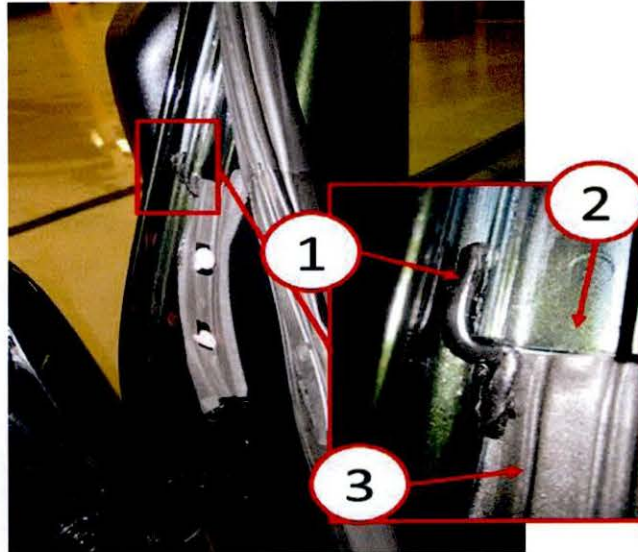
**Fig. 17 Butyl Tape Installation**

- 1 - Butyl Tape
- 2 - Door Seal Channel
- 3 - Foam Patch (right side shown)

27. Install approximately 1 inch of butyl tape to upper door weatherstrip channel as shown (Fig. 17).

**NOTE: Press butyl down with fingers to seal against the sides and bottom of the channel and along edge of foam.**
