TECHNICAL BULLETIN  
JTBO0302NAS1  
25 OCT 2013

**SECTION: 501-05**

Sun Visor Delamination

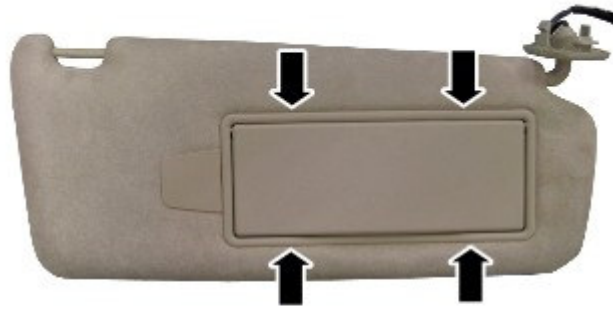
E150926

Using a suitable tool, release the retaining clips and remove the sun visor vanity mirror from the sun visor.

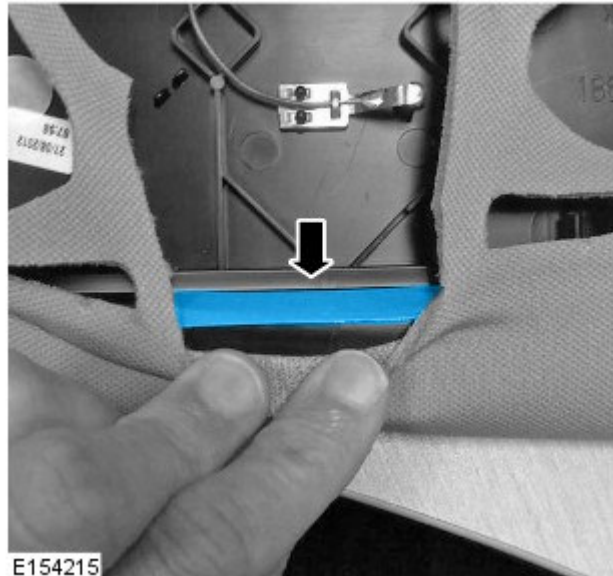
E154215

2. Install double-sided tape as shown.

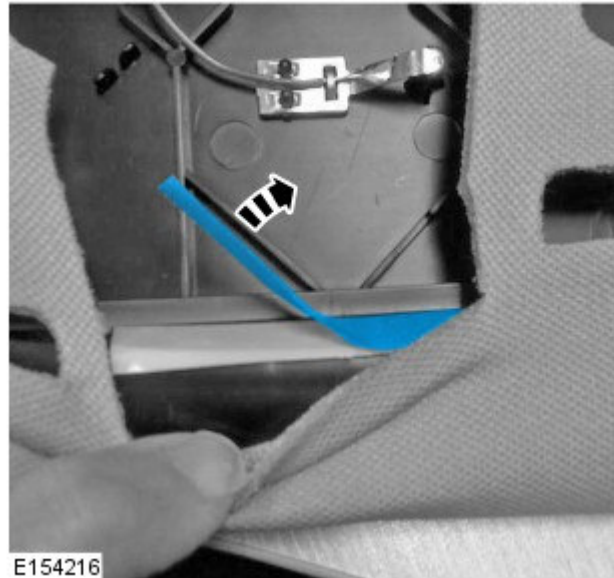
3. Remove the tape protector paper.

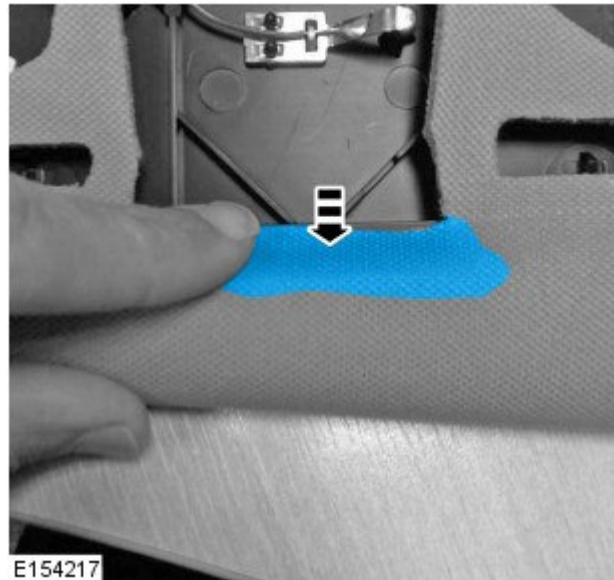
4. Position and press into place the fabric onto the double-sided tape.

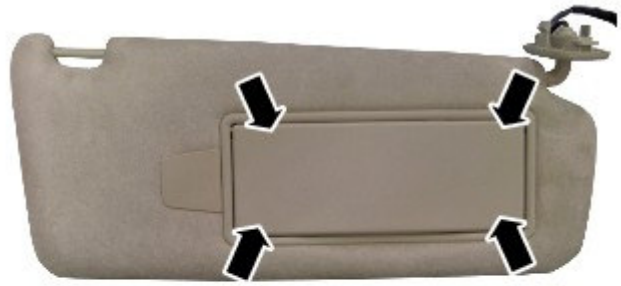
E150927

Install the sun visor vanity mirror by pressing firmly against the areas indicated until an audible 'click' is heard.
