TECHNICAL BULLETIN
JTB00304NAS1
16 SEP 2013

SECTION: 501-05

Sun Visor - Lower-Level Service Repair

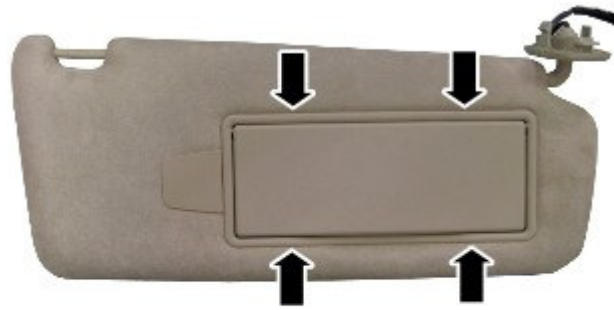
E150926

1. Using a suitable tool, release the retaining clips and remove the sun visor vanity mirror from the sun visor.

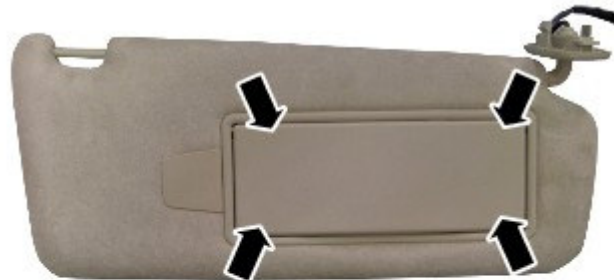
E150927

Install new sun visor vanity mirror, pressing firmly against the areas indicated until an audible 'click' is heard.

**CAUTION: Do not use excessive force to install the new sun visor vanity mirror.**
