**NUMBER:** 23-020-13

**GROUP:** Body

Right Front Door Body Side Molding Adhesive Visible

2013 (RT) Town and Country

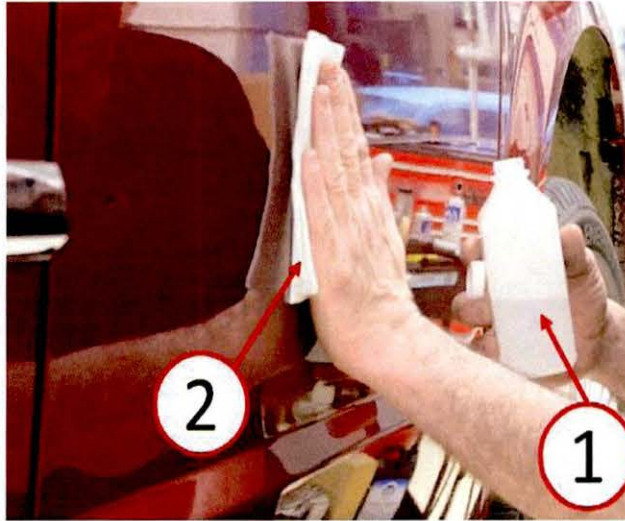
*Fig. 4 Cleaning Panel*

- 1 - Isopropyl Alcohol
- 2 - Lint Free Rag

4. Clean the surface area where the new molding will be installed with isopropyl alcohol (Fig. 4).

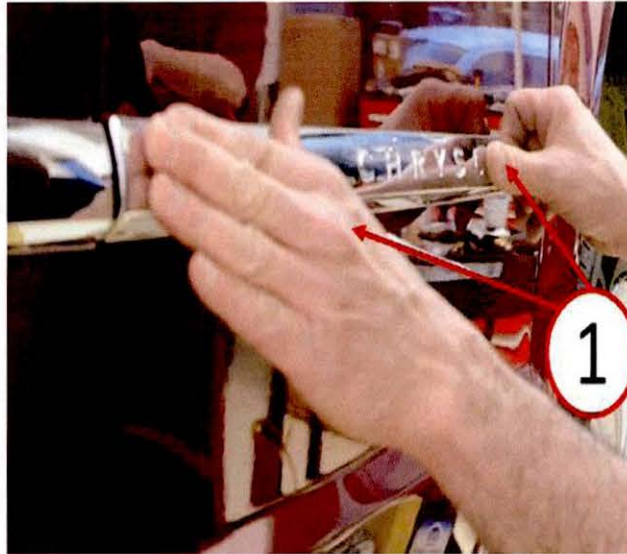
**Fig. 5 Installing Right Door Molding**

1 - Applying Firm Pressure And Aligning With The Sliding Door Molding

- 
5. Remove the adhesive protective backing from the new door molding and install on the vehicle aligning with the sliding door molding (Fig. 5).

**NOTE: Using your hands apply firm pressure to the molding in 20 second intervals to ensure it is properly wetted out.**
