NUMBER: 23-028-13
GROUP: Body
DATE: August 06, 2013

SUBJECT:
3rd Row Seat Unstow Strap Detached From Seat Bottom Frame

MODELS:
2012 (RT) Caravan / Town and Country

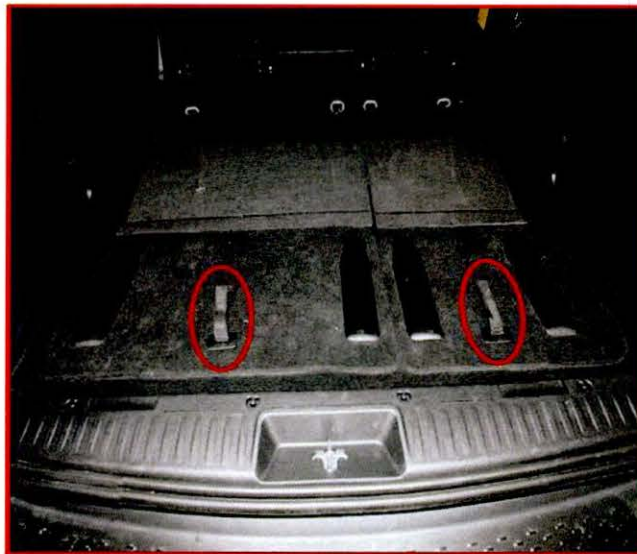
Fig. 1 Third Row Seat Bottom Pull Strap Locations

SYMPTOM/CONDITION:
The customer may experience the 3rd row seat unstow strap(s) (Fig. 1) detach from the bottom seat cushion frame when attempting to return the seats from the stowed to upright position.

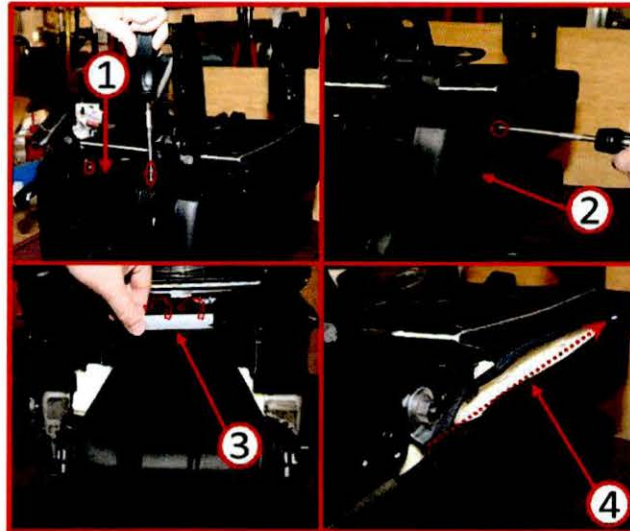
Fig. 2 Remove Seat Cushion Cover Trim

- 1 - Rear Trim Cover/Grocery Bag Holder (3rd Row 40% Bottom Seat Cushion Shown)
- 2 - Side Trim/Recliner Cover (Inboard of 40% Seat Shown Outboard Similar)
- 3 - Seat Cushion Upholstery Retainer/J-Strap (Under Rear Trim Cover)
- 4 - Bottom Seat Cushion Upholstery Cover Zipper (Inboard of 40% Seat Shown Outboard Similar)

1. Remove both third row stow and go seats. Refer to the detailed procedures available in DealerConnect >TechCONNECT > under: Service Info > 23 - Body > Seats, Third Row, Stow-n-Go > SEAT, Stow-n-Go > Removal.
2. Remove screws securing the rear trim cover/grocery bag holder (1) (Fig. 2).
3. Remove the inboard and outboard side trim/recliner covers (2) (Fig. 2).
4. Disengage the seat cushion upholstery cover retainer/J-strap (3) from the bottom cushion pan (Fig. 2).
5. Unzip both sides of the bottom seat cushion upholstery cover (4)(Fig. 2).

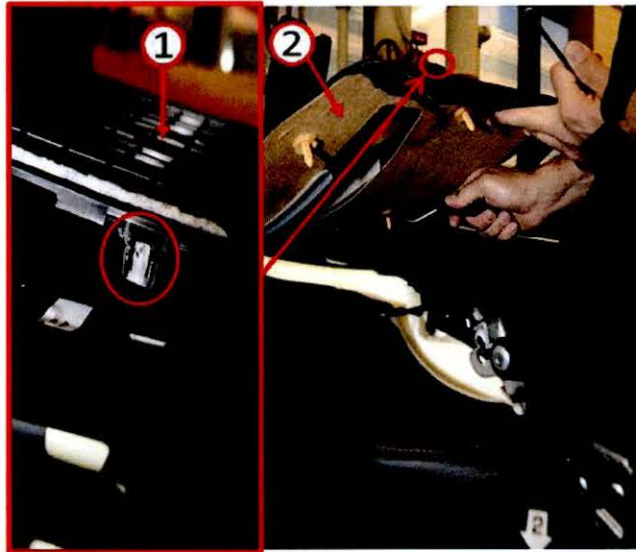
Fig. 3 Partially Remove Seat Cushion Cover

- 1 - Plastic Carpeted Closeout/Flip Panel (Inboard Side Retainer Shown Outboard Side Similar)
- 2 - Seat Cushion Upholstery Cover (Backer Board Shown)

-
6. Disengage the retaining tabs of the carpeted plastic closeout/flip panel (1) to access and remove the plastic retaining push clips of the seat cushion upholstery cover backer board (2) (Fig. 3).

7. Reposition the seat cushion upholstery cover to gain access to the bottom seat frame pull strap.

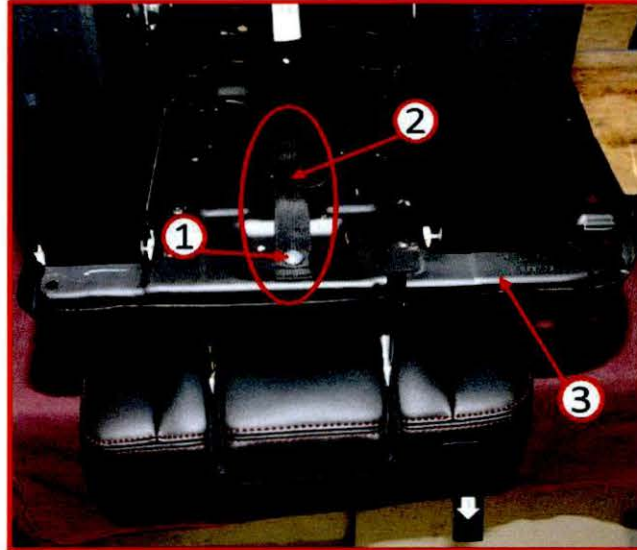
Fig. 4 Reinstall Pull Strap

- 1 - Location of Original Rivet (Retains Pull Strap to Seat Frame)
- 2 - Bottom Seat Frame Pull Strap
- 3 - Bottom Seat Frame (3rd Row 40% Seat Shown 60% Seat Similar)

-
8. Re-secure a new pull strap to the suspect seat bottom frame and/or modify the existing pull strap by removing the rivet and installing the 1/4"-20x1/2" Bolt with a 1/4"-20x1/2"Dia. Flat Washer on the top side of the pull strap and bottom side of the seat frame and secure the bolt using a 1/4"-20 lock nut (Fig. 4).
