Service Bulletin

Bulletin No.: 13144

Subject: 13144 – Service Update for Inventory and Customer Vehicles – Black Door Tape Replacement / Cleaning

Models: 2013 Chevrolet Aveo, Sonic, Spark M300 / T300

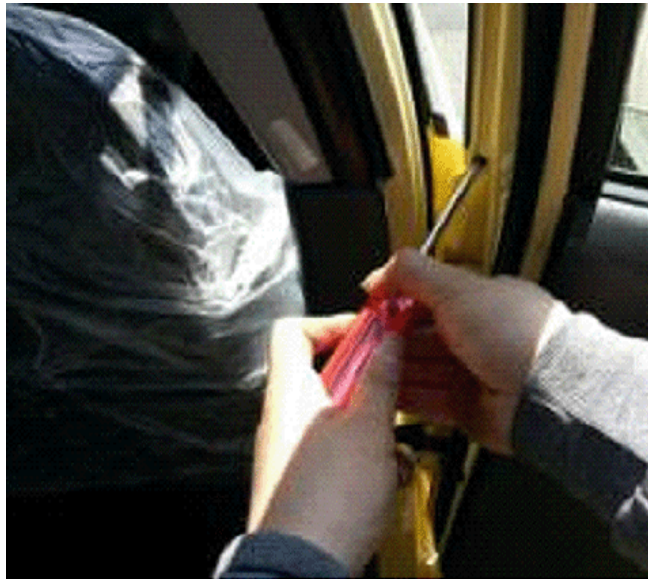
3512217

1. Remove the exterior door sill molding at the window.

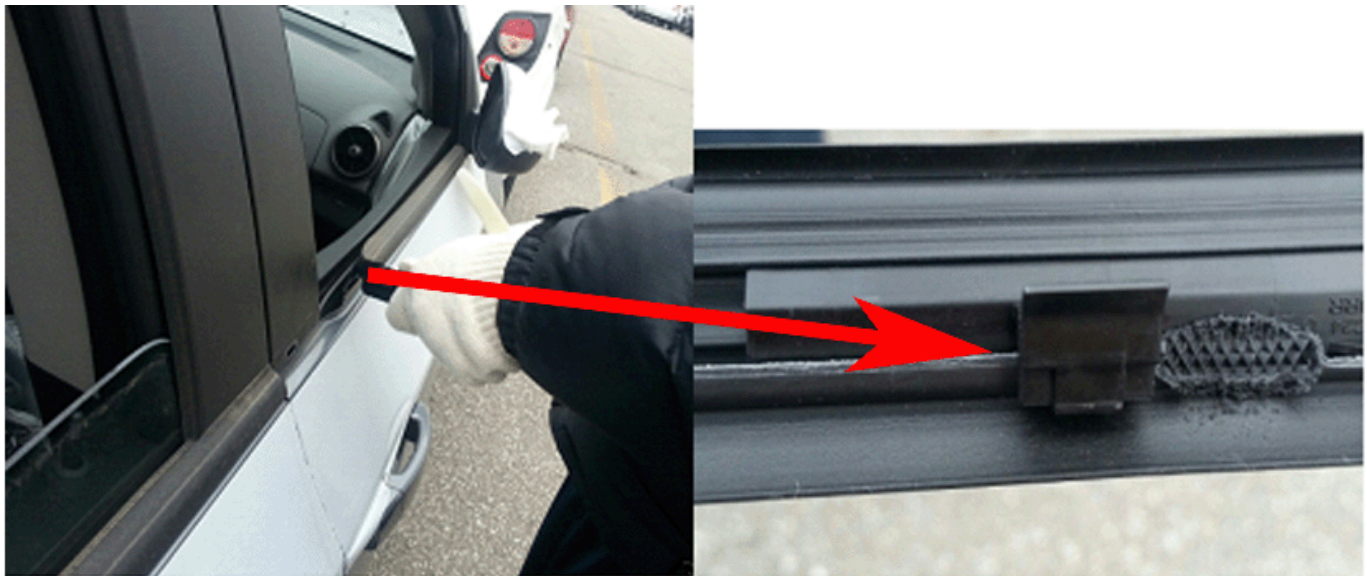
3512220

- **FOR M300 MODEL:** Lower the door glass window fully and remove the screw from door glass molding (located in interior door jamb) with screwdriver. (FRT LH/RH, RR LH/RH)

Important: Be careful not to bend or damage the molding when disassembling it. If you lift it up step by step slowly, you can avoid door molding bending & damage.

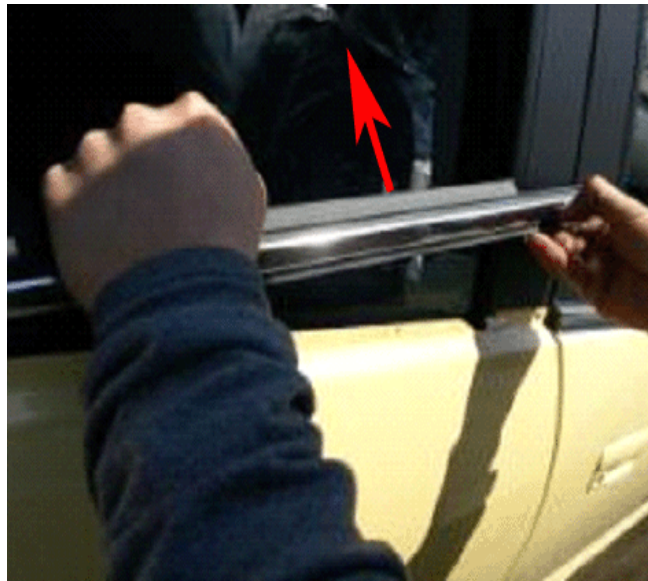
3512221

– **FOR T300 MODEL:** Lower the door glass window fully and remove the door glass molding with special tool.
(FRT LH/RH, RR LH/RH)

Important: A new exterior door glass sill molding should be replaced if clips are broken during disassembly.

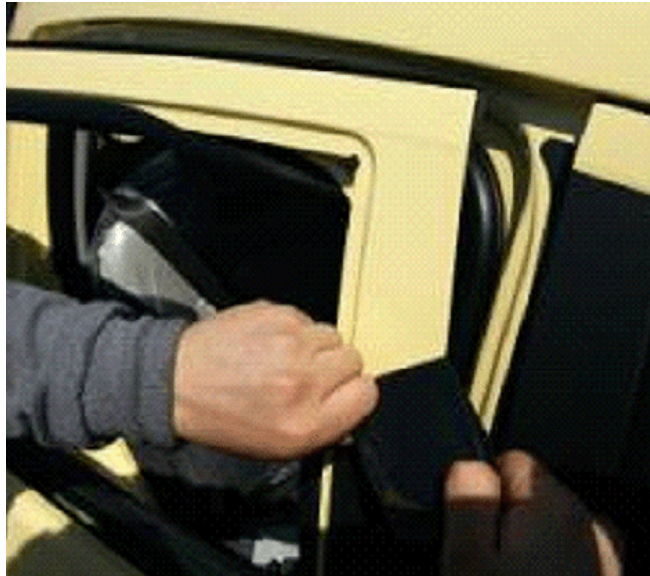
3512223

3. Pull the door weather strip to rework position.

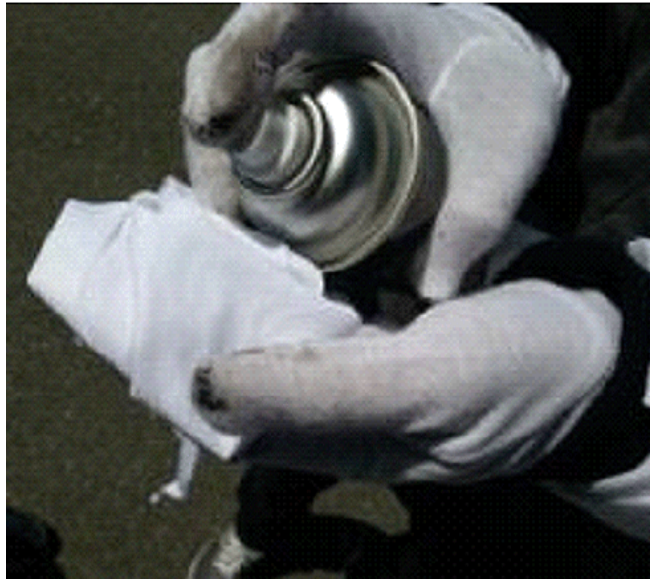
3512224

4. Remove the black tape from the door.

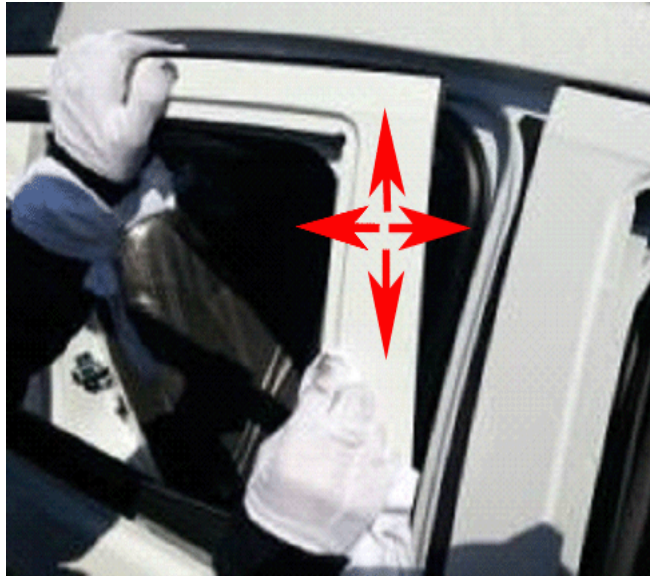
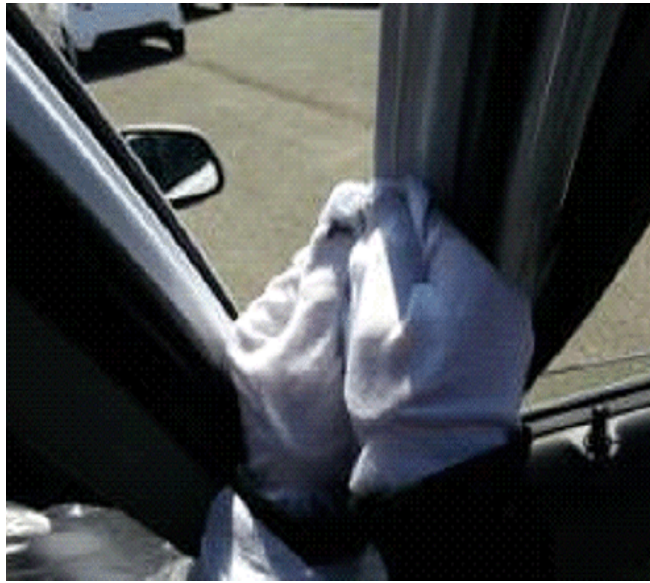
3512226

5. Wipe to remove adhesive residue using 3M Premium Sticker Cleaner – MS061 or equivalent if available.

Important: Do not spray the adhesive remover on the body directly.

Notice: Clean the stained remover on the body parts if required (OSRVM cover/Glass run/Door molding / Fixed glass molding.)

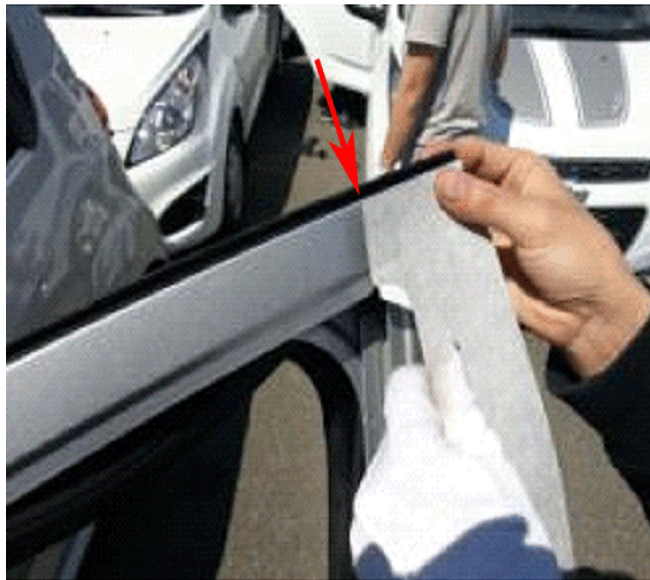
3512233

6. Align door top and the new black tape to the upper door edge and attach the black tape.

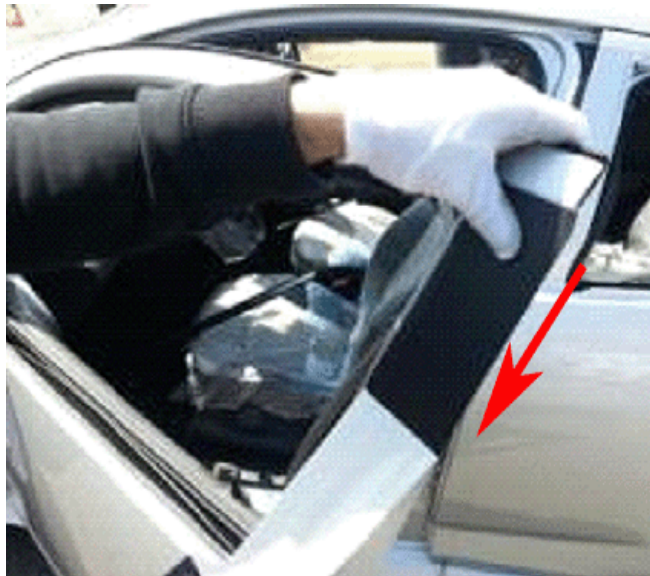
3512242

– Remove release-liner and squeeze with squeegee from top to bottom.

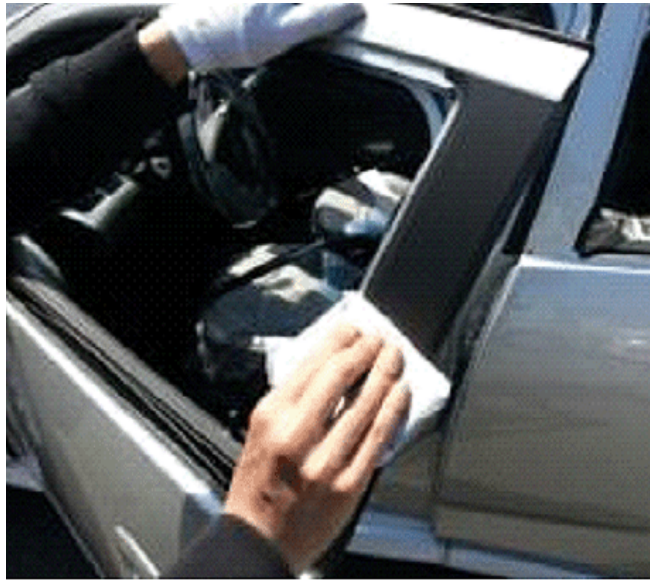
3512243

7. Remove the Pre-Mask Tape.

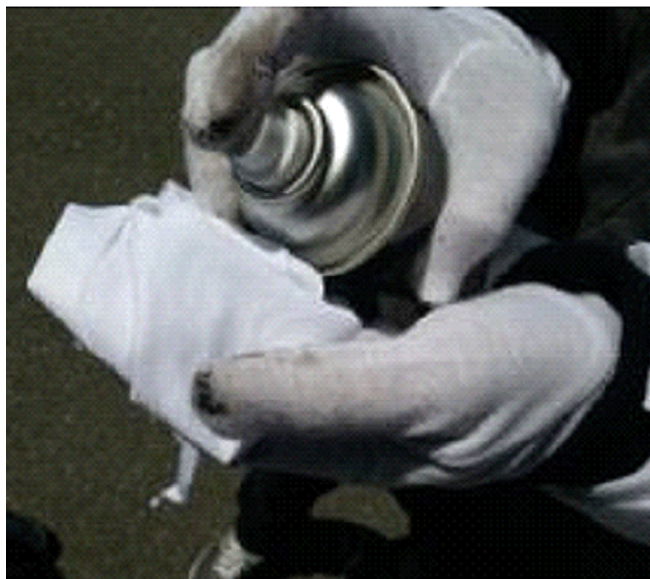
3512224

1. Remove the black tape from door body

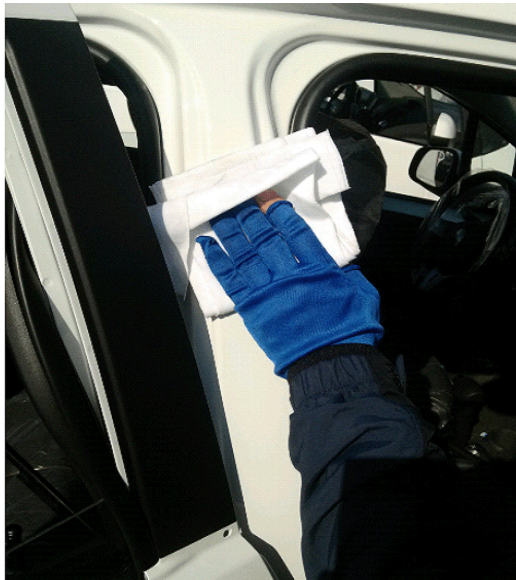
3512247

2. Wipe to remove adhesive residue using 3M Premium Sticker Cleaner – MS061 or equivalent if available.

Important: Do not spray the adhesive remover on the body directly.

Notice: Clean the stained remover on the body parts if required (OSRVM cover/Glass run/Door molding / Fixed glass molding.)

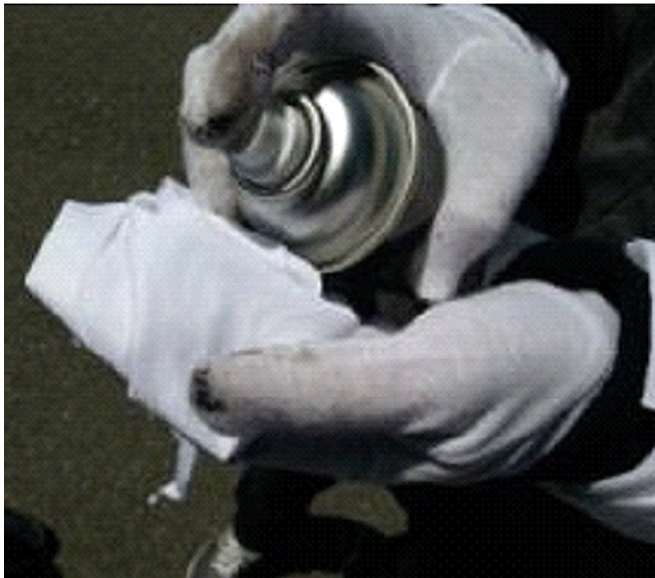
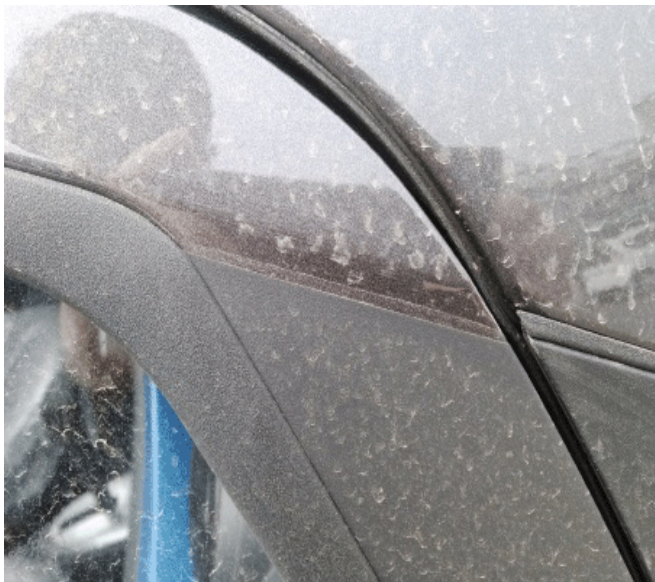
3512259

1. Wipe to remove adhesive residue using 3M Premium Sticker Cleaner – MS061 or equivalent if available.

Important: Do not inject the remover on the body directly

Notice: Clean the stained remover on the body parts if required (OSRVM cover/Glass run/Door molding / Fixed glass molding.)
