Model(s)	Year	Eng. Code	Trans. Code	VIN Range From	VIN Range To
Tiguan	2012- <mark>2014</mark>	2.0T (CCTA)	All	AX_CW000001	AX_EW527755

20 13 08 October 22, 2013 **2031557** Supersedes V201204 dated December 5, 2012 to include additional model year applicability.

Crank, No Start after Long Periods without Driving

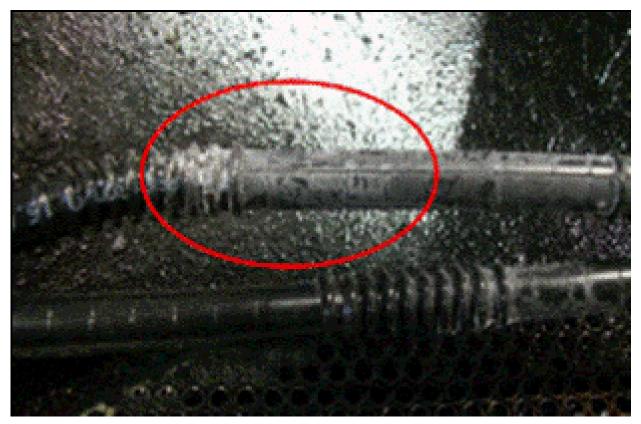
Figure 1

The black in-tank fuel lines contain a material known as PA12. PA12 was not meant to be used with fuel containing alcohol/methanol/ethanol. If PA12 fuel lines sit in fuel for over 3 day without driving and in temperatures over 77° F (25° C) a chemical reaction occurs that creates small white crystals to form on the lines (figure 1). These crystals can flake off into the fuel, gumming up the pumps and lines.

A reaction of the in-tank fuel line exterior will only occur one time, once the material has been removed, the lines and system require no further repairs.

Fuel lines made without PA12 to be placed into production.

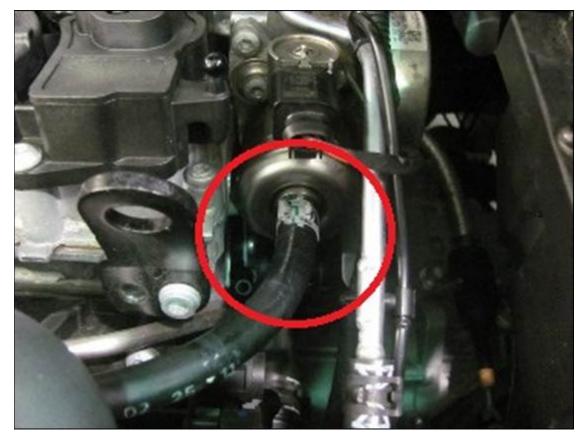
Figure 2

• Remove the fuel supply line to the high pressure pump (figure 2).

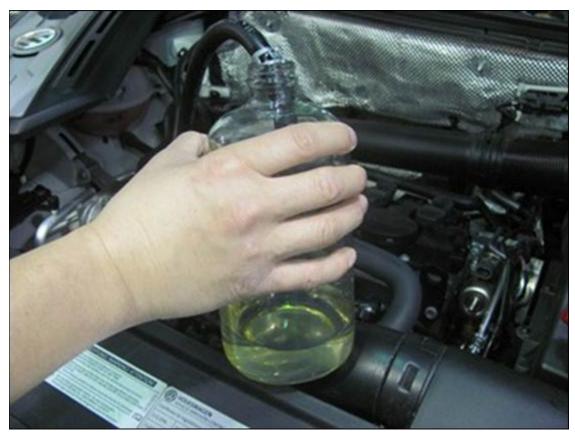
Figure 3

• Place the fuel supply line into a fuel safe clear container (figure 3) and cycle the key for 2 seconds 2 times.

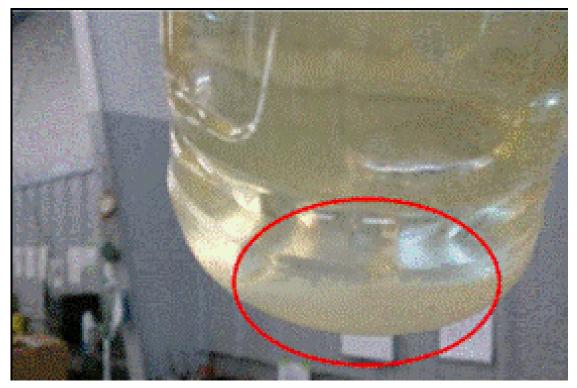
Figure 4

• Check the sample of fuel for debris.

- If debris is found (figure 4), remove the rear seat bottom to gain access to the in-tank fuel pump.
- If no debris is found (figure 4), please contact the Volkswagen Technician Helpline for further instructions.

- Remove the in-tank fuel pump and recover as much of the contaminated fuel as possible using an approved gas caddy.
- Once the fuel tank is empty, reinstall the in-tank fuel pump, rear seat bottom and fill the tank with \$20.00 of new fuel.

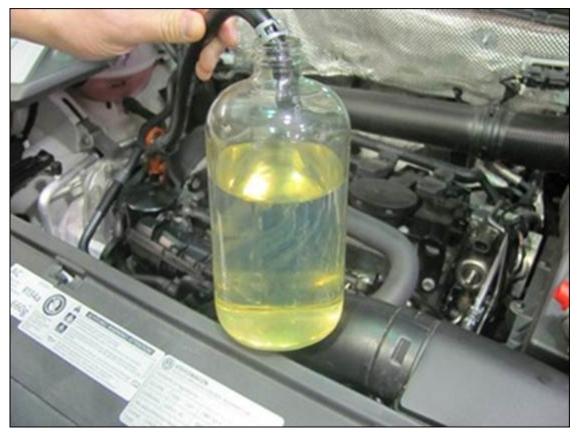
Figure 5

• With new fuel in the tank, reinsert the supply line into a fuel safe clear container and cycle the key for 2 seconds 5 times (figure 5). This is done to clean out the fuel line with good fuel.

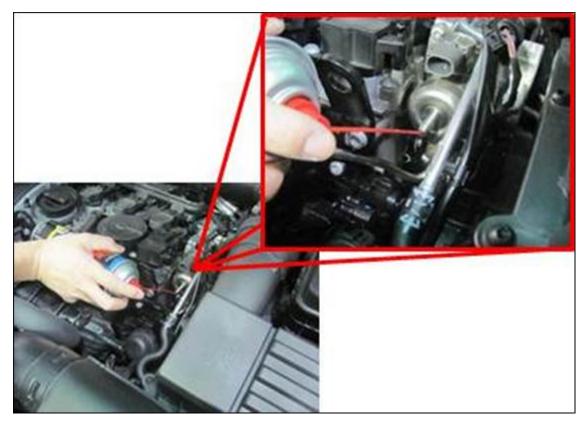
• Before reinstalling the fuel supply line onto the high pressure pump, use brake cleaner and shop rag to flush out the high pressure pump inlet (figure 6). Spray brake cleaner into inlet using a 1 second burst (you may have to repeat this step 2-3 times to ensure all debris is removed).

Figure 6 shows the placement of the brake cleaner nozzle to the high pressure pump. Figure 7 shows the placement of the shop rag and the removed debris, some pumps may contain more/less debris.

Make sure the shop rag is wrapped around the inlet/spray nozzle before spraying the brake cleaner
