**NUMBER:** 14-002-13 REV. A

**GROUP:** Fuel System

Fuel Spit Back During Refueling Due To Inlet Check Valve (X48 Lifetime Warranty Extension)

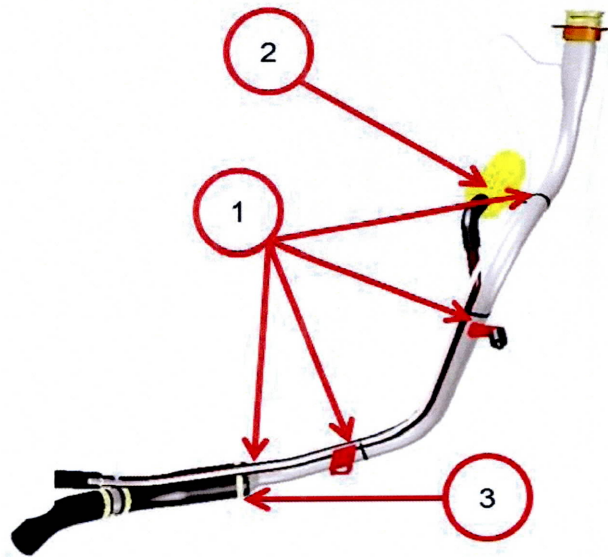
**Fig. 1 Fuel Filler Tube**

- 1 - Evaporative Emission Filter Retaining Tie Straps - Four Straps
- 2 - Evaporative Emission Filter and Hose Assembly
- 3 - Worm Gear Hose Clamp

1. **\*\*The new fuel filler tube (p/n CNNZX390AA) has an evaporative emission hose and filter assembly attached to the filler neck (Fig. 1) that will not be used in this repair. Cut the four tie straps that secure the evaporative filter and hose to the new fuel filler tube. Remove and discard the evaporative filter and hose.\*\***
2. On new fuel filler tube verify and write down existing torque (Fig. 1).

**NOTE: It may be necessary to loosen the worm gear hose clamp and rotate to allow the fuel filler neck to fit between the body and frame. If clamp is loosened then once installed re-torque to noted value.**
