Service Action Campaign

Code: 20U3

**Subject: 2010-2012 Model Year Audi A3 with TDI® Clean Diesel Engine
Install Misfueling Guard**

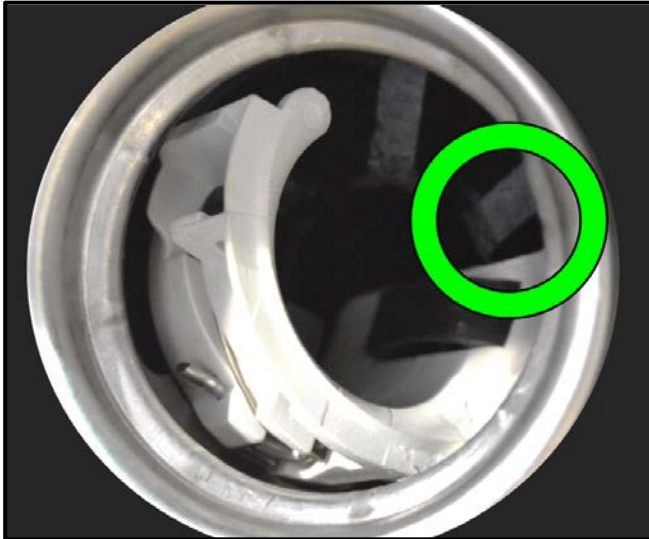
- ⇐ Insert the lockout mechanism into the filler neck and rotate from right-to-left <arrow> to seat properly into position.

Tip: The right side of the mechanism must be placed into the filler neck opening first.

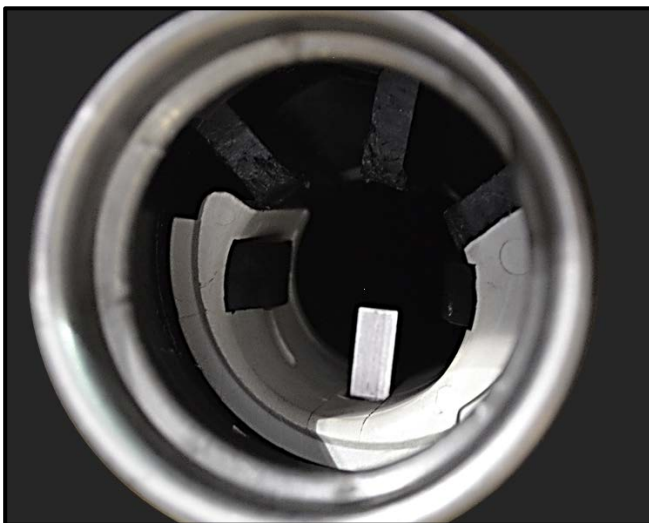
⇐ During installation the lockout mechanism must remain to the right of the right tab in the filler neck opening <circle>.

- With the right side of the lockout mechanism properly lined up, press the left side into the filler neck.
