Service Bulletin

Bulletin No.: 09-01-39-007B

Subject: Carpet Wet When A/C is On (Realign A/C Drain Tube)

Models: 2011-2013 Chevrolet Caprice PPV
2008-2009 Pontiac G8

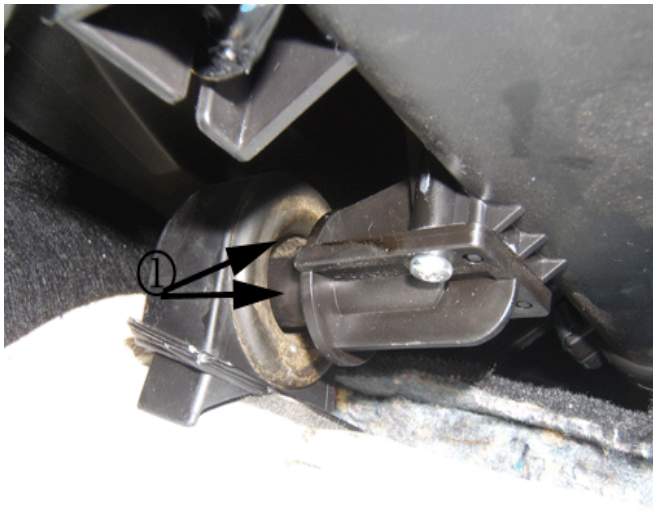
2321888

Example of a Collapsed A/C Drain Grommet

This condition may be caused by a collapsed A/C drain grommet (1), resulting in a wet carpet condition.

Remove the panels in order to gain access to the A/C drain pass-thru grommet and realign the drain tube using the procedure listed below.
