Tech Tips

TT 50-12-01

**2011-2014 Jetta Sedan – Water Leak into Front Passenger
Compartment**

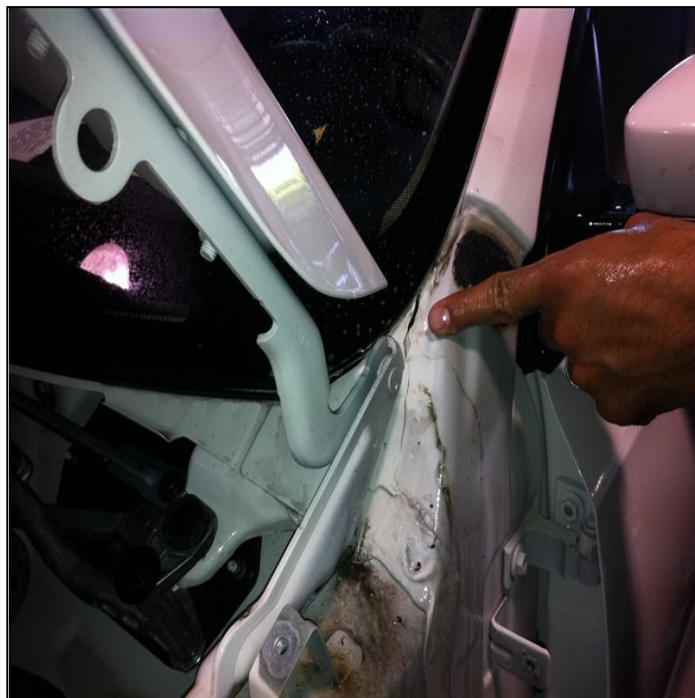
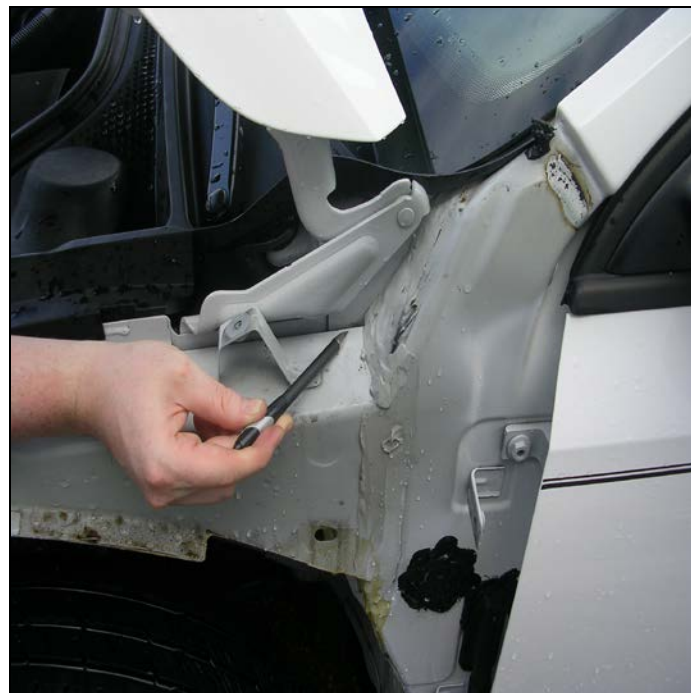
A concern of water leak into the front passenger compartment may be caused by a seam sealer skip or hole in the area around hood hinge or behind front fender.

Isolate leak location by switching HVAC blower on high, with all doors and windows closed, and then spraying soapy water, or a foaming cleaner, over seam sealer. If bubbles are observed at any point during this test, repair leak at location of bubbles using an appropriate seam sealer.
