# Service Bulletin

Bulletin No.: 13-08-51-001

**Subject:** Dark Stains on Tonneau Lid Outlining Convertible Roof

**Models:** 2005-2013 Chevrolet Corvette Convertible Models Only

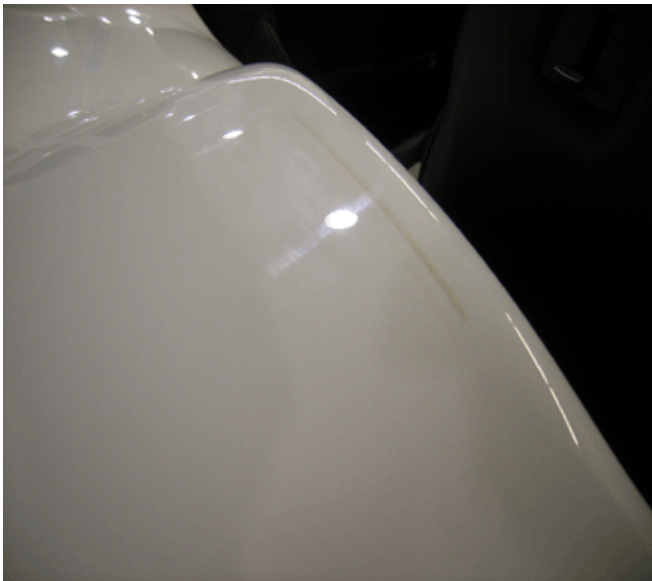
2182503

Some customers may comment on a stain on the rear tonneau lid, noticed when the roof is retracted and the tonneau is exposed. The stain is commonly found centered on one or both of the forward hump surfaces of the tonneau lid.

The cause of this condition may be the rear glass sunshade bleeding its dye onto the rear tonneau and the paint absorbing this dye due to the paint curing process at Bowling Green Assembly. This will typically be noticed on lighter colored vehicles, however, it may occur on any color vehicle.

To correct this concern, polish/refinish the rear tonneau and add two pieces of transparent protective film using the procedures below:

1. Following manufacturer specific instructions, use a light rubbing compound to remove the stain.
2. Polish the area.
3. Confirm that the stain is removed. If the stain is removed, apply one piece of transparent protective film, GM P/N 23117964 over the affected areas at each location to prevent the stain from reoccurring.

**If the stain is still present after using the light rubbing compound, do not apply the protective film until continuing with the remaining steps.**

4. Wet sand the affected area.
5. Refinish the panel using the appropriate base and clear coat.
6. Allow to dry fully, then apply one piece of transparent protective film, GM P/N 23117964 over the affected areas at each location to prevent the stain from reoccurring.
