Service Bulletin

SUBJECT: Service Update for Inventory Vehicles Only
Rear Side Door Reveal Molding Contact
Expires February 28, 2014

MODELS: 2012-2013 Cadillac Escalade ESV, Escalade EXT

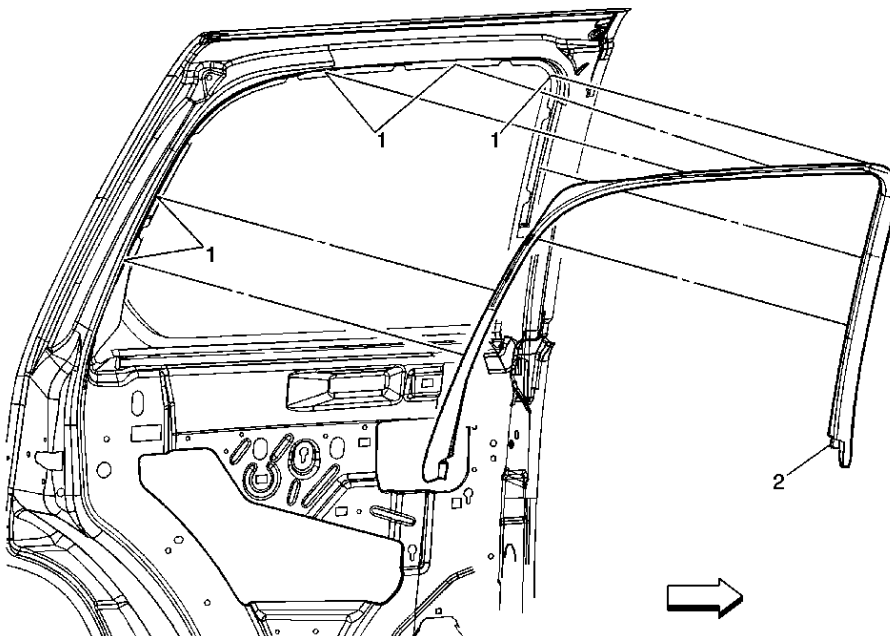
3274953

1. Carefully release the rear door opening garnish molding and carefully release lower ends from behind door trim panel.

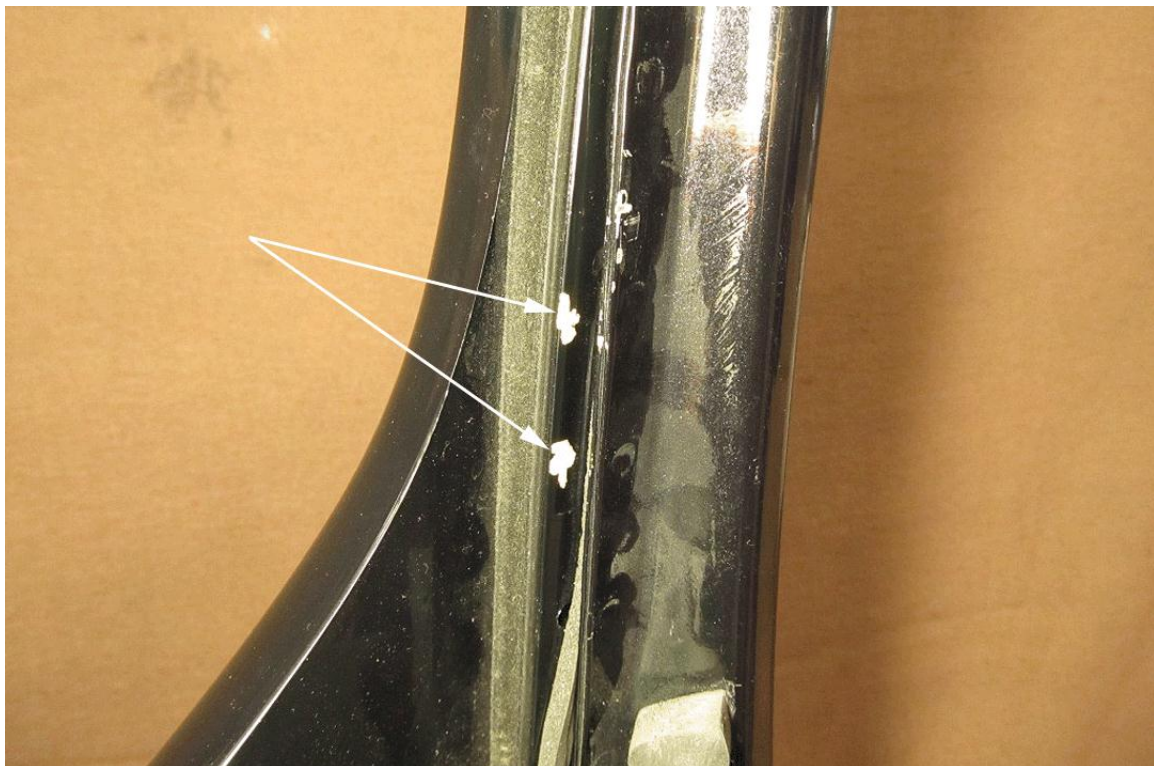
3274932

Note: The window reveal molding has a recessed flat area in the approximate location to mount the spacer.

2. Locate the lowest clip (1) on the rear edge of the window reveal molding. Measure 75mm (3 in) below the clip and mark the location on the molding. Measure 25mm (1 in) down from the first mark and mark the lower point.

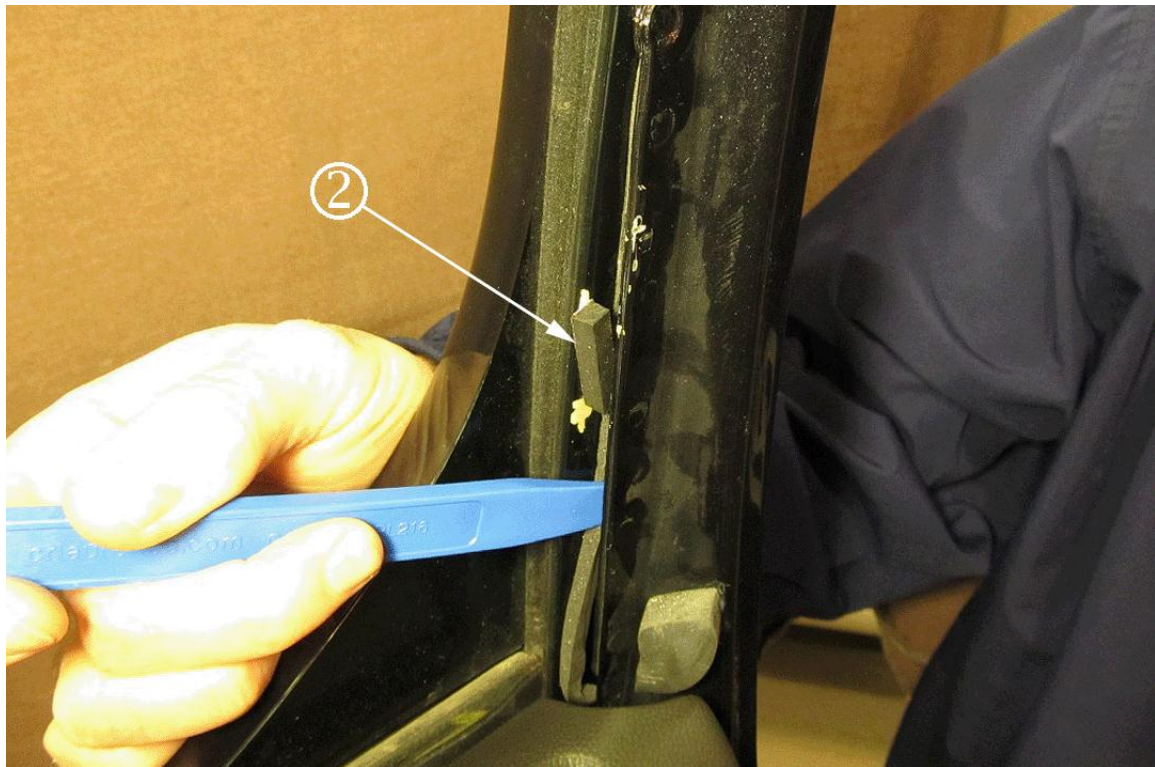
3274921

3. Using a trim stick, carefully pry the window reveal molding outward to increase clearance to the affected area.
4. Clean the surface of the reveal molding where the spacer will be placed using a general purpose adhesive cleaner to ensure that the surface is free of contaminants that may affect adhesion.
5. Wipe the repair area where the spacer will be placed with *3M Automotive Adhesion Promoter, 3M P/N 06396.
6. While providing additional clearance with the trim stick, install one supplied spacer (2) (P/N WPC695), onto the reveal molding in the marked area.

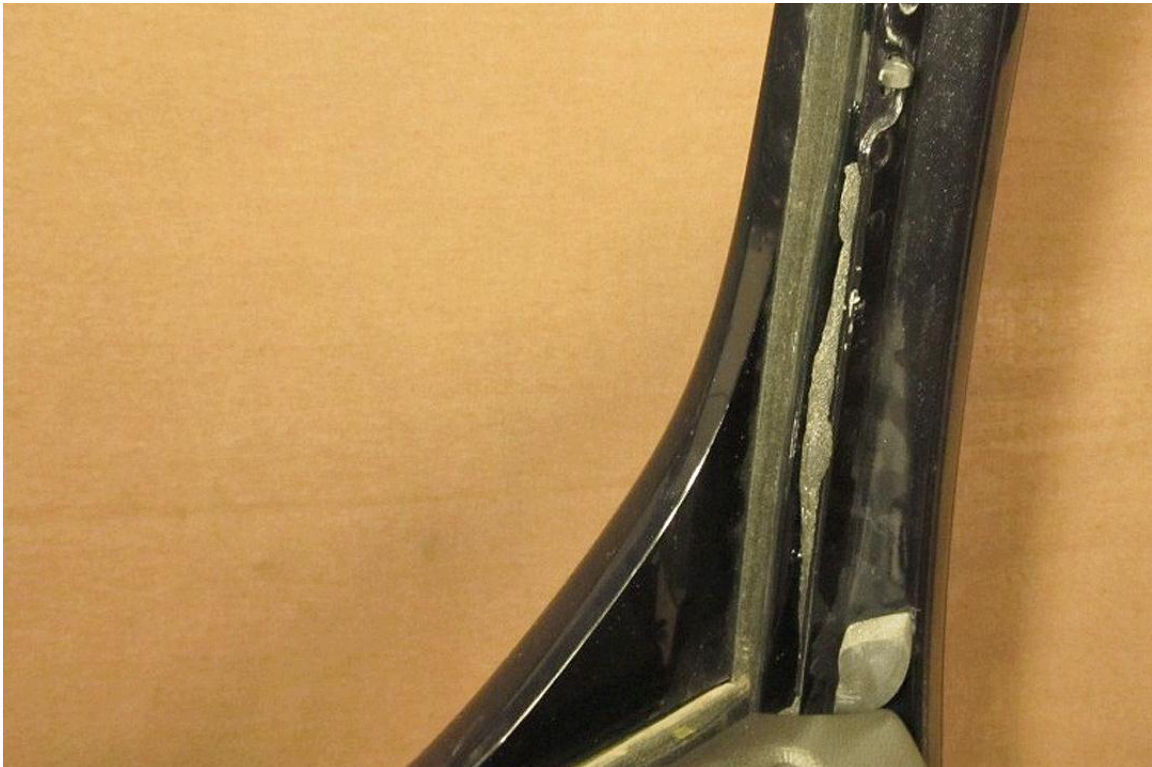
3274945

11. Inspect positioning of the weatherstrip to ensure it will not interfere with the fit of the garnish molding.
