TECHNICAL BULLETIN
LTB00612NAS1
19 NOV 2013

'Creak' Noise From Front Seat Frame

Range Rover (LG)

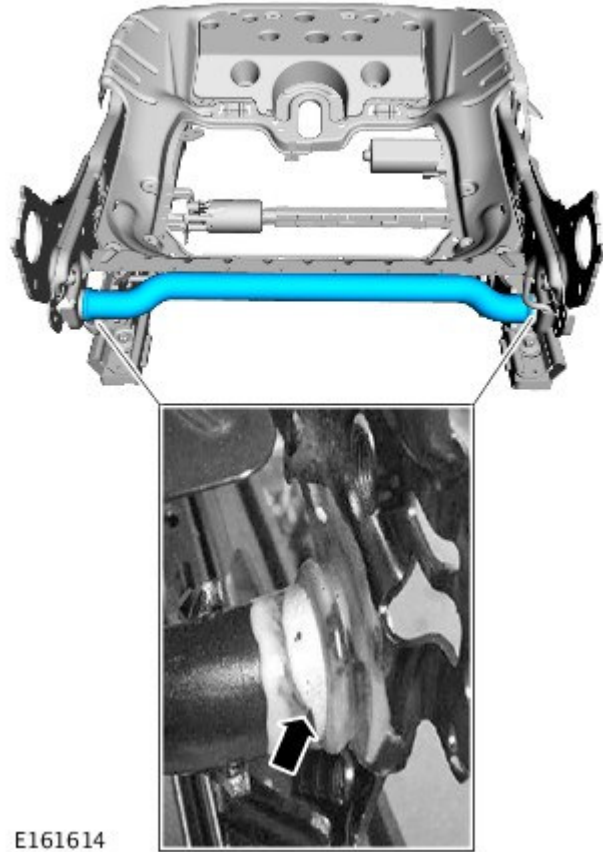
**NOTE: Repeat this procedure on both sides of the seat frame.**

**NOTE: Apply Nyogel 774L grease to both sides of the seat frame in the areas shown.**

Apply Nyogel 774L grease from the Squeaks & Rattles Kit in the area shown.

Situation: A 'creak' noise from the base of the front seat may be evident.

Cause: This may be caused by insufficient lubricant during the assembly process.
