Service Bulletin

Bulletin No.: PI0291A

Subject: High Release Efforts on Driver or Passenger Seat Back Latch or Release Handle
Difficult to Operate

Models: 2010-2012 Chevrolet Camaro

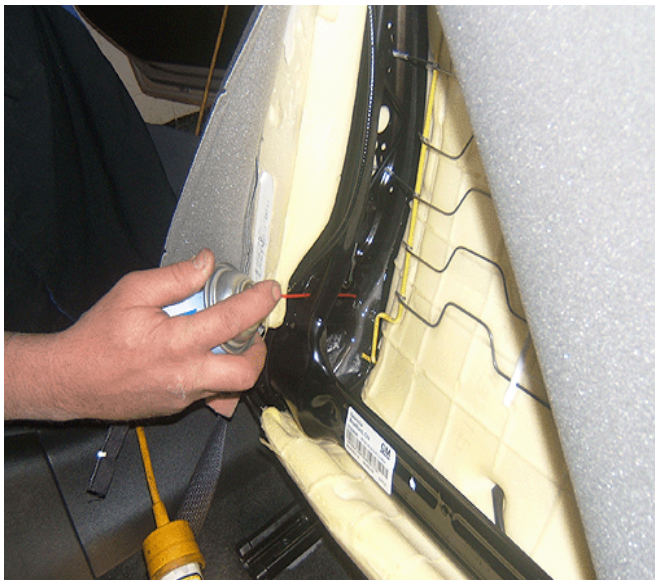
2540453

Note: One side latch has open access while the opposite side may have more limited access due to its location behind the seat recliner motor. Openings in the seat back frame should allow application of the spray to both the front and back side of the latches.

2. Gain access to the release latches by disengaging the seat back cover rear J-channel from the seat frame, then unzipping the cover on each side.
