Service Bulletin

Bulletin No.: PI0397A

Subject: Water Leak in Rear Compartment/Trunk – Convertible Top Water Management Bag Repair

Models: 2011-2014 Chevrolet Camaro Convertible

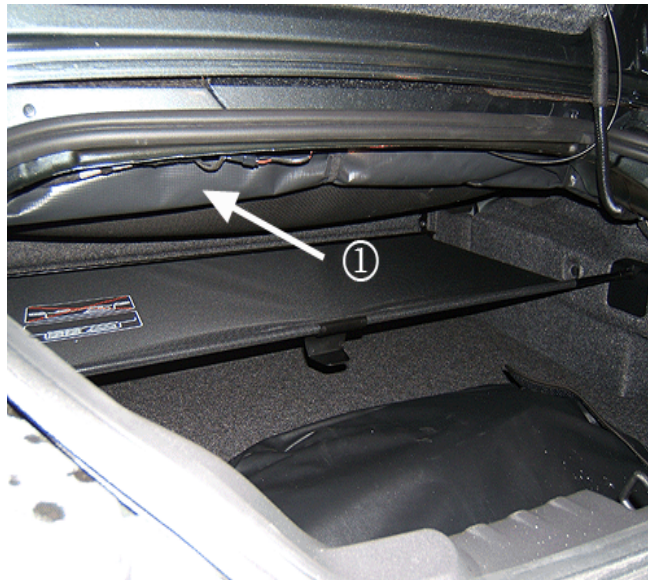
2593362

After water testing and visual inspection, the technician may find that the convertible top water management bag (1) is leaking due to a puncture or tear in the material. Aside from obvious holes/tears, the following locations should be closely inspected as potential leak areas:

Do This	Don't Do This
Repair the convertible top water management bag.	DO NOT replace the convertible top water management bag.

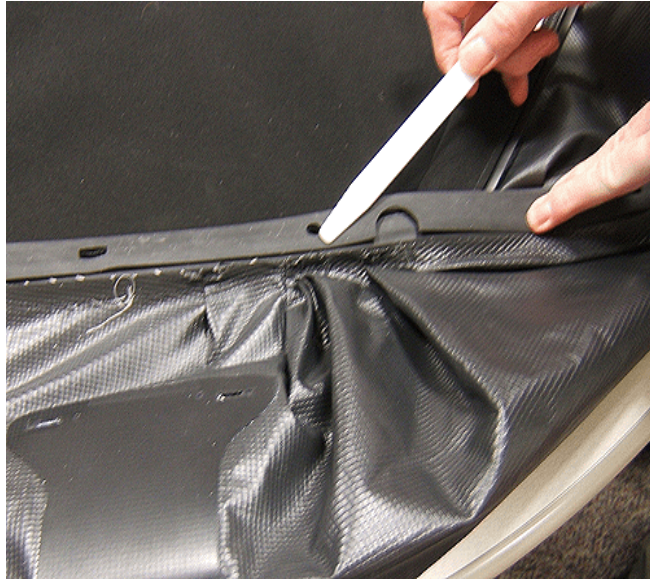
2593368

Areas of Material Folds and Seams Sewn Together

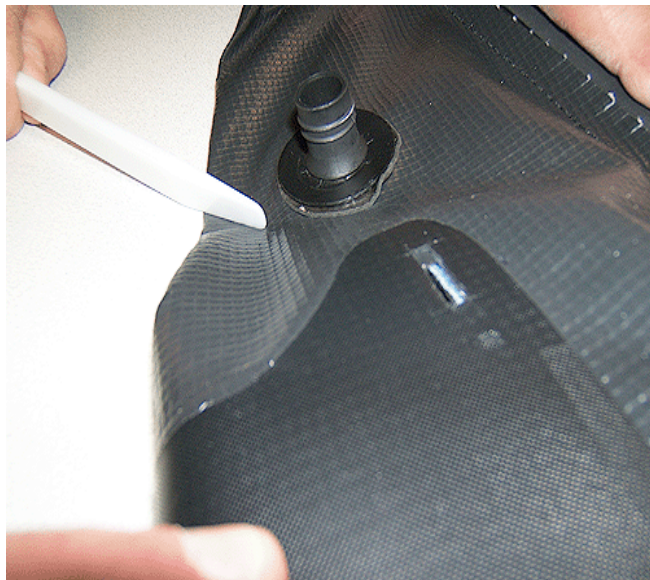
2593375

Drain Valve Locations

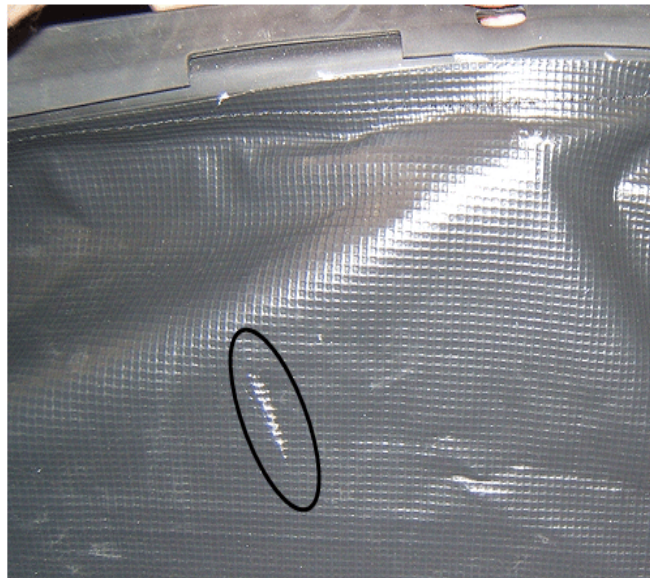
2593392

Thin/Worn Areas

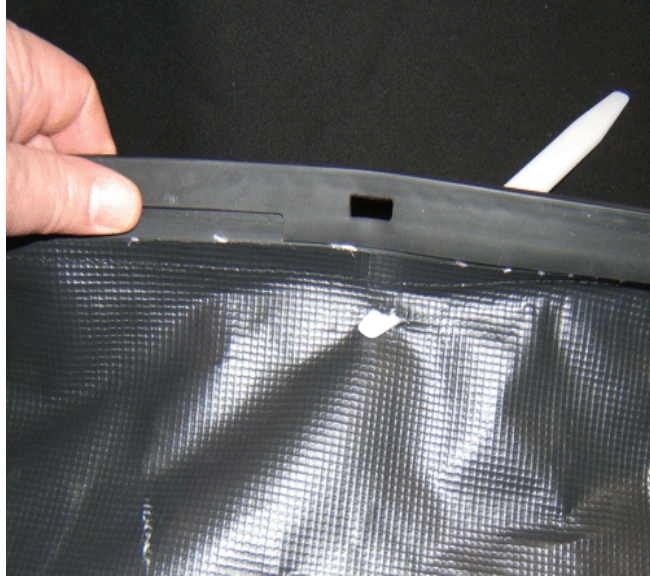
2593395

Small Holes/Punctures

For smaller repair areas, apply *Kent Automotive Quick Seal™ Seam Sealer Black P/N P10556, or equivalent, directly to the bag material:

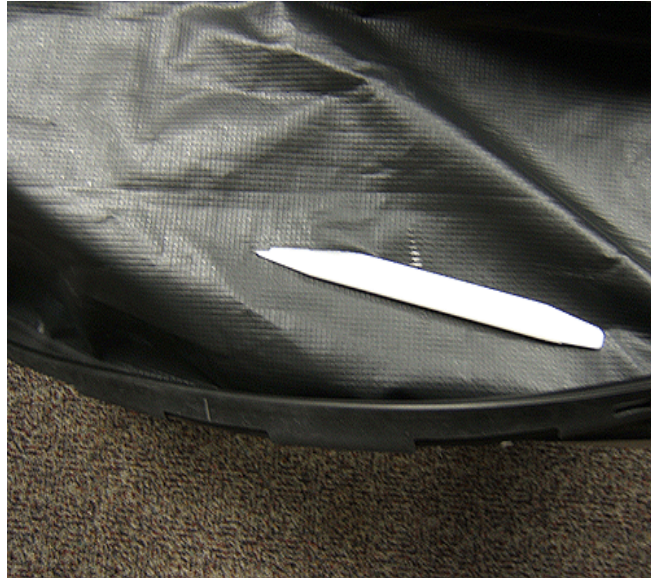
2593404

Larger Holes/Tears

For larger repair areas, reinforce the area before applying *Kent Automotive Quick Seal™ Seam Sealer Black P/N P10556, or equivalent:

Note: For wider tears/holes, it is recommended to apply the mesh tape and the seam sealer to BOTH sides of the bag material.
