Service Bulletin

Bulletin No.: PI0887A

Subject: Pulsating/Rotational Noise from Right Rear of Vehicle on Brake Apply

Models: 2012-2013 Chevrolet Cruze
Equipped with Drum Brake (RPO J93)

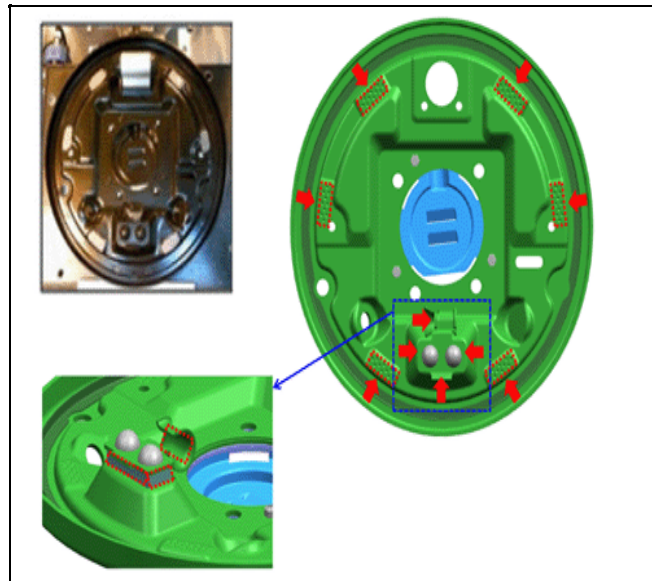
2965726

Some customers may comment about a pulsating/rotational noise coming from the right rear of the vehicle during brake apply.

This noise may be caused by an interaction from the cut between the brake drum and brake shoe.

The right rear brake drum and rear brake shoes need to be replaced including applying a high temperature grease, GM P/N 12345996 (in Canada, 10953501), or equivalent, on all the locations of the backing plate as shown in the illustration above.

Note: DO NOT replace the left rear drum and shoes as this noise condition only pertains to the right side.
