Service Bulletin

Subject: Exhaust Leak and/or Service Vehicle Soon (SVS) On and DTC P0171 Set

Models: 2013 Chervolet Cruze, Sonic 2013 Chevrolet Trax (Canada Only) Equipped with 1.4L Engine (RPO LUV)

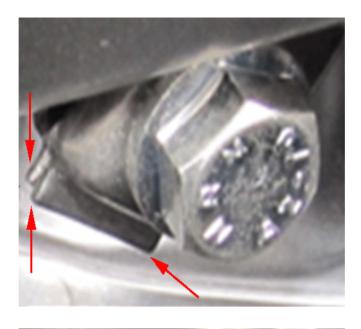
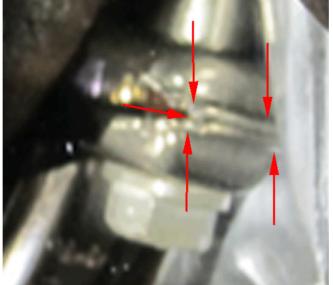
3272387

Note: The illustrations above show the ends of the V-band clamp with both flanges together completely.
