# Service Bulletin

Bulletin No.: PI0907B

**Subject:** Check Engine Light On with DTC P1101 Set

**Models:** 2013 Buick Encore  
2011-2013 Chevrolet Cruze  
2012-2013 Chevrolet Sonic  
2013 Chevrolet Trax  
Equipped with 1.4L Engine (RPOs LUJ, LUV)

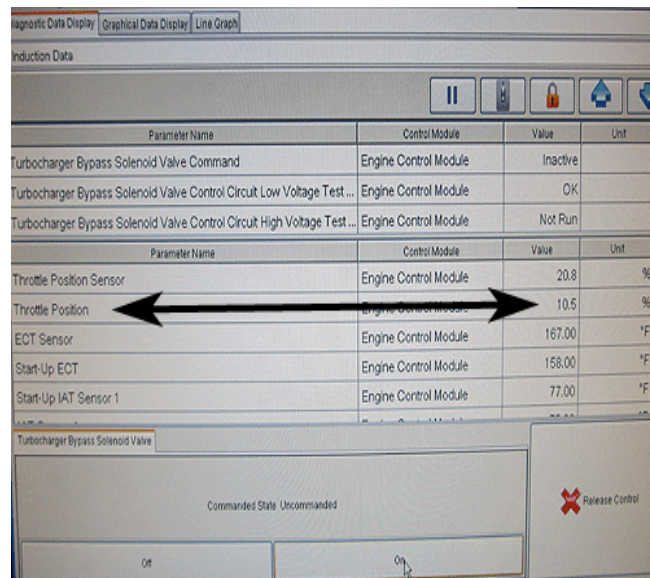
3274363

A bad throttle position reading would be less than 7% and that would indicate unmetered air is getting into the intake. If the throttle position percentages remain low and DTC P1101 still sets, refer to SI for further diagnosis.

An area to check for this is the PCV pipe with the back pressure valve open at the turbocharger air inlet. Remove the PCV pipe from the intake manifold and put a piece of tape over the opening. If the throttle position goes back to normal percentages, replace the PCV pipe following the steps below:

1. Open the hood and install fender covers.
2. Remove the air cleaner outlet duct.
3. Disconnect the PCV pipe from the intake manifold.
4. Disconnect the PCV pipe from the turbo inlet.

5. Remove the PCV from the retainers.
6. Cut away tape from the vacuum line on the PCV pipe.
7. Remove the PCV pipe.
8. Install the new PCV pipe.
9. Install vacuum line on to the PCV pipe with tape.
10. Install retainers to the PCV pipe.
11. Connect the PCV pipe to the turbo inlet.
12. Connect the PCV pipe to the intake manifold.
13. Install the air cleaner outlet duct.
14. Remove the fender covers and close the hood.

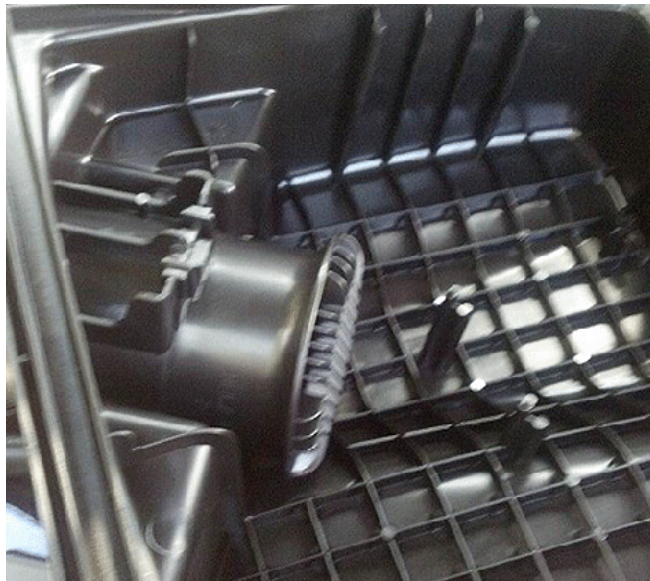
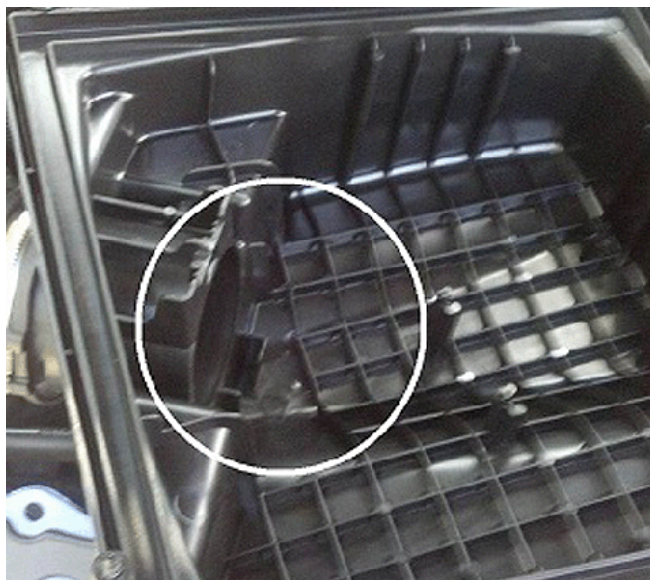
#### **Chevrolet Cruze Only**

For Chevrolet Cruze only, a missing or mispositioned air baffle in the air cleaner box could cause the TPS readings to be low and the vehicle setting P1101. Verify the air baffle is in the proper place before continuing with diagnostics. Refer to the pictures below.
