# Service Bulletin

Bulletin No.: PI0925A

**Subject:** Ventilated Seat Fan Clicking or Ticking Noise When Operating

**Models:** 2013 Cadillac XTS with RPO KU1, KU3

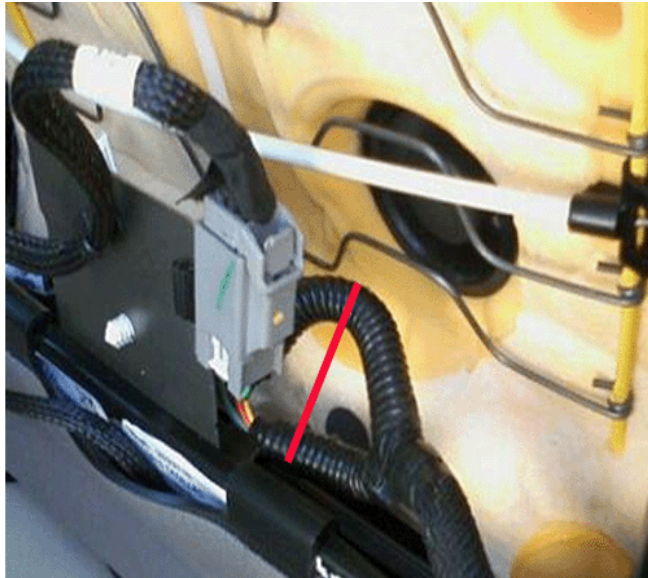
3304704

10. Inspect the under seat harness for excessive length and interference with the fan blade.
