Service Bulletin

Bulletin No.: PI0934

Subject: Service Stabilitrak or Antilock Brake System Warning Lamp Illuminated

Models: 2013 Chevrolet Equinox
2013 GMC Terrain
All Built Prior to February 26, 2013

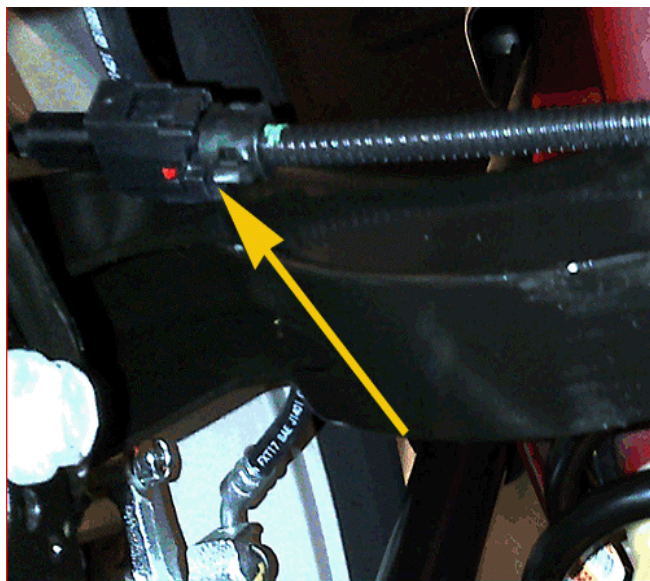
3329901

When diagnosing the vehicle, the technician may find DTC C0045 Left Rear Wheel Speed Sensor Signal or C0050 Right Rear Wheel Speed Sensor Signal set.

This condition may be caused by one or both of the rear wheel speed sensor (WSS) harness terminal(s) or connector(s) not being fully seated (connected).

Important: Do not attempt to re-seat the terminal into the connector. This will not be a permanent repair. If the terminal is out of position or not locked into the connector, the connector must be replaced.
