Service Bulletin

Bulletin No.: PI0948A

Subject: Driver or Passenger Power Seat Back Recliner Stuck and/or Will Not Recline

Models: 2013 Cadillac ATS

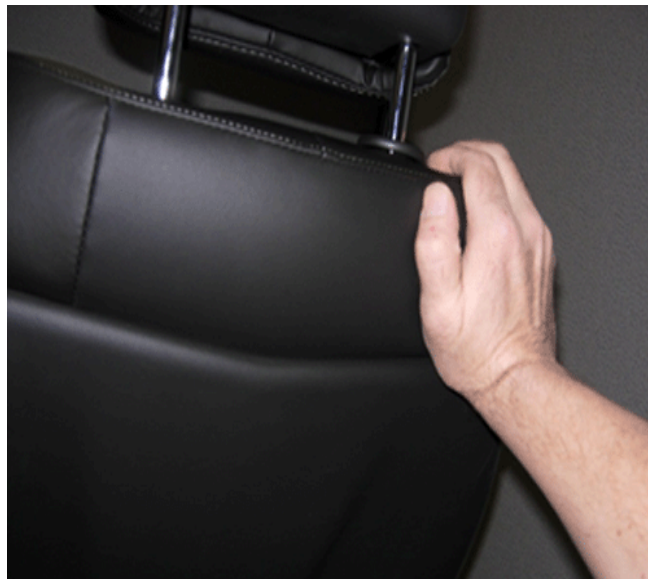
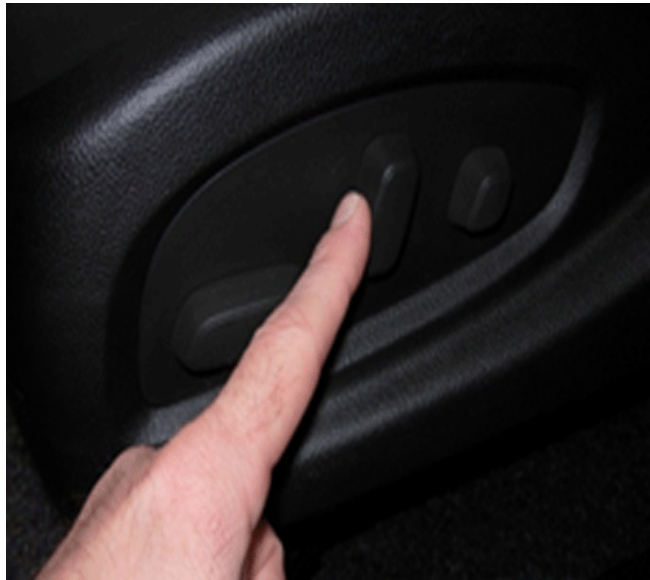
3356939

Some customers may comment that the driver or passenger power seat back recliner is stuck and/or will not recline. This may be caused by the seat back recliner stuck at the full forward or against the travel stop.

1. Push forward against the rear inboard top surface of the seat back while pushing the recliner switch rearward as shown in the illustrations above.

Note: Once the seat back starts to move rearward, stop pushing on the rear inboard top surface.
