Service Bulletin

Bulletin No.: P11008

Subject: Accessory Headrest DVD Screens Will Not Power Up After Installation

Models: 2014 Buick Enclave
2014 Chevrolet Traverse
2014 GMC Acadia
Equipped with RPO UJ5 (Dealer Installed Accessory Headrest DVD) or ACO -
Accessory Headrest DVD

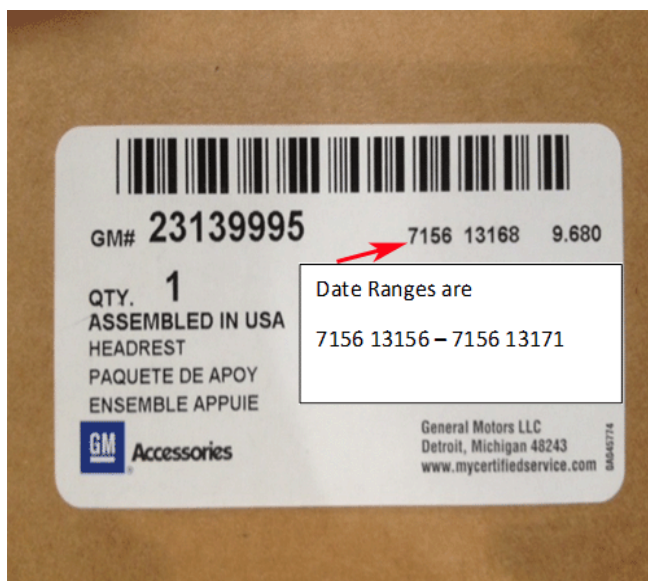
3512901

This may be caused by the power and ground wires being reversed in the accessory wiring harness. This affects headrests DVD kits built prior to June 21, 2013. Refer to the picture and table below for build date and part number information.
