# Service Bulletin

Bulletin No.: PI1034A

**Subject:** Check Engine Light On with DTC P0442 Set

**Models:** 2014 Chevrolet Impala

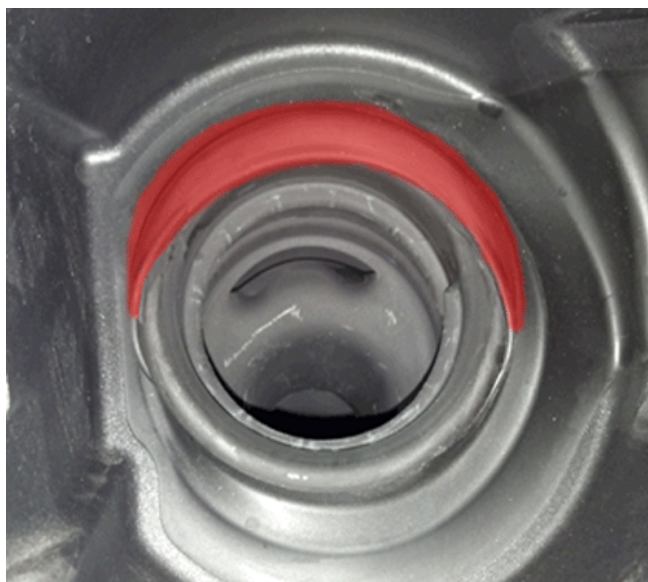
3603856

Some customers may comment on a check engine light being on. The technician may find DTC P0442 set.

This condition is due to the seal on the fuel tank filler pipe housing not seated properly during vehicle assembly, causing a small EVAP leak and the seal to overlap the fuel tank filler neck as shown in the illustration above.

Using a trim stick, push the seal over the filler neck and clear the DTC.
