# Service Bulletin

Bulletin No.: PI1070

**Subject:** Front Seat Lateral or Vertical Movement and/or Click Type Noise

**Models:** 2013-2014 Cadillac ATS

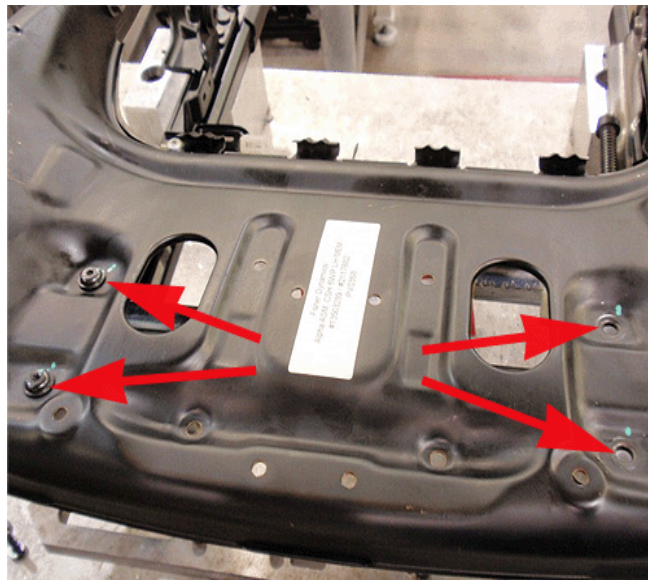
1. Remove the lower seat cushion pad on the affected seat. Refer to Driver or Passenger Seat Cushion Pad Replacement in SI.
2. Place the seat assembly on a suitable work area. Use care to place the seat on a soft clean surface to prevent damage to the seat upholstery.

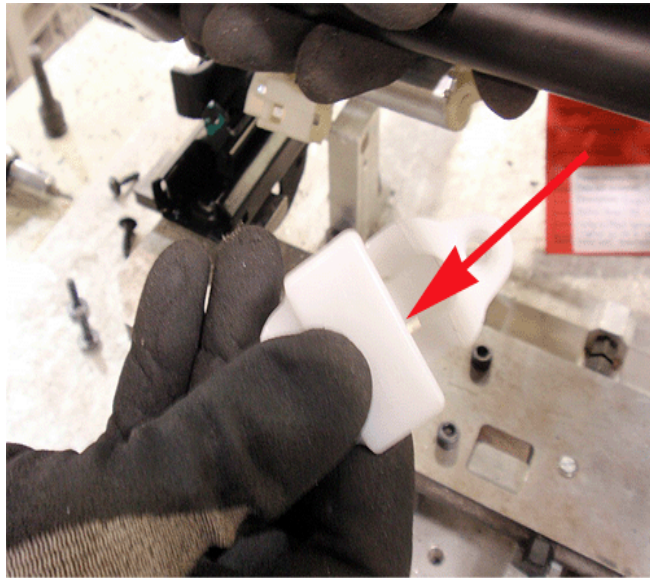
3619958

3. Remove the four screws that attach to two pivots to the seat pan.

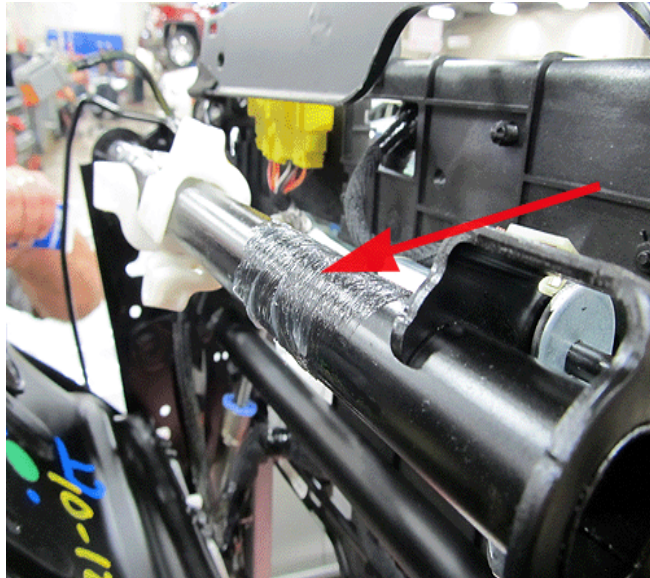
3619959

4. Remove the two seat pan pivots from the seat.

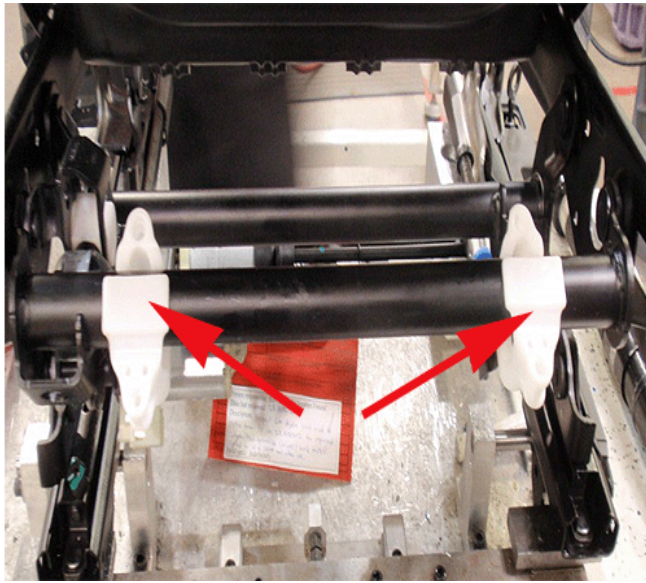
3619960

5. Using a small brush, apply GM Super Lube GM #12371287 as shown. Ensure the complete contact surface is coated.

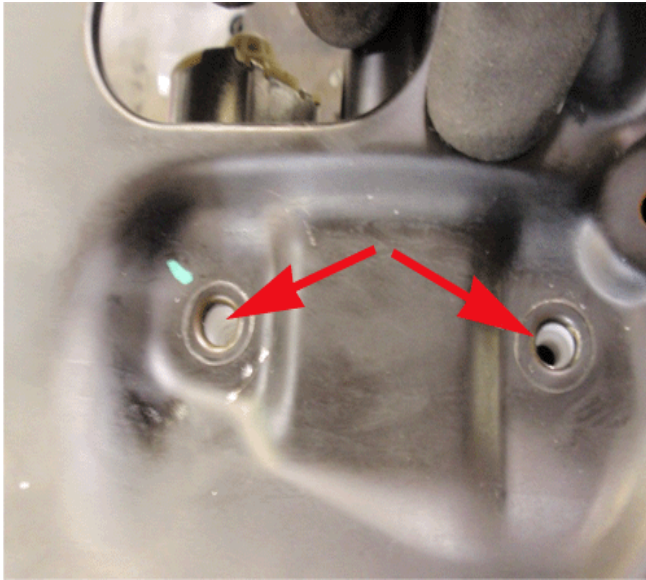
3619962

6. Reinstall the pivots onto the cross bar.

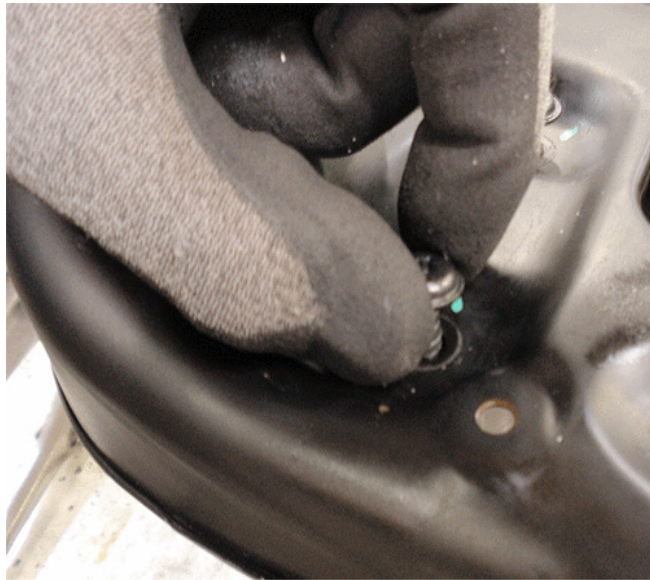
3619963

7. Align the holes in the seat pan with the holes in the pivots.

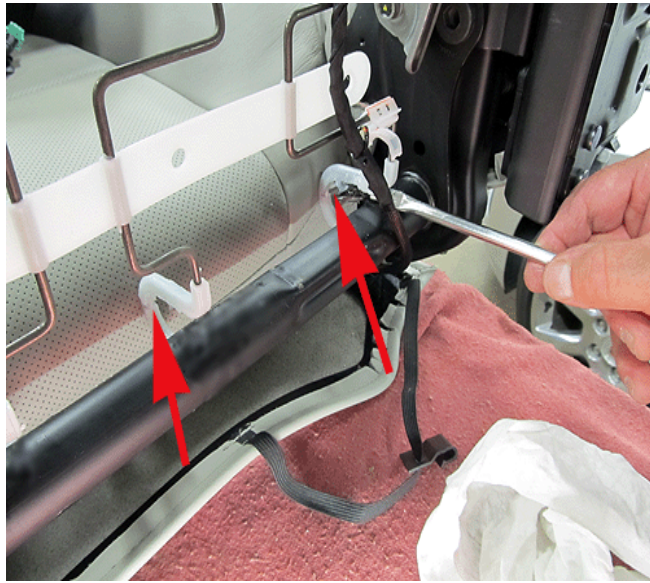
3619965

11. Locate the four rear seat cushion support hooks. Unhook the hooks from the seat frame.

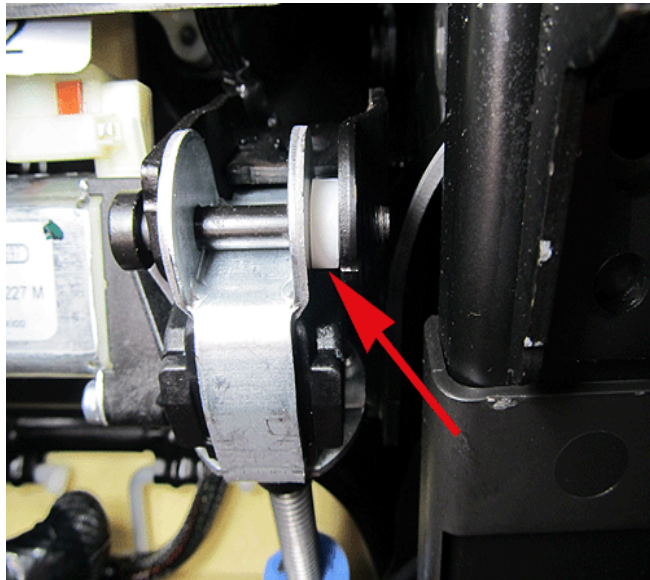
3619967

14. Locate the power seat vertical adjuster actuator attachment to the seat frame.

15. Install the shim clip as shown.  
It may be necessary to slightly spread the bracket on the seat frame with a large screwdriver to allow clearance for the clip.
16. Reinstall the lower seat cushion pad on the affected seat. Refer to Driver or Passenger Seat Cushion Pad Replacement in SI.
