# Service Bulletin

Bulletin No.: PI1088

**Subject:** Information on Proper Auxiliary Power Connections

**Models:** 2011-2014 Chevrolet Caprice PPV  
Equipped with Auxiliary Battery RPO K4S or K5S

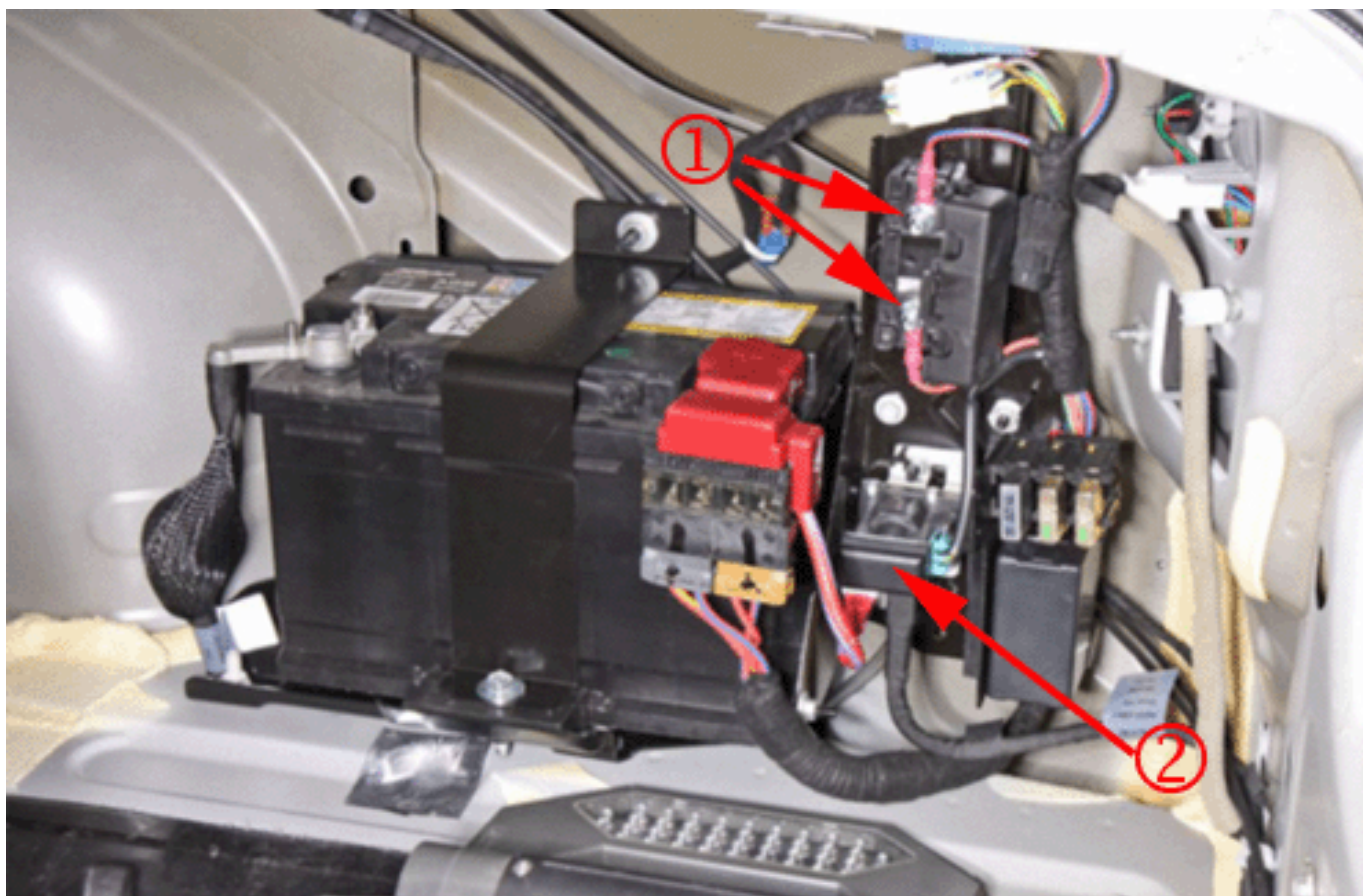
3634969

The Caprice PPV equipped with the auxiliary battery utilizes an isolation relay to protect the auxiliary battery from being discharged during engine starting. To eliminate the possibility of improper power tapping, refer to the image below to identify the location of the proper power taps on vehicles equipped with the auxiliary battery, which is located in the trunk of the vehicle directly behind the RH wheel.

- (1) Auxiliary Power Taps (shown with cover open)
- (2) Isolation Relay - DO NOT use as power taps

Improper electrical connections using the power studs on the isolation relay rather than the provided power studs. Any added power circuit in the trunk electrical center should not utilize the studs on the isolation relay.
