Bulletin No.: PI1102

Service Bulletin

Subject: Rear Bumper Fascia Paint Lifting, Chipping or Bubbling at Lower Edge of Center High Mounted Stop Lamp (CHMSL)

Models: 2014 Corvette
Condition/Concern

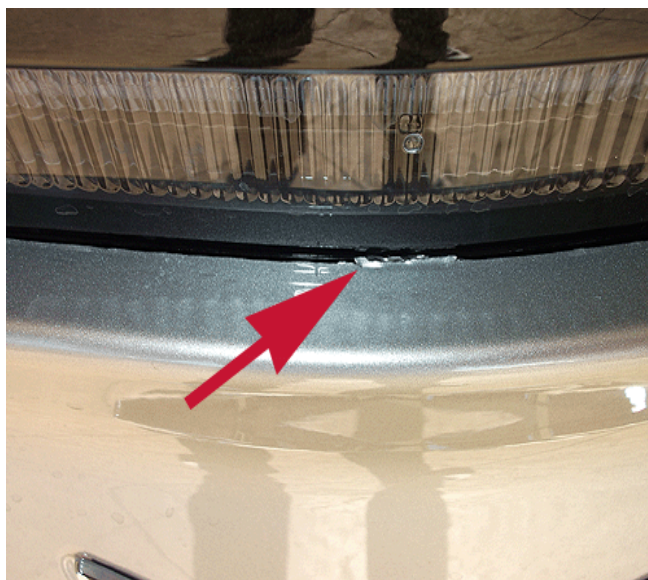
3644033

Some customers may comment the rear bumper fascia paint is peeling, lifting, bubbling or chipping on the area under center high mounted stop lamp (CHMSL).

This condition may be caused by the center high mounted stop lamp being positioned too far forward in the fascia. This allows the lower edge of the lamp assembly to contact the edge of the lamp opening in the fascia. This condition occurs when the vehicle is being driven at speed. The fit of the lamp to the fascia appears correct when the vehicle is not moving.

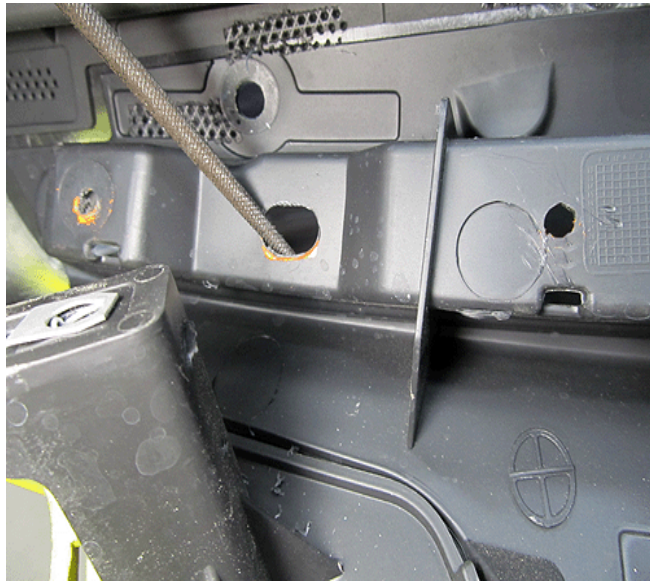
3644038

4. Using an appropriate size file or die grinder, remove 3 mm of material from the holes as shown.
5. Using a utility knife or file, remove any loose material left around the revised mounting holes.
6. Turn the fascia assembly over and apply masking tape to protect the painted surface of the fascia while performing the next steps.

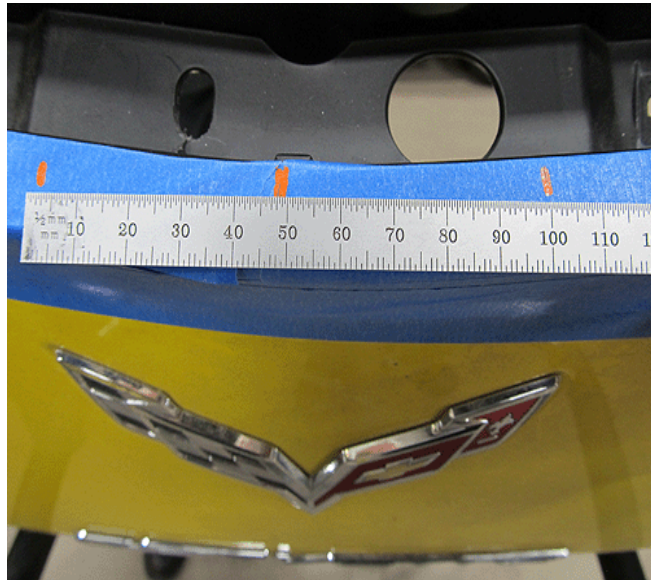
3644041

8. Measure 50 mm on both sides of the center point and mark with a paint pen creating a 100 mm application area.

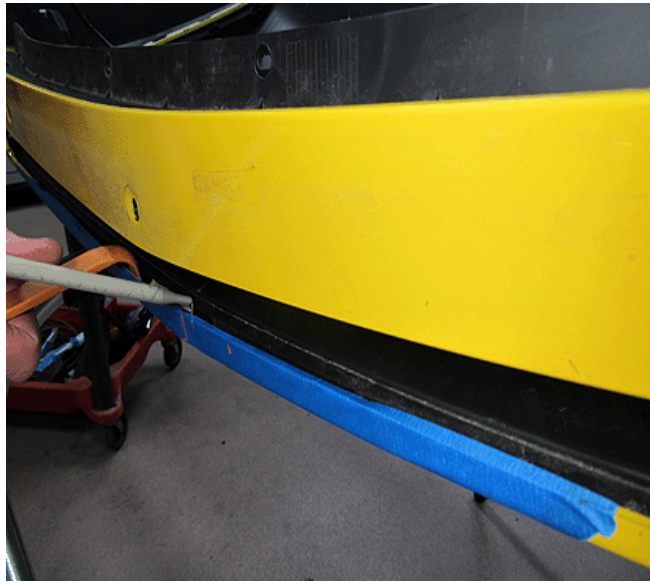
3644064

12. Apply a 10 mm bead of adhesive between the lamp bracket and the inner fascia as show.

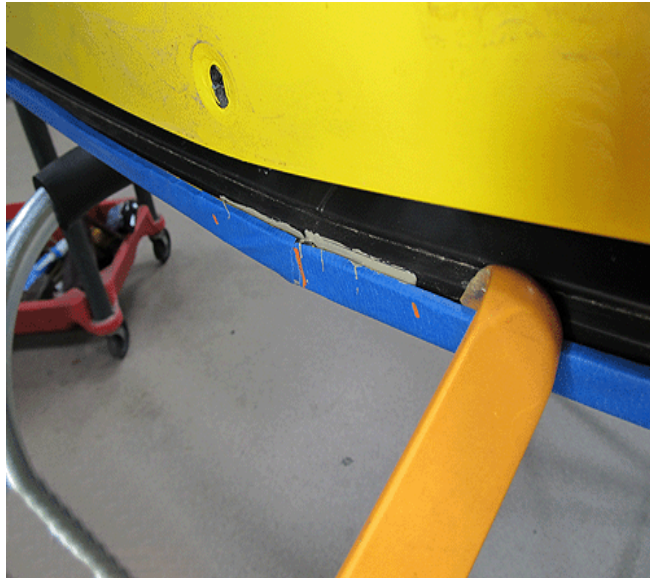
3644068

Ensure this bead covers the 100 mm application area.

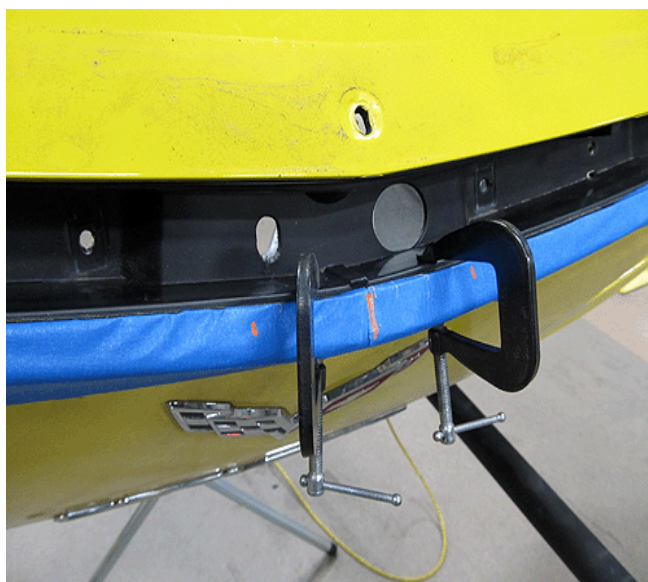
3644071

13. Clamp the lamp bracket the fascia as shown and allow the adhesive to cure per the manufacturers instructions.

Note: Test fit the CHMSL to ensure the repositioned lamp covers the damaged paint edge on the fascia. If the paint damage is not covered by the lamp, repair the paint as required.
