Service Bulletin

Bulletin No.: PIC4858A

Subject: Navigation Radio CD Error - CD Player Will Not Accept Discs

Models: 2004-2009 Cadillac XLR

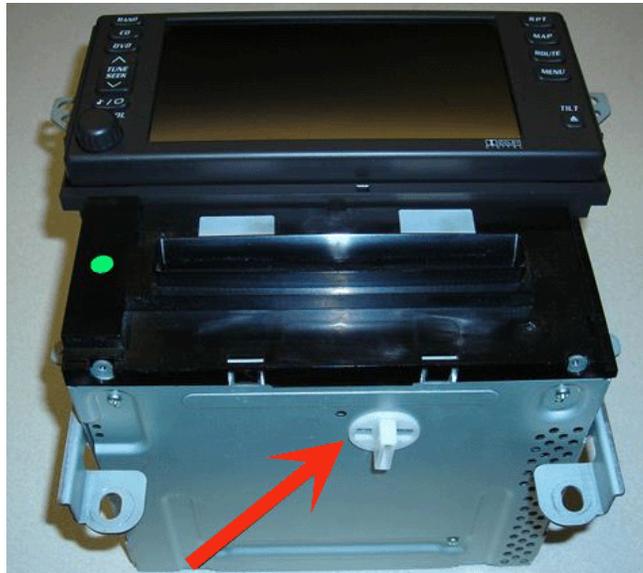
3282818

Remove the shipping pin from the bottom of the CD changer prior to installing into the vehicle. This item is called out by an arrow in the first picture below. The second picture shows the shipping plug that has already been removed from the CD changer.

If returning the Navigation radio to the Electronic Service Center, be sure to reinstall the shipping pin to prevent damage to the unit while in transit.
