# Loose Windshield Dam at Lower Right Corner of Windshield

**Service Category** Vehicle Interior

**Section** Interior Panels/Trim

| YEAR(S) | MODEL(S) | ADDITIONAL INFORMATION |
|---|---|---|
| 2012 – 2013 | Yaris | Body Type(s): 3Dr. Hatch Back, 5Dr. Hatch Back |

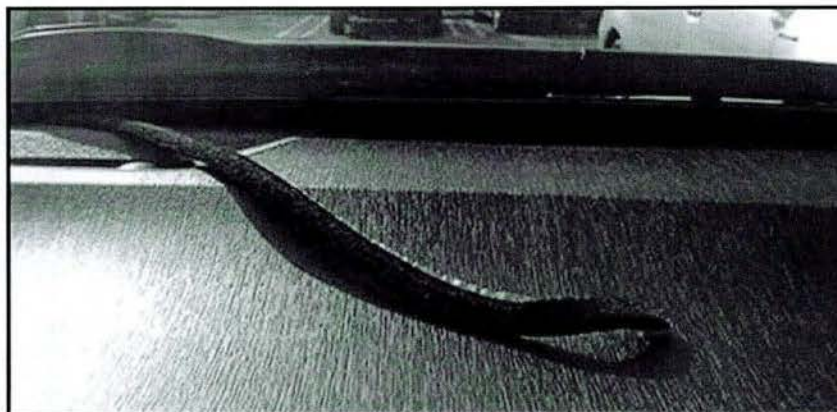
Figure 1.

Some 2012 – 2013 model year Yaris Hatchback vehicles may exhibit a condition where a piece of foam that fits between the instrument panel and the windshield may come loose. Parts have been revised to address this condition.
