<p>GENERAL COACH America, Inc. Thor Industries Commercial Bus Division</p> <p>[] Safety Recall [] Field Campaign [X] Service Information [] Product Improvement</p>	<p align="center"><u>FIELD SERVICE BULLETIN</u></p> <p align="center"><u>HC International</u></p> <p align="center"><u>Cab/Body Separation</u></p>	<p>FSB_2013-103 Revision: 0 Issue Date: 08/21/13 Manual Section: N/A Author: Shawn Yopp Approval: D. Hill Form Rev. C 05/08/09</p>
---	---	--

UNITS AFFECTED: Champion Bus and General Coach Golden Touch Units.

DESCRIPTION: Extreme conditions have caused separation of Cab and Body.

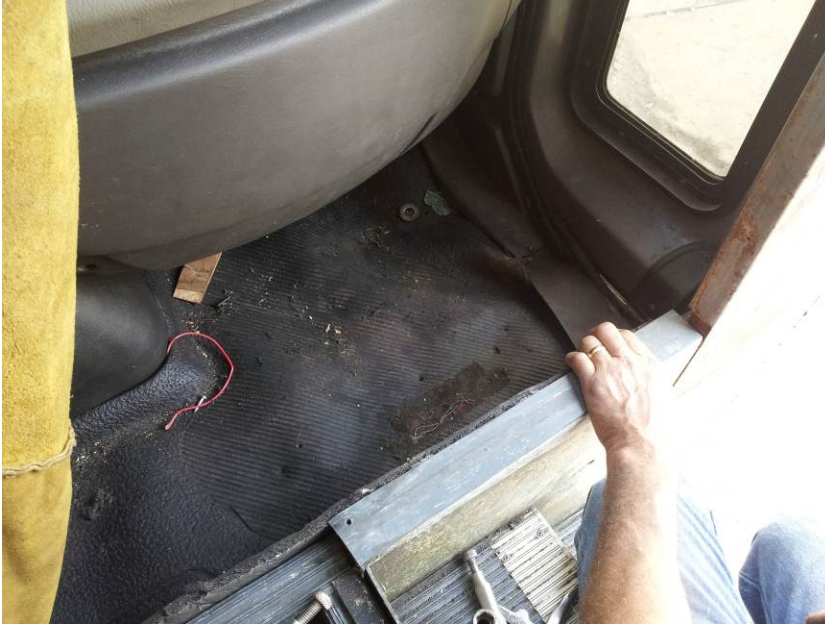
1. Remove from front cab both extinguisher/bracket and flare/bracket from flooring just forward of entry stairwell.

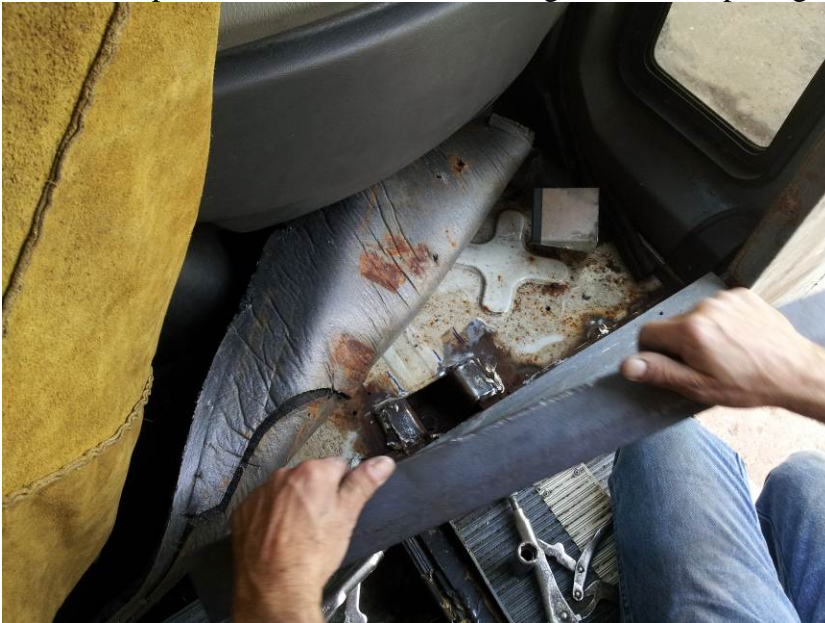
2. Remove staples and roll back front flooring mat, thus exposing cab floor.

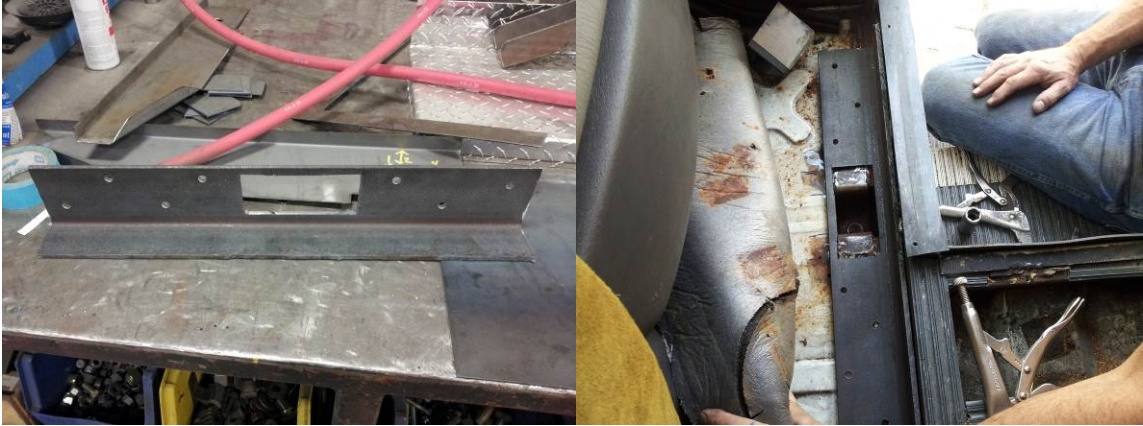
3. Place support bracket tight against stairwell structure (holes down) and align rectangular cutout centered over cab support mount as shown.

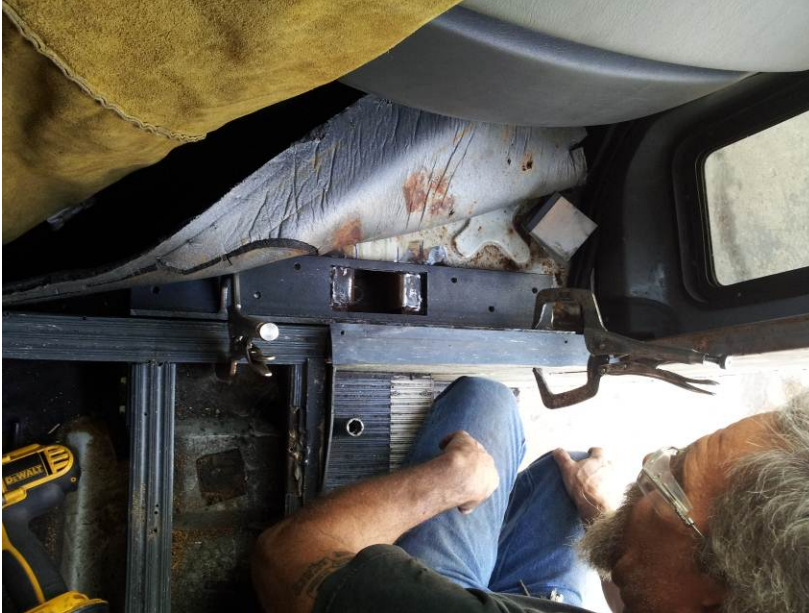
4. Clamp bracket tightly to stair well in 2 places.

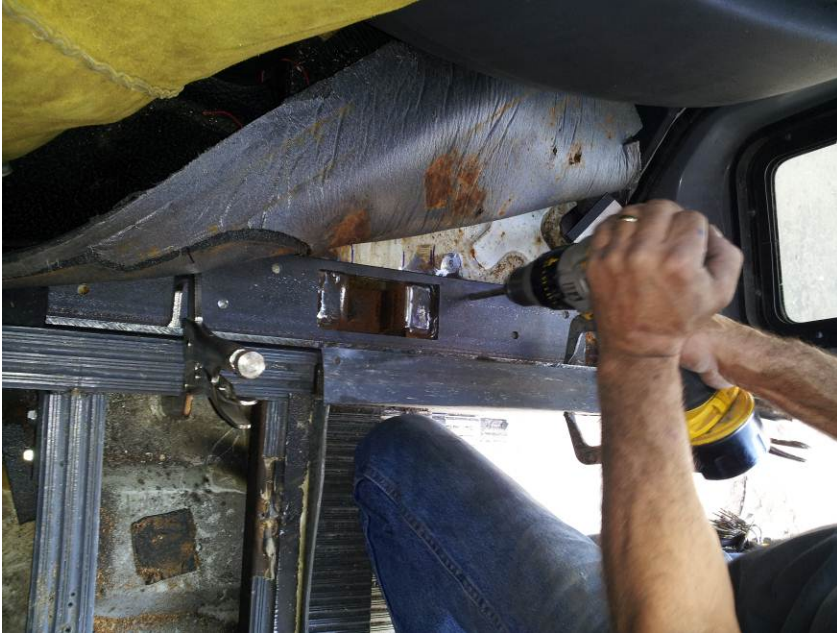
- Using drill and 3/8" steel bit, drill (7) holes through the cab floor using pre-drilled holes in bracket as a guide.

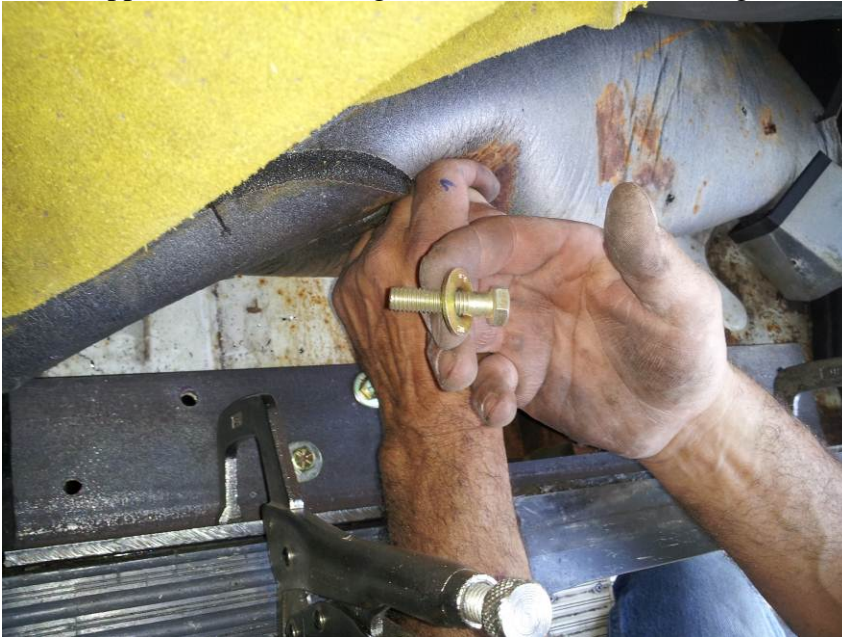
- Place supplied 3/8" x 1-1/2" grade-8 bolt & washer through drilled holes (7 places)

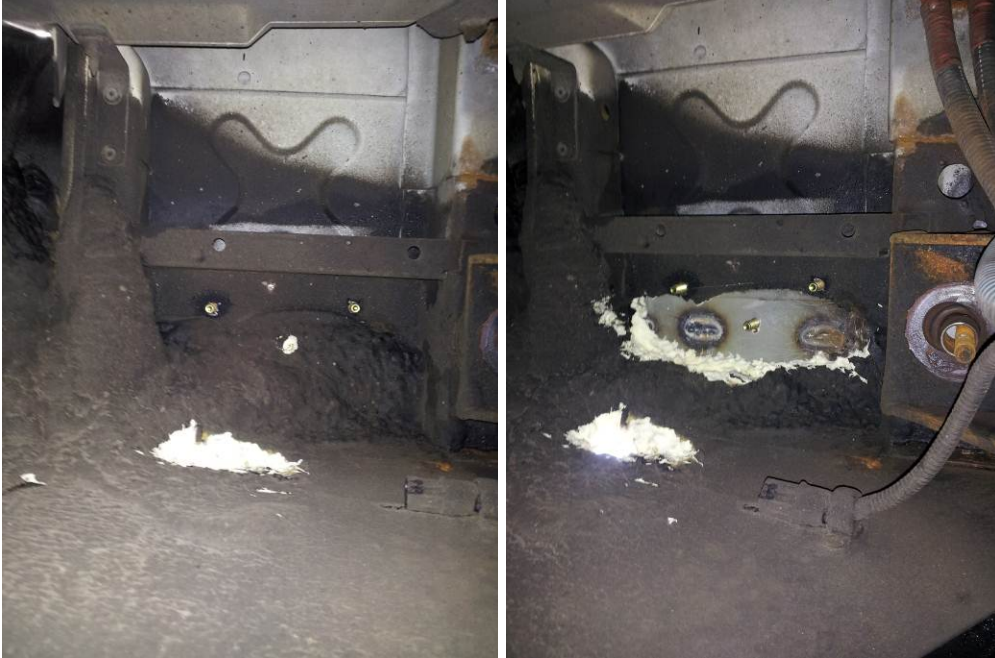
7. From underside of bus, locate the newly protruded bolts and remove all foaming materials around bolted area. Clear enough space to provide room for draw-plates.

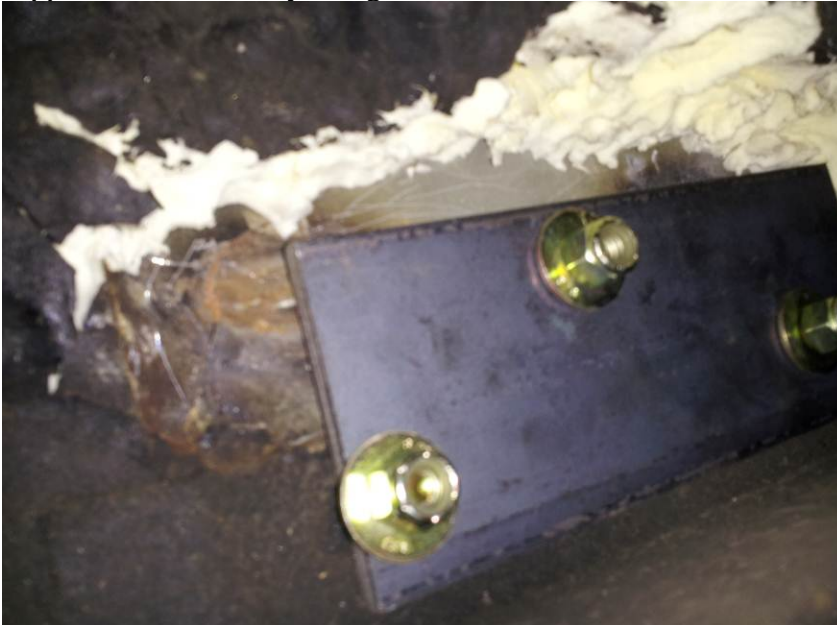
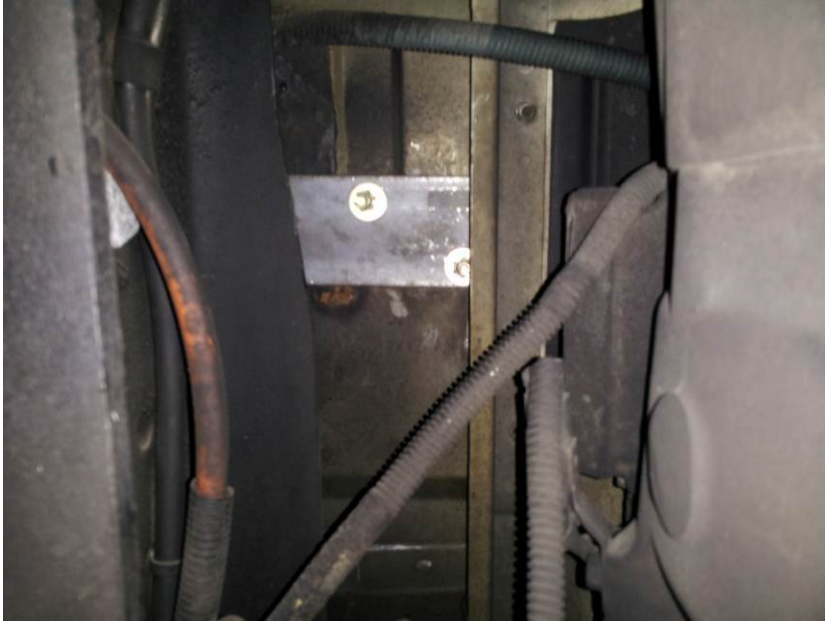
8. Place first draw-plate (may require several attempts at orientation) and hold using supplied washer and nylock grade-8 nuts.

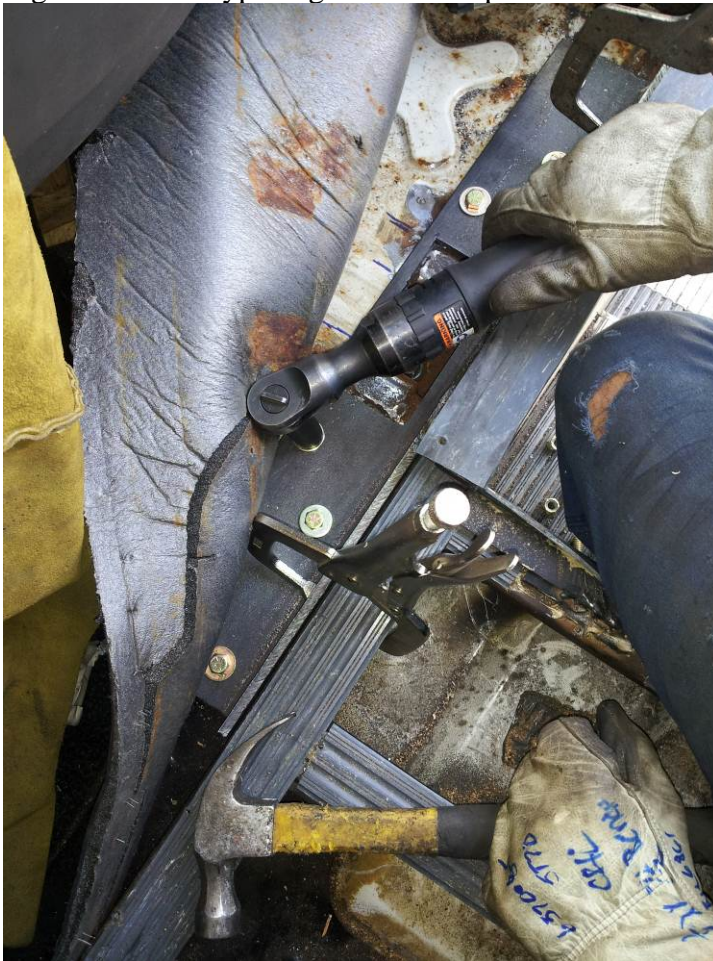
9. Tighten bolts to typical grade-8 bolt specifications.

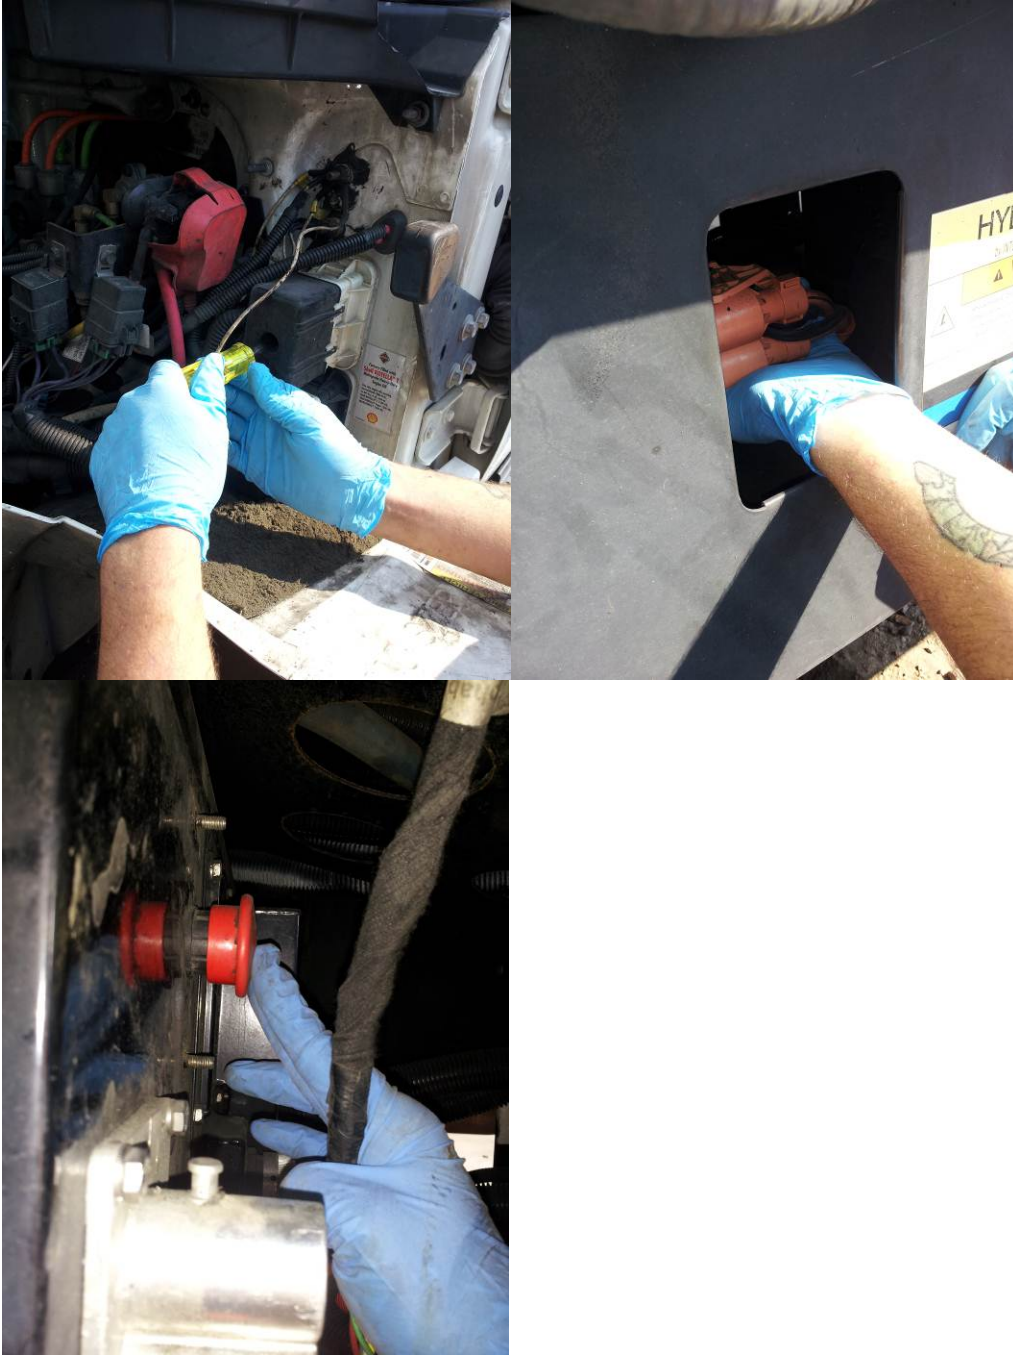
10. Disable PCM, Batteries and “kill switch” for hybrid systems per specifications of disconnect procedures attached at the end of this bulletin.

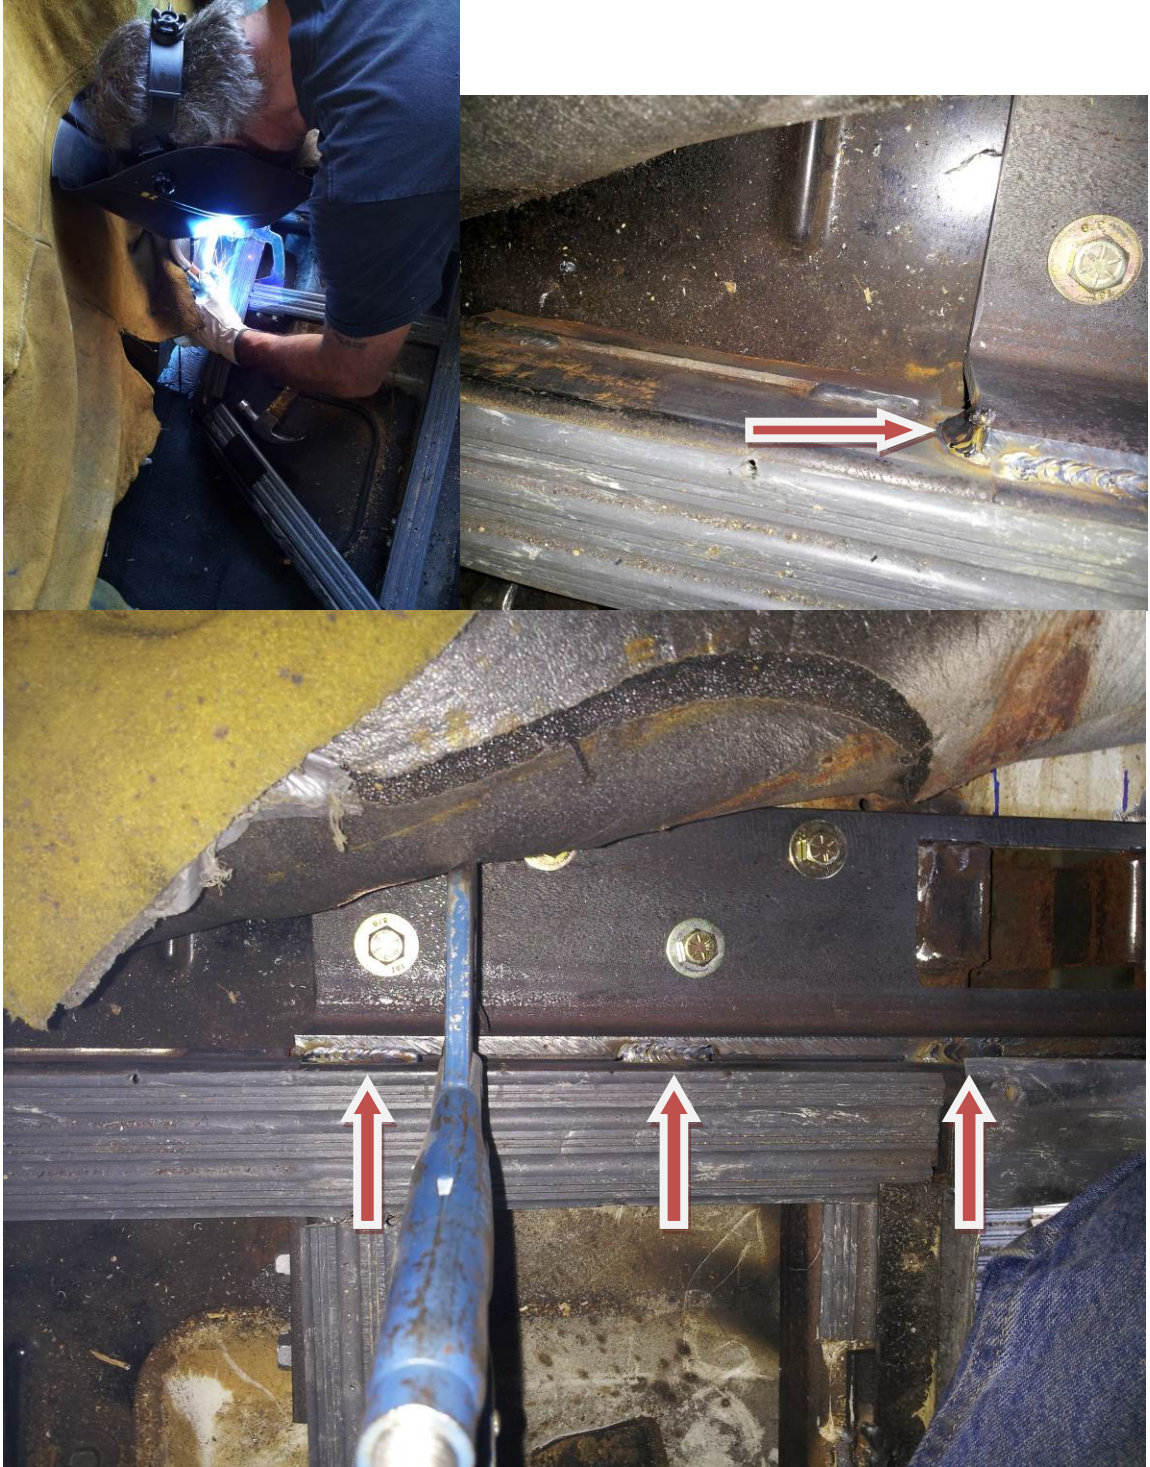
12. Weld bracket on inside of bus to stair support structure, stitch-weld as shown using 1" welds approximately 4" apart. Weld full length of bracket and (1) each side.

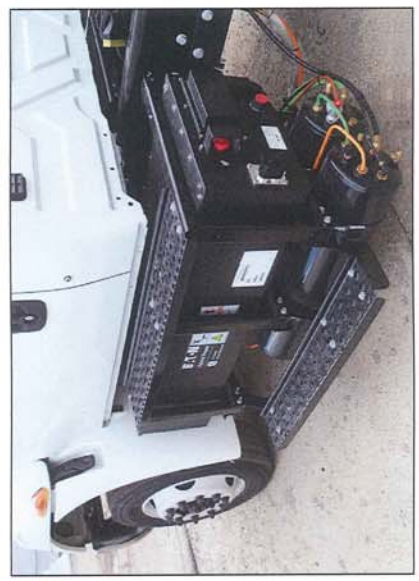
FIGURE 1 HYBRID PEC LOCATION

- STEP 1: DETERMINE IF CHASSIS IS A EATON HYBRID CONVERSION OR NOT.
 - STEP 2: DISCONNECT HYBRID BATTERY PAC (PEC) BY DISENGAGING THE RED SERVICE SWITCH LOCATED ON THE REAR OF THE PEC FIGURES 2, AND 3.
