**SUBARU.****QUALITY DRIVEN® SERVICE****SERVICE BULLETIN****APPLICABILITY:** 2013MY BRZ**NUMBER:** 12-131-12R**SUBJECT:** Condensation in Rear Combination Lamp**DATE:** 06/12/12**REVISED:** 01/28/13**INTRODUCTION**

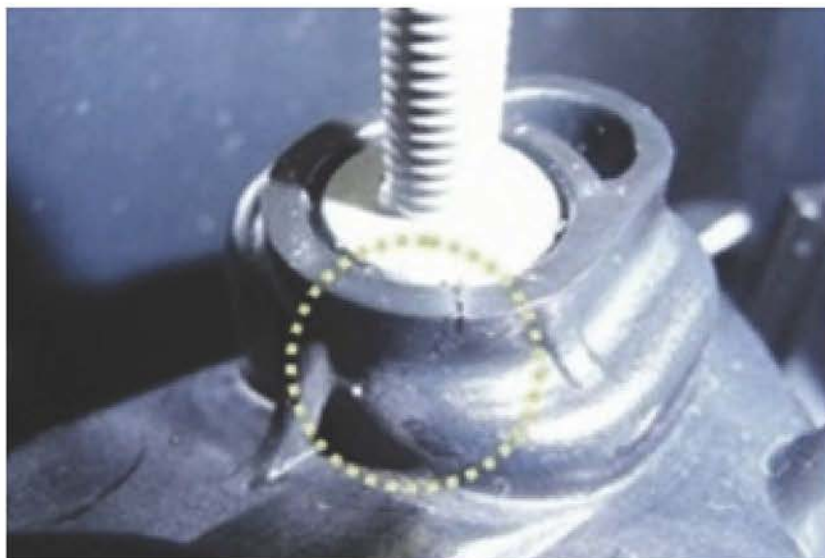
**Example of crack**

If you encounter a vehicle which has condensation in the rear combination lamp(s) the boss that houses the mounting stud may be cracked. To verify the condition, the combination lamp will need to be removed and inspected.

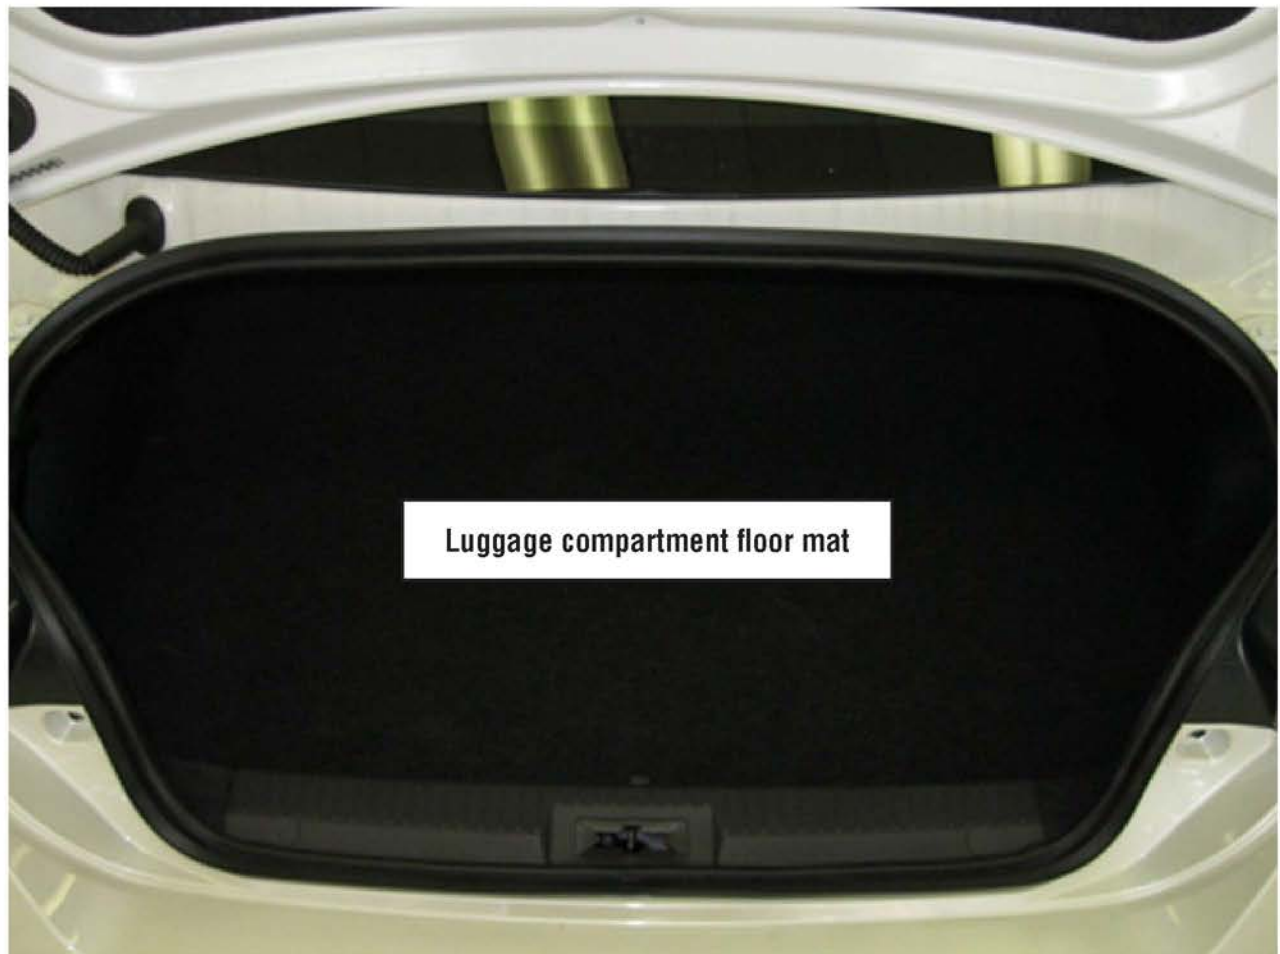
- Remove the luggage compartment floor mat.

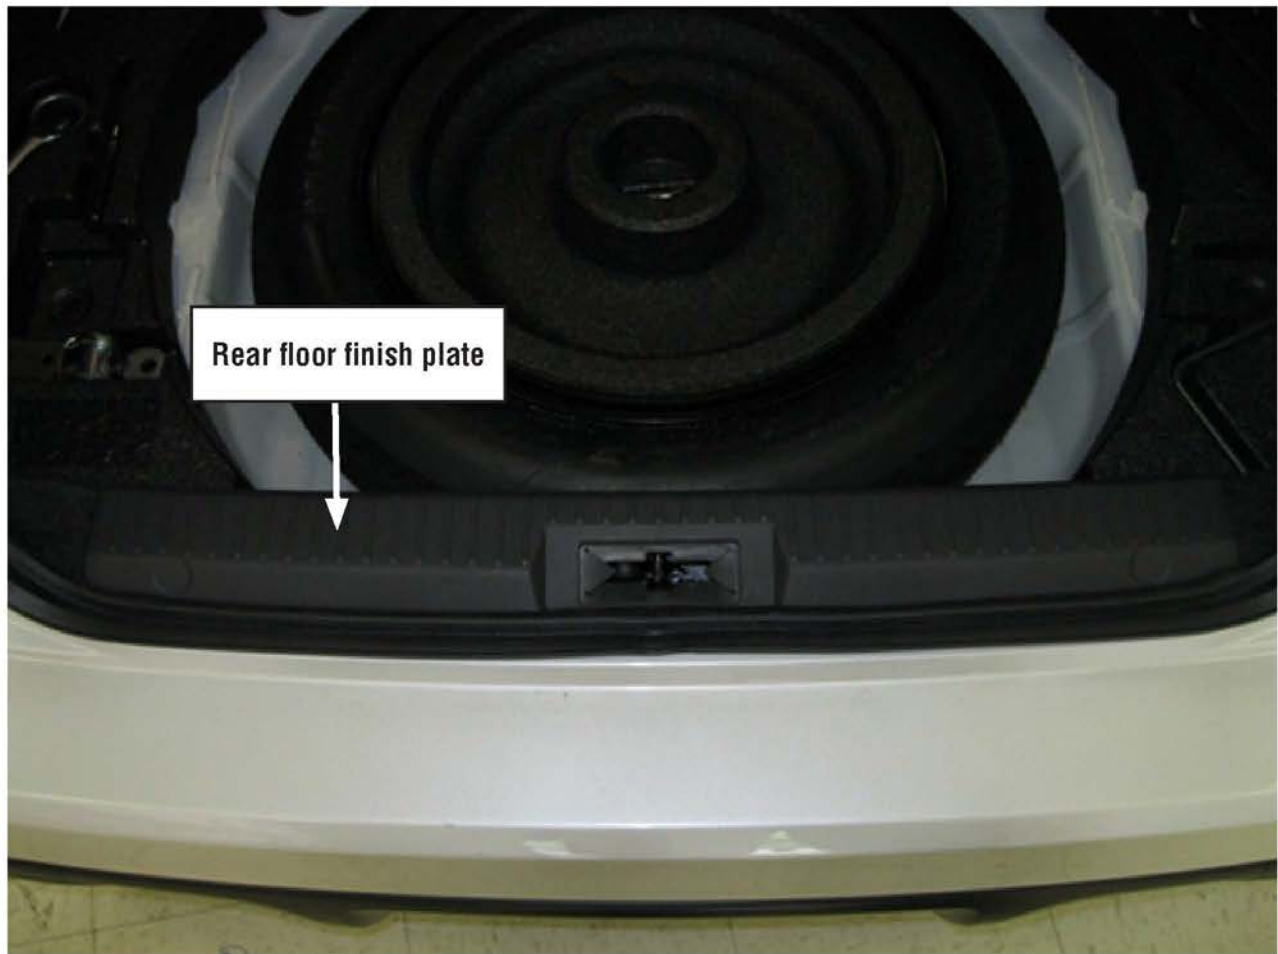
- Remove the rear floor finish plate which is attached by 3 clips.

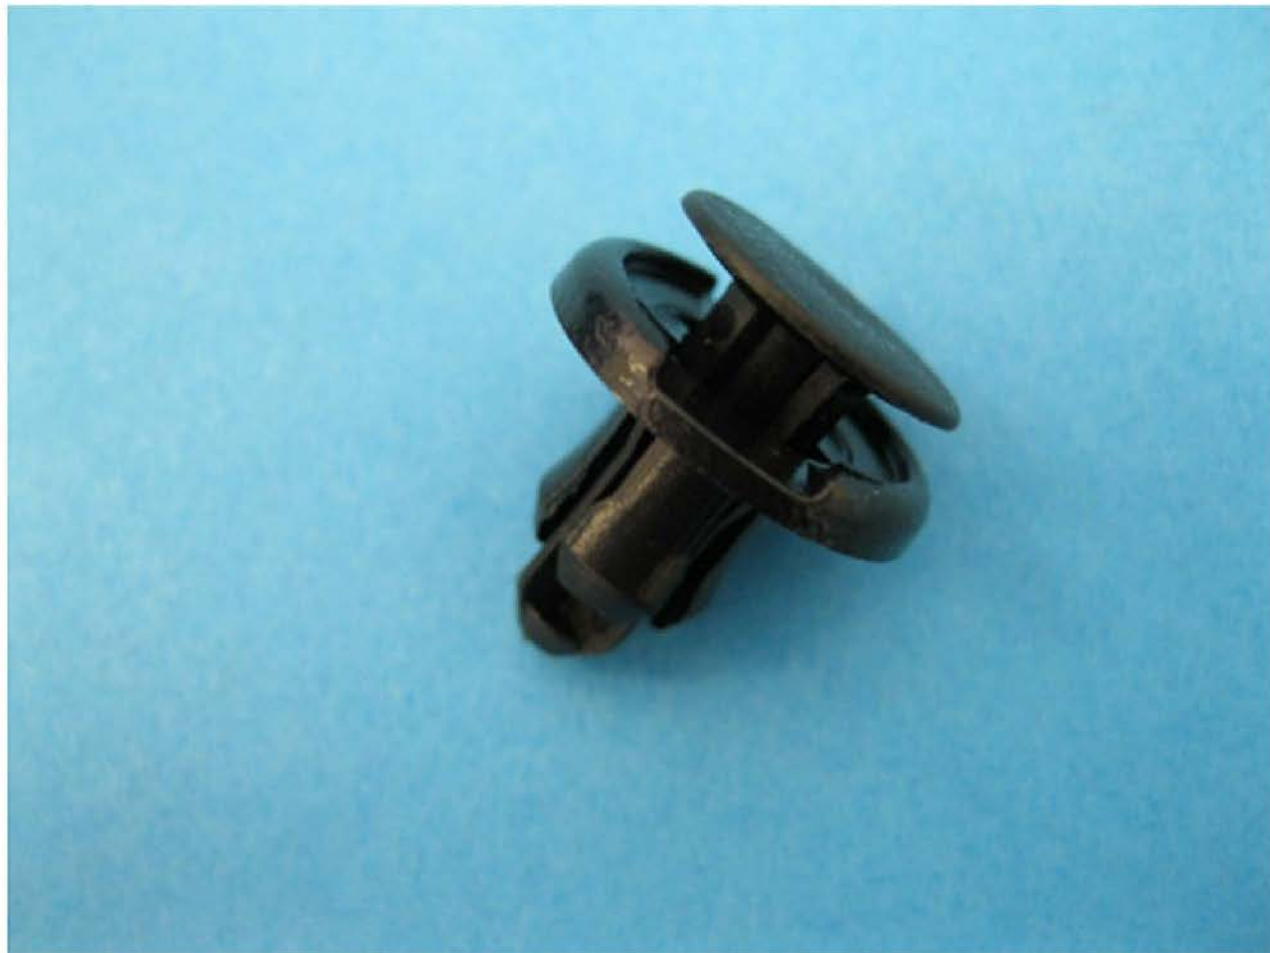
**TIP:** The clips are a 2 piece design. Use a small flathead screwdriver, disengage the inner piece from the outer piece and then remove both pieces together.

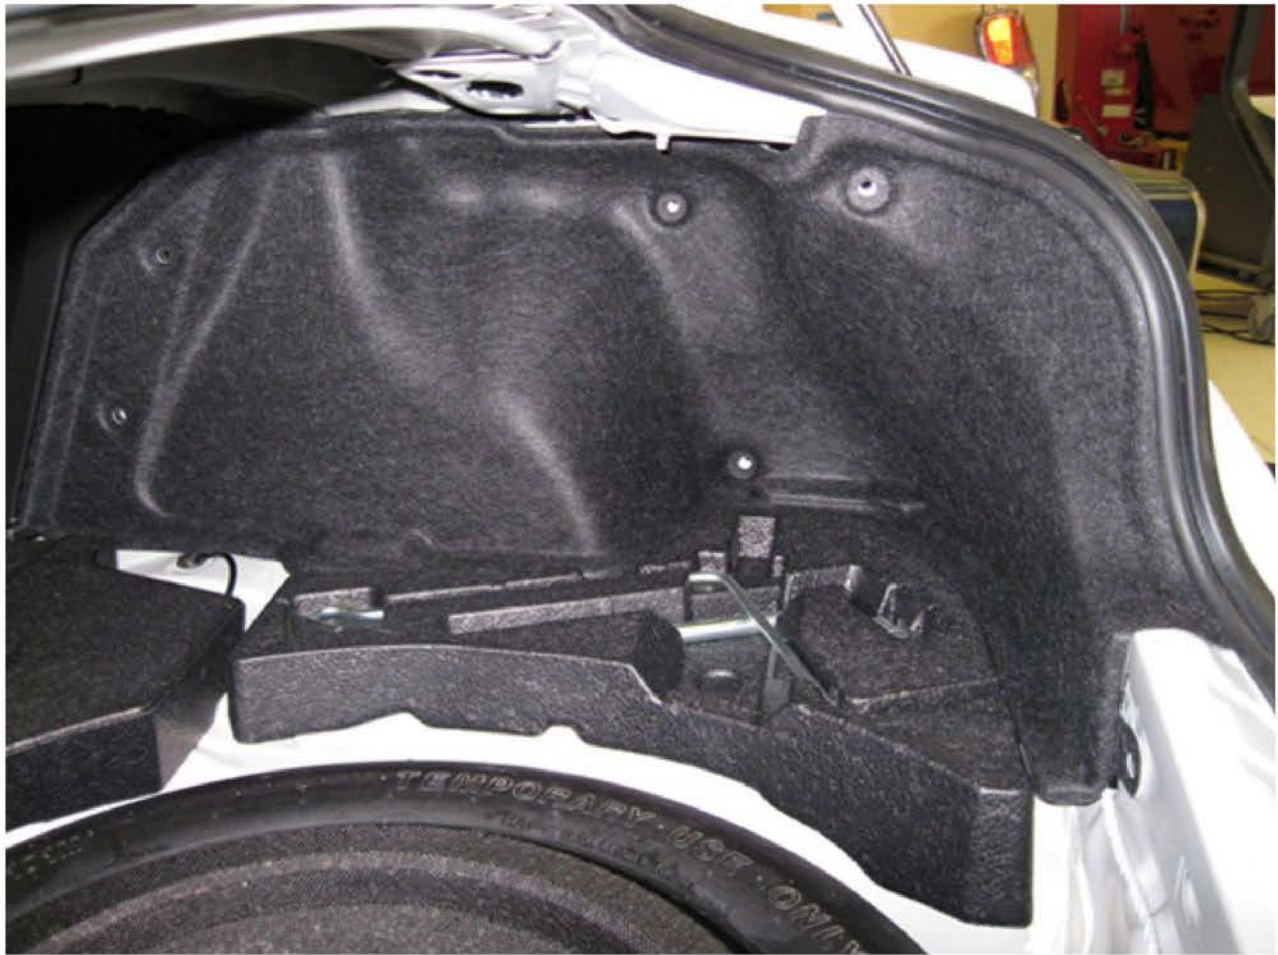
- Remove the luggage compartment trim which is attached by 5 clips.

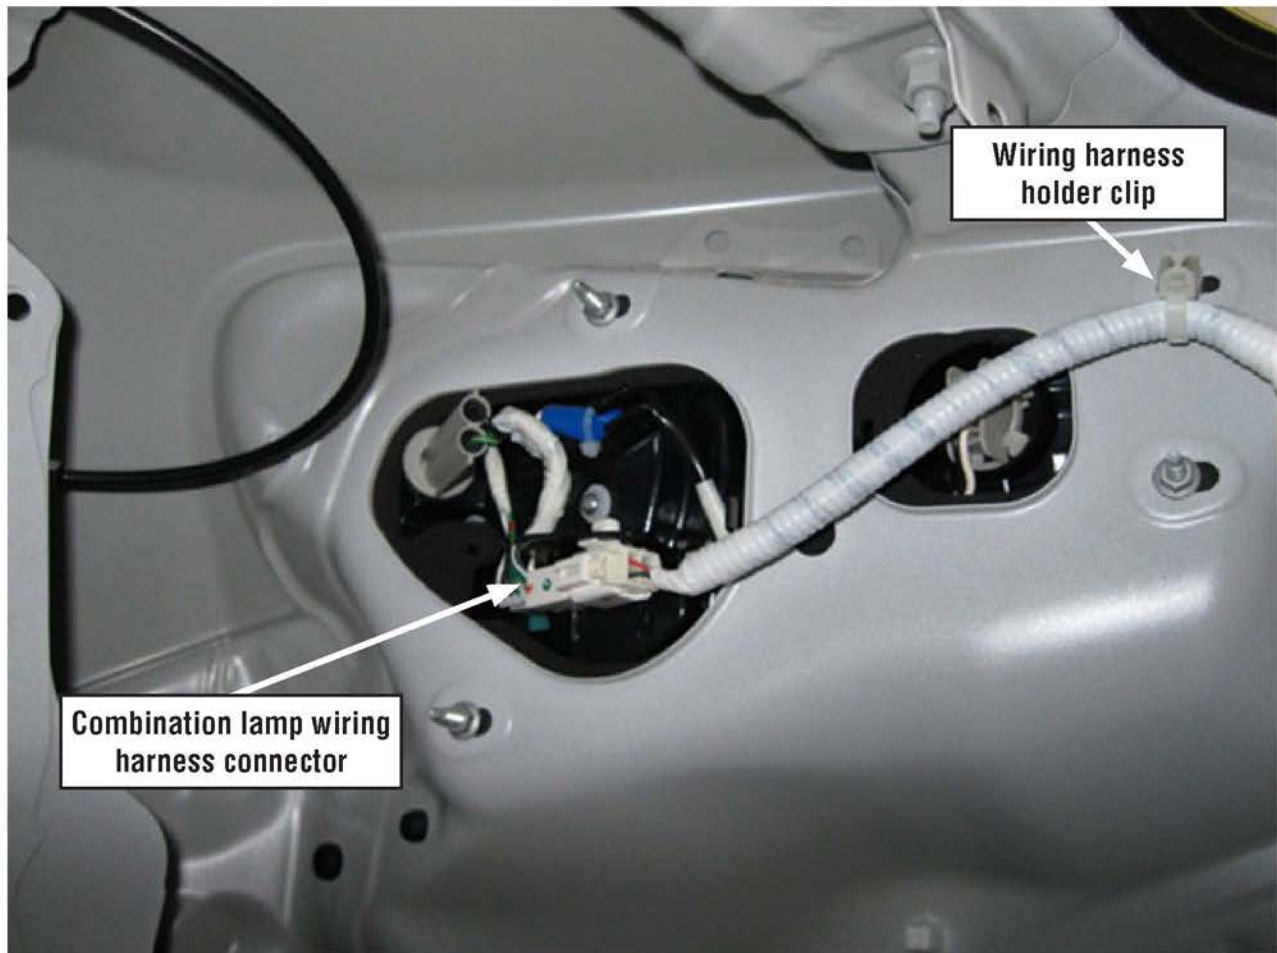
- Remove the wiring harness holder clip using a clip remover tool. **Note:** Do not cut the wire ties.
- Disconnect the combination lamp wiring harness connector.
- Remove the 4 combination lamp nuts.

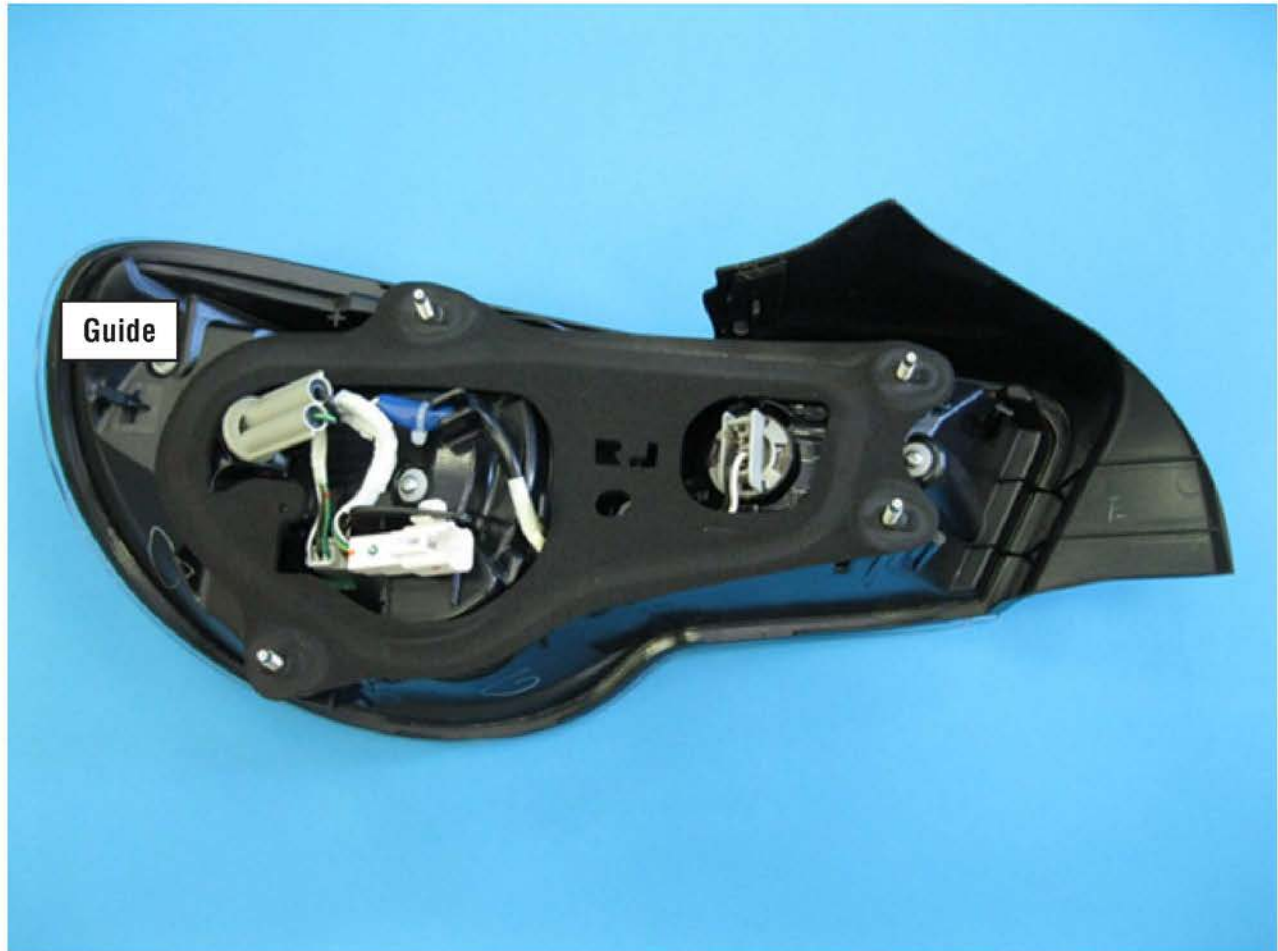
- Remove combination lamp. **Note:** There is a guide on the outside corner. Be careful when removing the lamp not to break the guide.

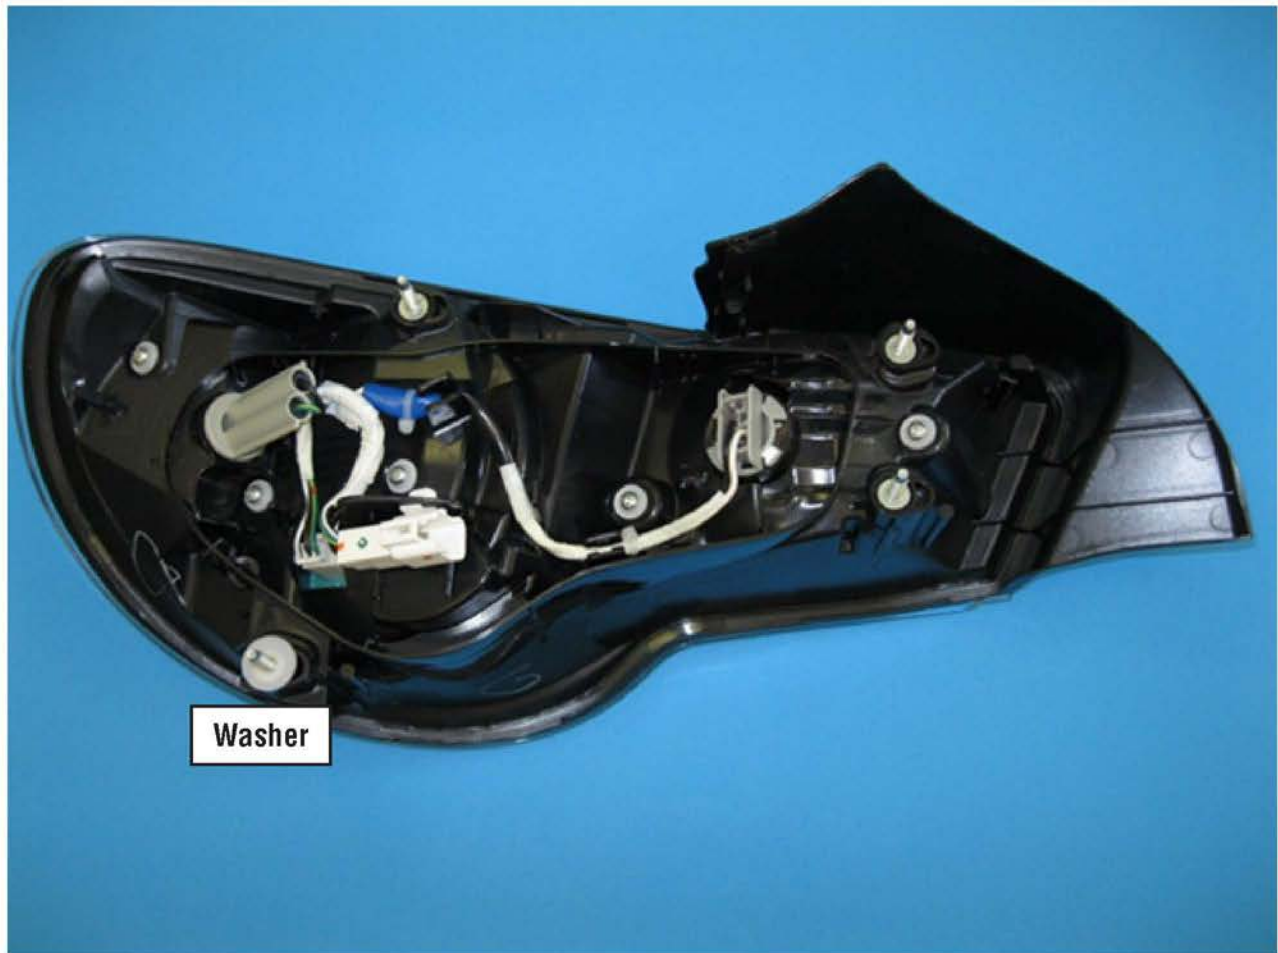
- Remove the gasket, turn signal bulb / side marker bulb as a unit with the rear combination light socket & wiring sub-assy and white plastic washer (all of which will be transferred to the new combination lamp except for the gasket).

- Transfer the turn signal bulb / side marker bulb as a unit with the rear combination light socket & wiring sub-assy and white plastic washer to new lamp.
- Install new gasket (make sure it is seated properly).
- Install combination lamp and gasket in reverse order of removal.

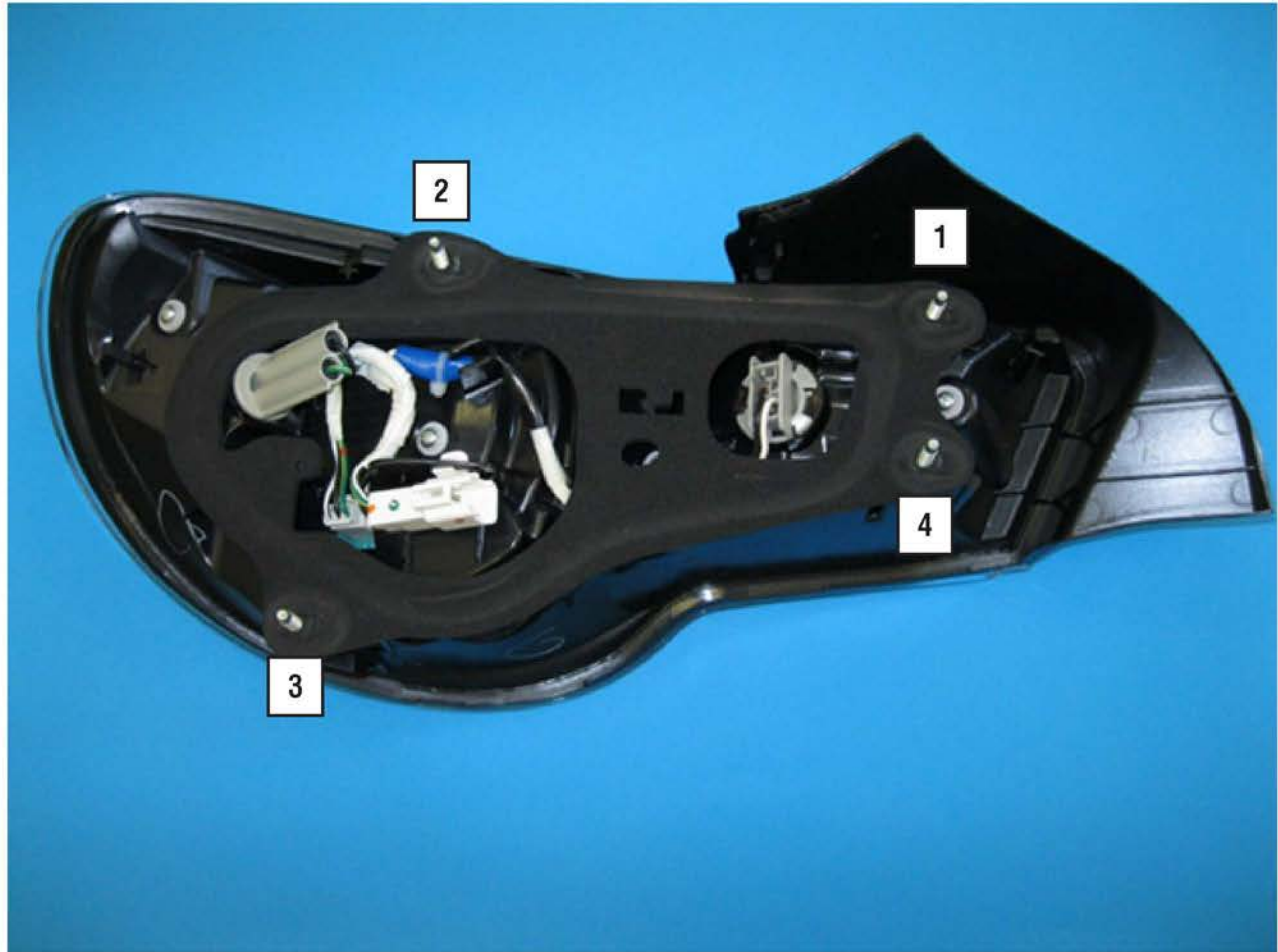
**Right Side - Tightening Sequence**

**Caution:** Failure to follow the proper tightening sequence and torque specification will result in damage to the new combination lamp. Starting with number 1, hand tighten each nut in order prior to torquing them to the final specification. Torque the nuts down in the same order.

Torque Specification: 4.5 N-m (0.46 kgf-m, 39 in.lb)
