**45CLFW: Interim Transmission Yoke Bolt Inspection and  
Tightening**

**Property Name:** LACMTA

**Top Bus Number:** 95000, 218000, 269000, 286000, 315000

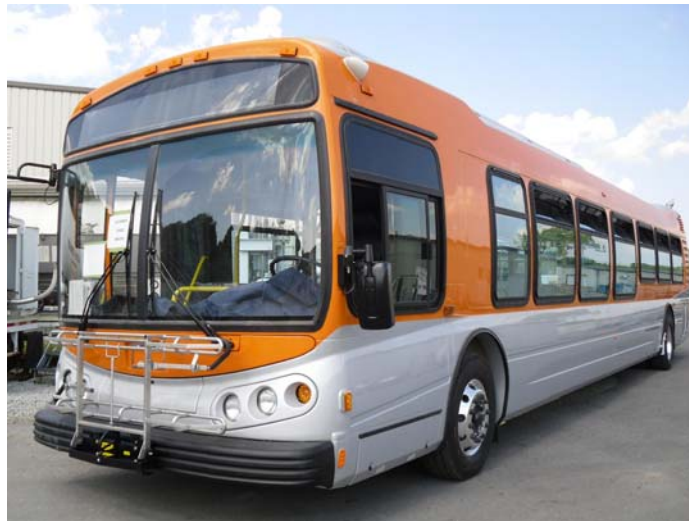
**Issue:** Interim inspection for loose yoke bolt on transmission.

**Solution:** Interim inspection and repair (as required) of loose transmission yoke bolt per this work instruction.

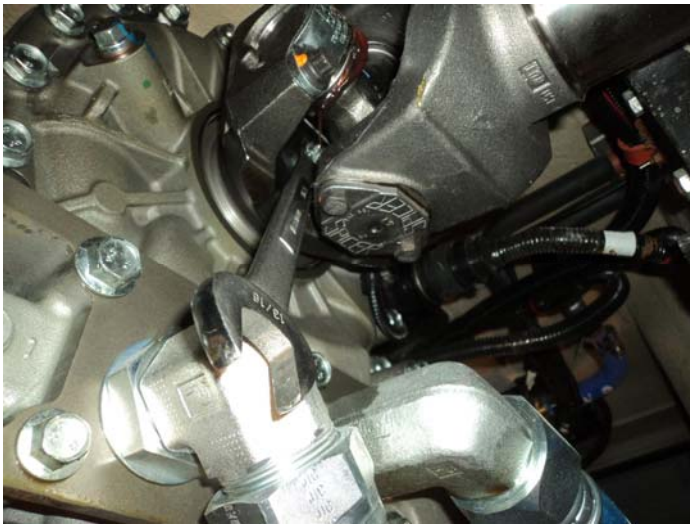
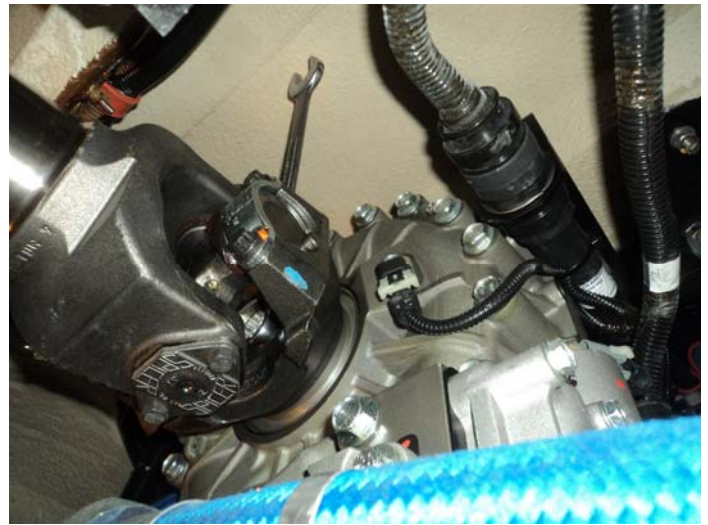
1. Park the bus on a leveled surface above a service pit and apply the parking brake.
2. Place the 13/16 wrench on the transmission yoke bolt and check if the bolt can be tightened. ***Tighten the bolt hard with the wrench.*** Depending on the position of the yoke the wrench can be placed under or above the yoke. Rotate the yoke (move buses forward) if required to provide better access to the bolt.

3. Mark the yoke with white paint and record bus number if loose yoke bolt was found. These buses will have to have a new yoke bolt installed later.
4. Record Bus Number, Date of inspection and Mileage.
