INSTRUCTION TO SERVICE

ITS: 5585	
SECTION:	600 Electrical
WRITTEN BY:	Kevin Robinson
SUBJECT:	Remove straight quick connect fitting and replace with 90 degree fitting.

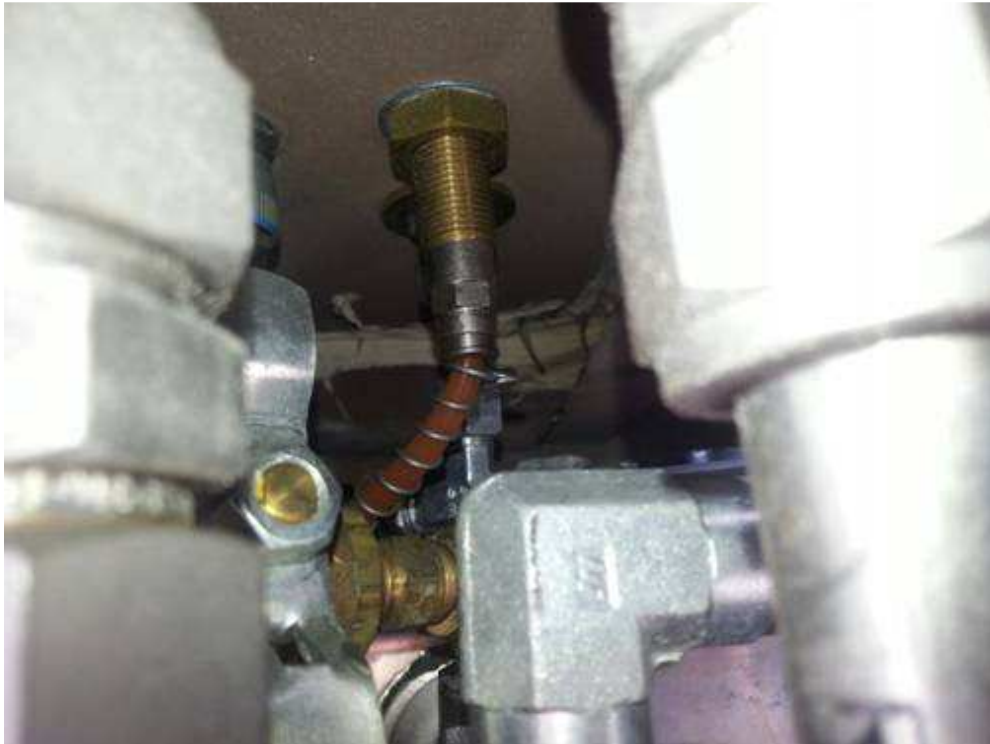
1. Turn the main battery disconnect switch to the “OFF” position.
2. Inside the bus, locate the Fogmaker extinguisher cylinders above the rear street side window behind the light panels.
3. Install the safety screw into the control head of the accumulator (large cylinder). The safety screw is hanging from a tether attached to the control head.
4. Turn the valve located on the detector bottle (smaller cylinder) off.
5. Locate the detector tube bulkhead connector, where the detector tube enters the engine compartment. This bulkhead fitting is on the street side of the bus, above the radiator.

Figure 1: Bulkhead fitting and detector tube

6. Loosen the straight quick connect fitting, attached to the bulkhead, slowly. This allows the built up pressure to escape through the threads.
7. Remove the straight quick connect fitting once the pressure is released.
8. Remove the detector tube from the straight quick connect fitting.
9. Inspect the tube for damage or kinking. If damage is present, cut it off using a Synflex cutter or equivalent tool to ensure a clean straight cut perpendicular to the tube.

10. Install the new 90 degree quick connect fitting (NF PN 416285) to the bulkhead connector. Apply Loctite thread sealant (NF PN 438128) to the threads of the new fitting prior to installation.

11. Mark off 22 mm (about 7/8") from the end of the detector tube.
12. Install the detector tube into the new 90 degree quick connect fitting. The mark made in the previous step should be close to the edge of the new quick connect fitting, if installed correctly.
