## Squeaking noises from the belt drive

Topic number	LI13.20-P-049041
Version	3
Design group	13.20 Belt drive, general
Date	12-13-2013
Validity	Belt drive, engine 272 and engine 273.
Reason for change	Modified poly-V-belt
Reason for block

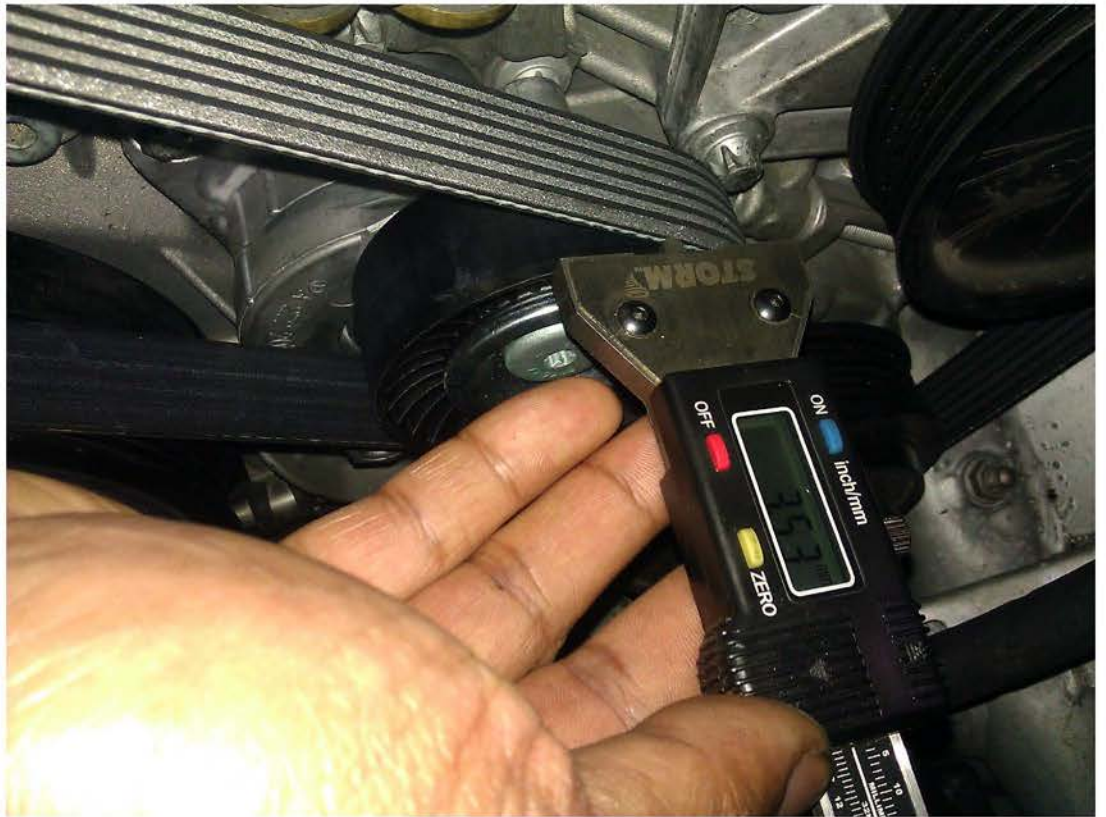
Checking belt alignment  
on tensioner .jpg:

- Measure the distance from the front edge of the belt to the front edge of the belt tensioner pulley (refer to attachments). The width of the belt tensioner pulley is 26 mm, the width of the poly-V-belt is 20.5 mm. The measured distance should be close to 2.75 mm. If the belt runs too close to the front edge of the belt tensioner pulley and the poly-V belt runs up against the front inner edge of the lower guide pulley, it will be required to install one of the shims (either 1 mm or 0.5 mm thick) behind the lower idler pulley (just above the belt tensioner) to align the belt properly. Refer to parts table for shims.

Attachments	
File	Designation
Checking belt alignment on tensioner .jpg	Illustration measurement of distance of the edge of the poly-V belt to the front edge of the belt tensioner pulley
Belt drive system M272 M273.pdf	Illustration of the belt drive system

Only one shim can be installed.

If after installing shim the belt is still not properly aligned, the belt tensioner might be worn. Observe proper alignment of the drive belt system. Check system after completing all repairs.
