**SERVICE ADVISORY # 13-188**

Vantage Roof Tape Repair

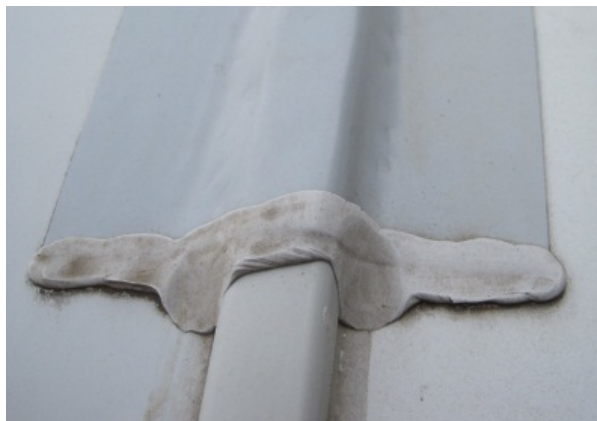
Fig. 1

**Step 1** Inspect the front and rear roof to end cap tape seams for damage, peeling, etc. The new installation will overlay the existing tape wherever possible. Trim any loose or curled tape, if present, to provide a flat, smooth surface for overlayment of new tape. See Figure 1.

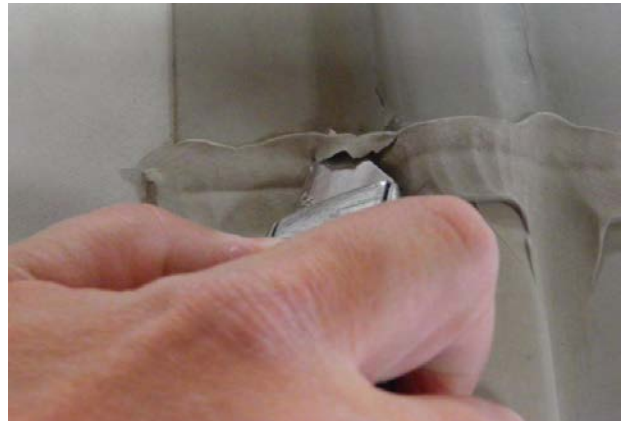
Fig. 2

**Step 2** Trim Silicone end beads flat and smooth. Use care not to puncture the roof membrane. Trimming the existing silicone bead will allow for a smoother, lower profile application of new silicone. See Figure 2.

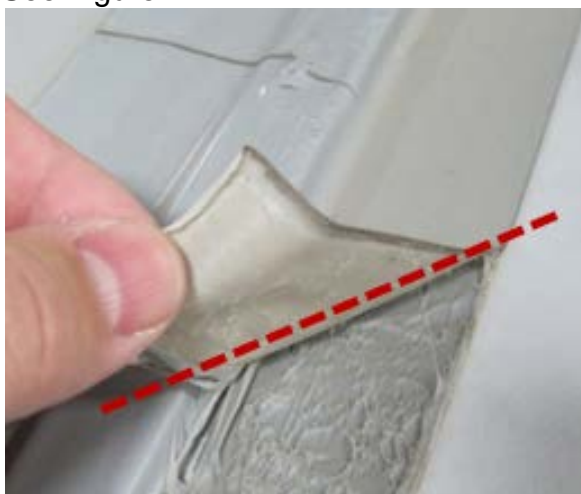
Fig. 4

**Step 4** If possible, remove the top film membrane from the old tape. To do this, try to separate the membrane at a corner and then slowly and steadily pull up at a 90 degree angle. Do not continue if removing the membrane disrupts the adhesive layer underneath, or if residue from the adhesive layer remains on the interior surface of the membrane. Cut any loose membrane off even with the existing tape to ensure an even, flat bonding surface. See Figure 4.

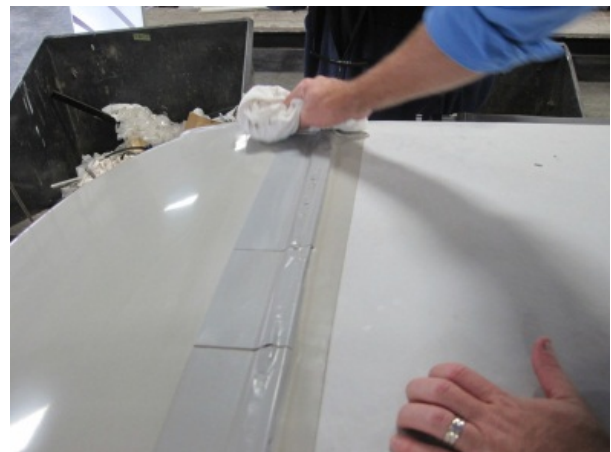
Fig. 5

**Step 5** Where the top film remains intact, clean the bonding area with Naphtha by wiping with a clean cloth (do not use red shop towels). Clean an area 3-4" past the existing tape on both the EPDM roof side and the fiberglass cap side. Allow Naphtha to flash off for 5 minutes. Areas where previous mastic is exposed can be wiped in the same manner. Allow Naphtha to flash off for 5 minutes. See Figure 5 above.

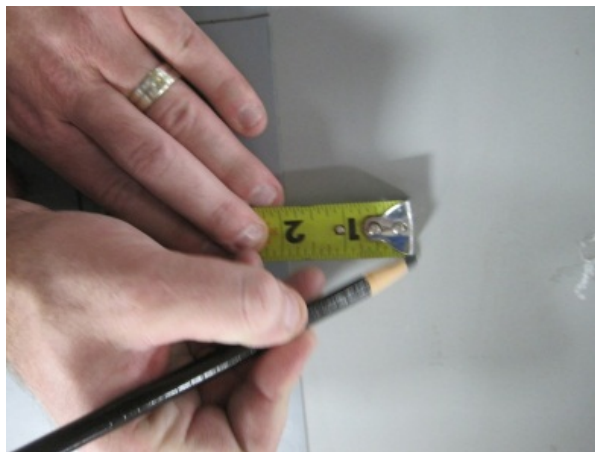
Fig. 6

**Step 6** With a grease pencil, mark an alignment mark 2" out from the edge of the existing tape outward on the fiberglass cap side of the tape. These marks will be a guide for applying the new tape so mark about every 18" across the RV. See figure 6.

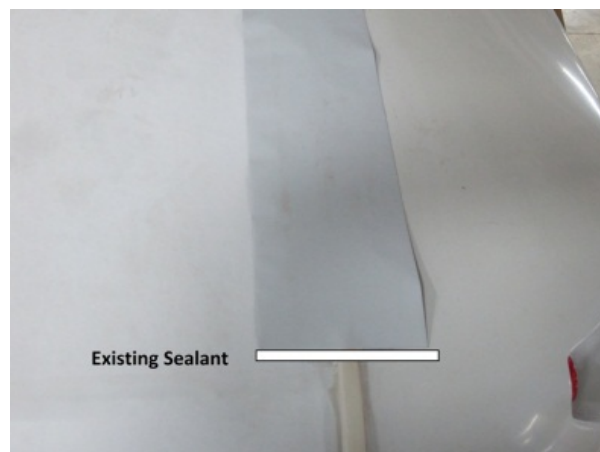
Fig. 7

**Step 1** Dry fit the new tape (with backing still on) to ensure that it fits between the end applications of silicone sealant. Trim if necessary so the new tape will fit against the existing sealant. See figure 7.

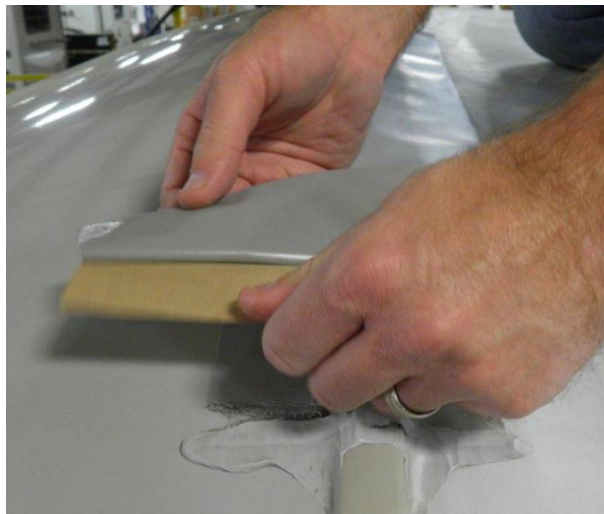
Fig. 8

- Step 2** Starting on one end, peel back release paper and adhere new tape, using care to line up the edge with the 2" hash marks made previously. Adhere to the high point (above the aluminum trim) in middle first, then work the tape tightly around and down onto the fiberglass cap and the EPDM roof membrane. Try not to stretch the tape during installation. See figure 8 & 9.

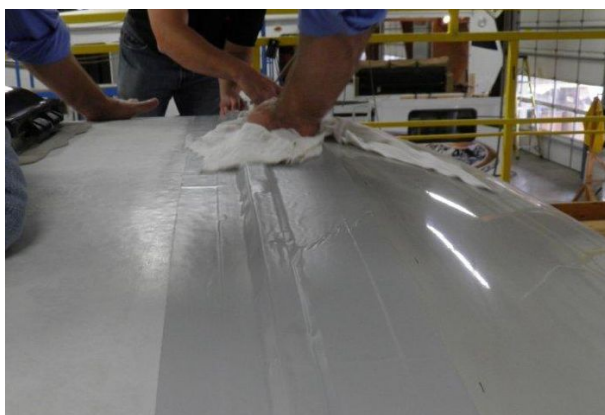
Fig. 10

- Step 3** Use a clean rag to compress out the tape. A small roller can also be used to press out the tape to ensure a tight fit. Use care not to crease the tape during install. See Figure 10.

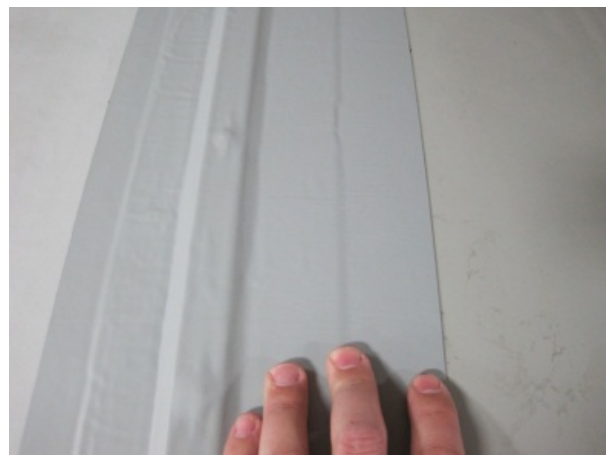
Fig. 11

- Step 4** Finished application should be a snug overlay atop the existing tape and extrusion. See figure 11 above.

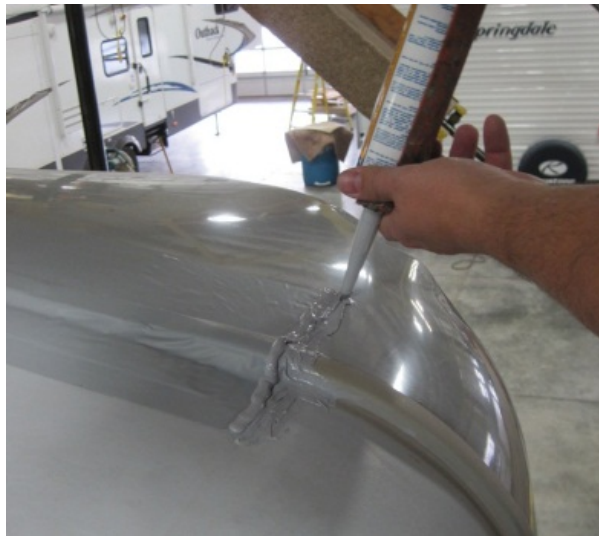
Fig. 12

- Step 5** Apply new silicone sealant over the edge of the newly applied tape. Tool the new sealant smooth and overlap the edge of the tape a minimum 1/2". For aesthetics, completely cover the existing silicone as well. See figure 12.

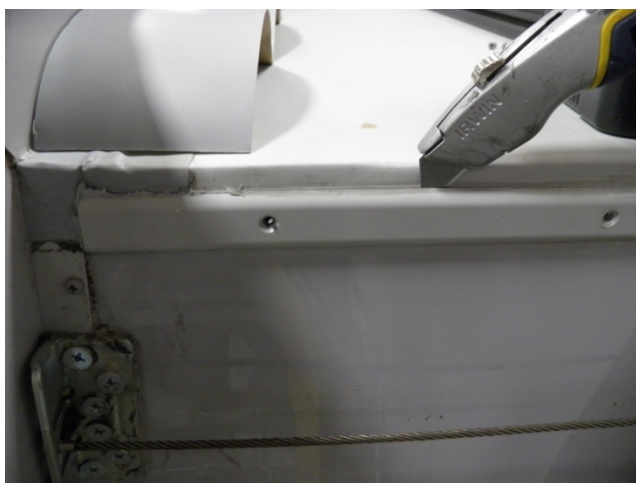
Fig 14

**Step 2** Remove the screws from the slide out roof line molding. Cut the silicone seal on the roof line molding. Separate the roof line molding from the side of the slide out to allow access to the roof tape. Clean the slide out sidewall and roof tape so new tape can be applied. Repeat for the other end of the slide out. Start the new membrane even with the edge of the original roof seal membrane under the roof line molding. Apply the membrane against the inside edge of the exterior fascia along the length of the slide out roof. Cut the membrane and wrap it over the edge of the slide out to finish flush with the bottom edge of the original roof seal membrane. See figure 14 & 15.

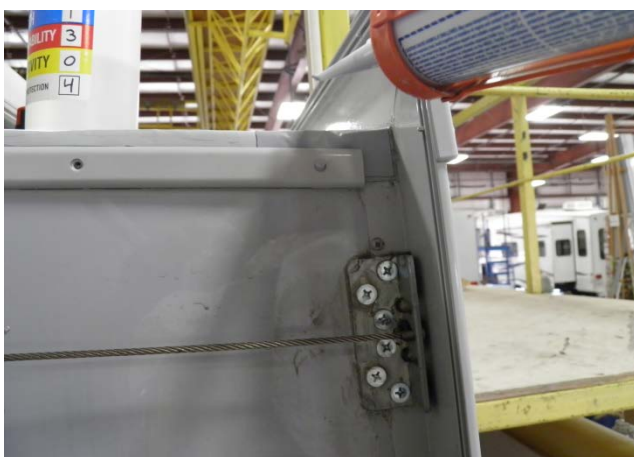
Fig. 17

- Step 4** Use a clean rag to compress out the tape. A small roller can also be used to press out the tape to ensure a tight fit. Use care not to crease the tape during install.
- Step 5** Finished application should be a snug overlay atop the existing tape and extrusion.
- Step 6** Clean the roof line molding and roof membrane to prep for resealing. Fill the screw holes with silicone and remount the roof line molding. Reseal the roof line molding See figure 17 & 18.
