## **SERVICE ADVISORY # 13-188**

### **Vantage Roof Tape Repair**

#### **REPAIR INSTRUCTIONS**

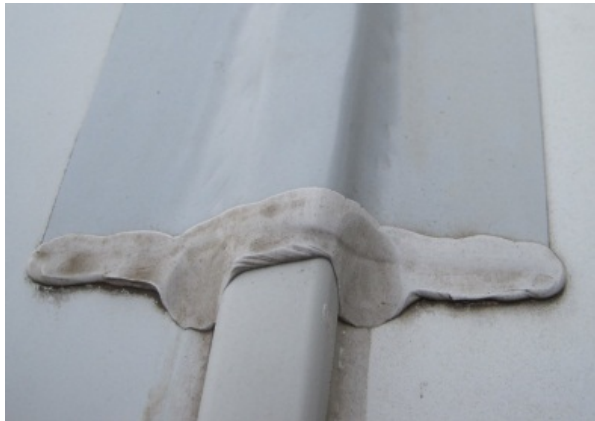
Fig. 1

**Step 1**        Inspect the front and rear roof to end cap tape seams for damage, peeling, etc. The new installation will overlay the existing tape wherever possible. Trim any loose or curled tape, if present, to provide a flat, smooth surface for overlayment of new tape. See Figure 1.

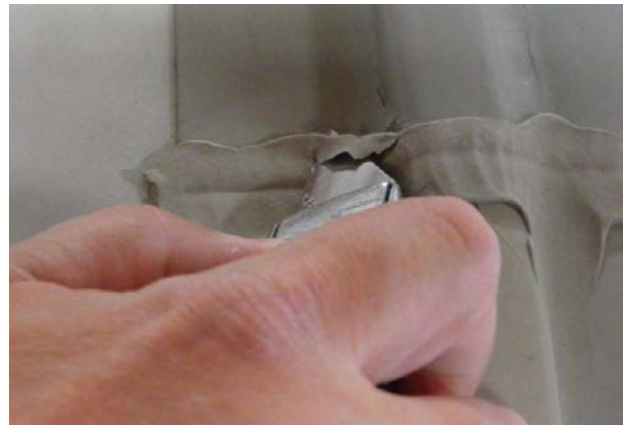
Fig. 2

**Step 2**        Trim Silicone end beads flat and smooth. Use care not to puncture the roof membrane. Trimming the existing silicone bead will allow for a smoother, lower profile application of new silicone. See Figure 2.

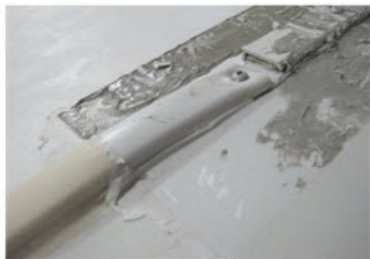
Fig. 3

**Step 3**        Inspect the overall condition of the tape and proceed accordingly. See figure 3

| <p>Intact membrane, no peeling, cracks may be present</p> <p>Proceed to step 5.</p> | <p>Peeling membrane, loose corners, poor adhesion</p> <p>If there are loose sections of existing tape membrane, proceed to step 4.</p> | <p>Areas of previous repair or missing membrane</p> <p>Clean up peeled, loose areas, trim any sealants down smooth, taking care not to damage the roof below. then proceed to step 5.</p> |

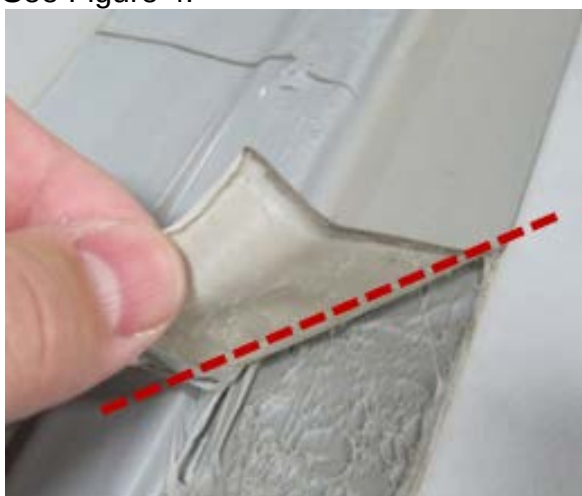
Fig. 4

If possible, remove the top film membrane from the old tape. To do this, try to separate the membrane at a corner and then slowly and steadily pull up at a 90 degree angle. Do not continue if removing the membrane disrupts the adhesive layer underneath, or if residue from the adhesive layer remains on the interior surface of the membrane. Cut any loose membrane off even with the existing tape to ensure an even, flat bonding surface. See Figure 4.

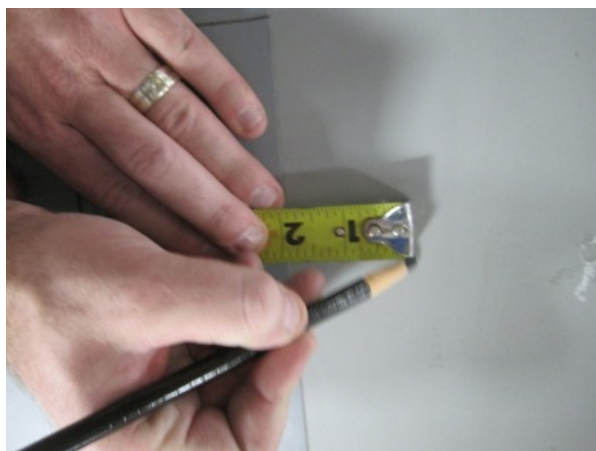
Fig. 6

With a grease pencil, mark an alignment mark 2" out from the edge of the existing tape outward on the fiberglass cap side of the tape. These marks will be a guide for applying the new tape so mark about every 18" across the RV. See figure 6.

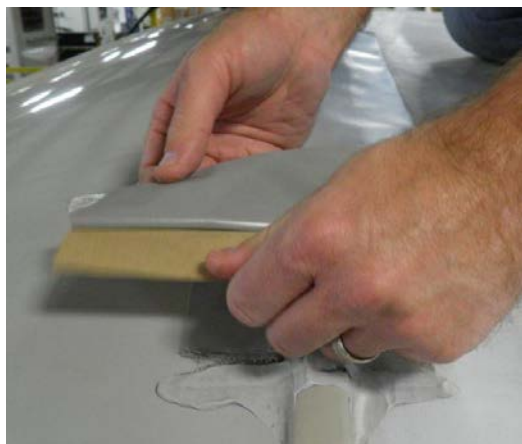
Fig. 8

Starting on one end, peel back release paper and adhere new tape, using care to line up the edge with the 2" hash marks made previously. Adhere to the high point (above the aluminum trim) in middle first, then work the tape tightly around and down onto the fiberglass cap and the EPDM roof membrane. Try not to stretch the tape during installation. See figure 8 & 9.

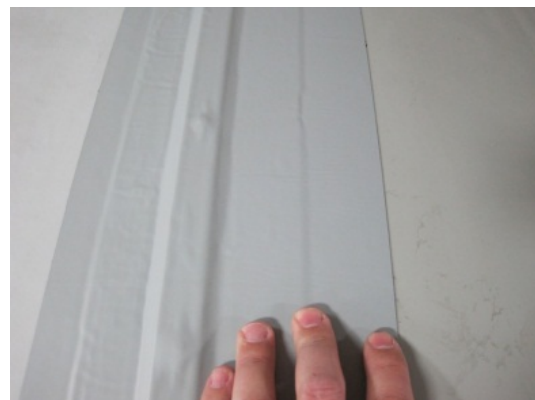
Fig. 11

Finished application should be a snug overlay atop the existing tape and extrusion. See figure 11 above.

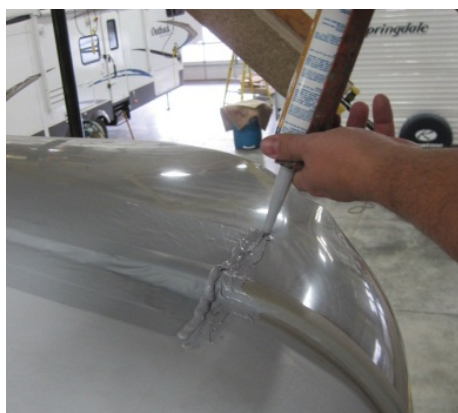
Fig. 12

Apply new silicone sealant over the edge of the newly applied tape. Tool the new sealant smooth and overlap the edge of the tape a minimum  $\frac{1}{2}$ ". For aesthetics, completely cover the existing silicone as well. See figure 12.
