TECHNICAL BULLETIN
LTB00592NAS1
10 SEP 2013

SECTION: 206-03

Front Brake 'Squeal' Noise

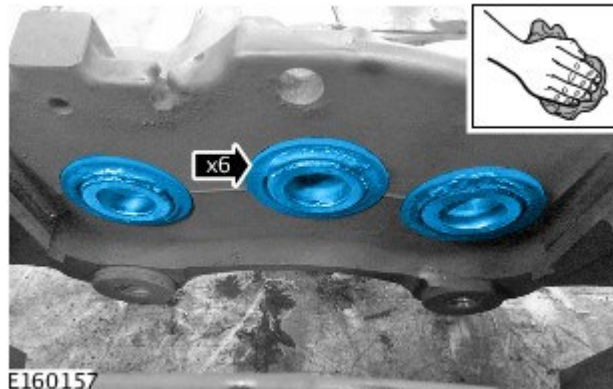
Thoroughly clean all six (6) brake caliper pistons and piston seals with brake cleaner to remove all traces of grease and dust.

- NOTE: Make sure to thoroughly clean the brake caliper pistons and piston seals; failure to do so will reduce the effectiveness of this Service Instruction.**

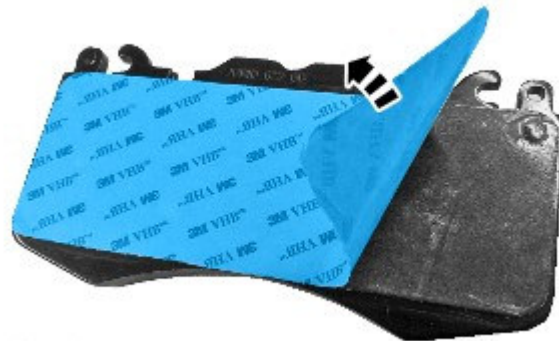
- Gently remove the backing from the new brake pads.

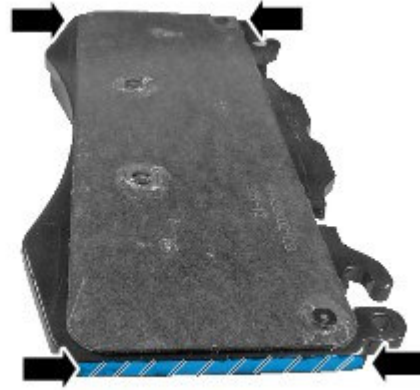
E160161

Grease pad abutments at both ends with Molykote C u- 7439+.

- NOTE: Do not apply grease to the piston contact area.**
