## EPB DTC CODES C2007-11 C2008-11.doc

Reference	SSM66897
Models	LR2 / L359 Range Rover Evoque / L538
Title	RR Evoque and Freelander 2: EPB DTC Codes C2007-11 and C2008-11
Category	Chassis
Last modified	09-Sep-2013 00:00:00
Symptom	302000 Parking Brake System
Content	<p><b>Issue:</b> Customers have reported warning lamp illumination and Park Brake Activation / De-Activation functionality issues with related DTCs C2007-11 or C2008-11.</p> <p><b>Cause:</b> JLR Engineering are continuing to investigate root cause of the issue.</p> <p><b>Action:</b> In order to implement a Right First Time repair, dealers are instructed to follow the attached process for root cause investigation should the above DTCs be observed. Following analysis, dealers are requested to report the causal part for the DTC flag via an EPQR.</p>

DEALER SMM INFO FOR EPB DTC CODES C2007-11 AND C2008-11.

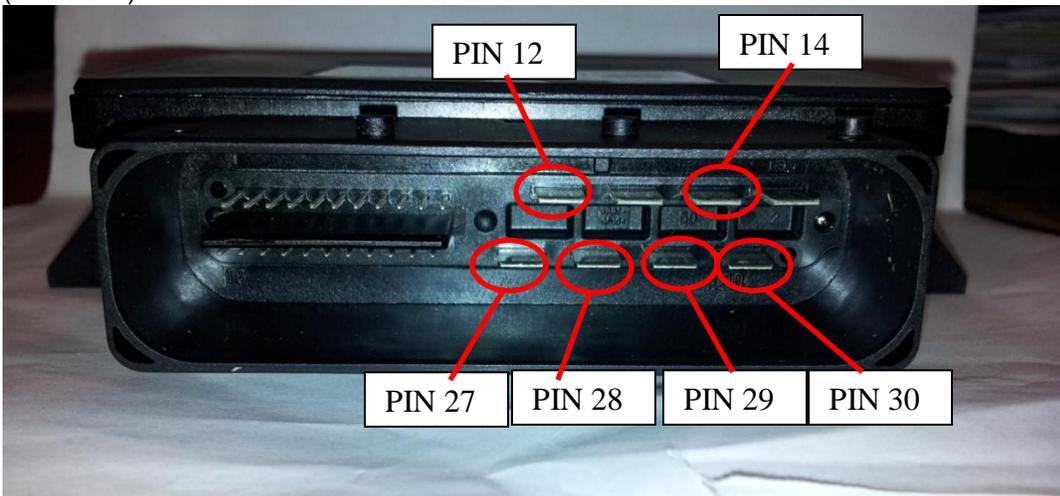
- 5) REMOVE LINK LEAD AND CAREFULLY CHECK FOR ANY VISIBLE SIGNS OF DAMAGE (CHAFING, PINCHING AND STRETCHING).
- 6) REMOVE EPB ECU (REFER TO TOPIX) AND TEST THE RESISTANCE BETWEEN THE MOTOR LINES AND GND ON THE ECU. USING PINS 12 OR 27 (MULTIMETER POSTIVE) TO PIN 28 (GND) FOR THE RIGHT CHANNEL (2007-11). USING PINS 14 OR 29 (MULTIMETER POSTIVE) TO PIN 30 (MULTIMETER G ND) FOR THE LEFT CHANNEL (C2008-11). THE RESISTANCE SHOULD BE **12.7 K OHM +/- 0.7 K OHM**
