TECHNET TIMES

VOL. 24, ISSUE 05

PUBLISHED BY THE NATIONAL SERVICE TRAINING & SUPPORT DEPARTMENT

Volume 24 Issue 5 September 2014

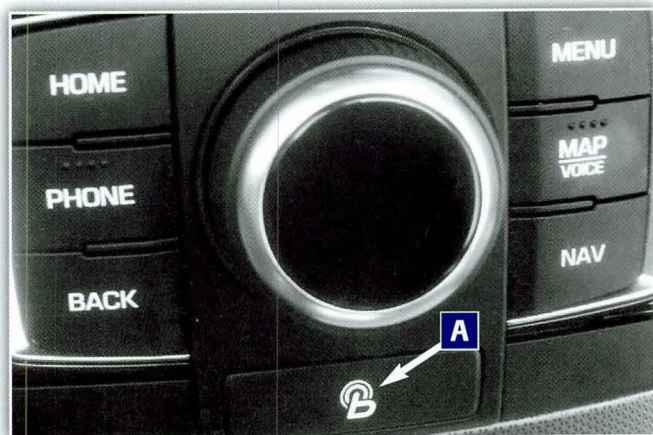
1. Turn vehicle and the Navigation system ON.
Press the Blue Link (A) button shown on the image below.

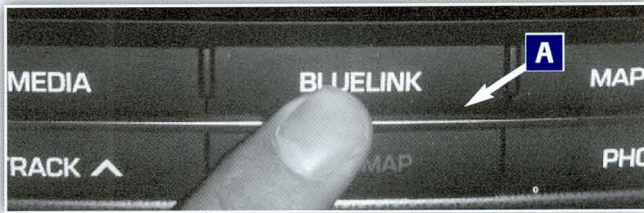
1. Turn vehicle and the Navigation system ON.
Press the Blue Link (A) button shown on the image below.

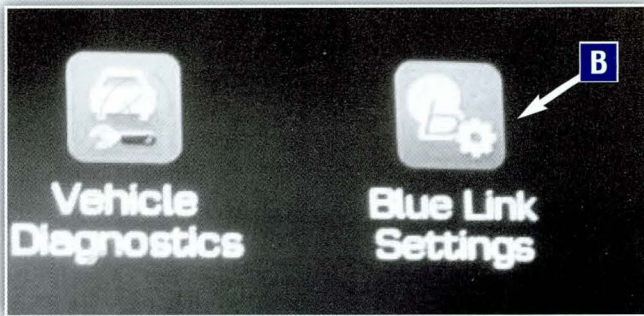
2. Press the Blue Link Settings (B) icon to enter the setting screen.

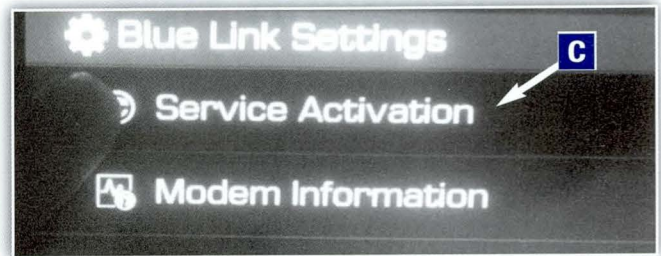
3. Press the Service Activation (C) selection on the screen.

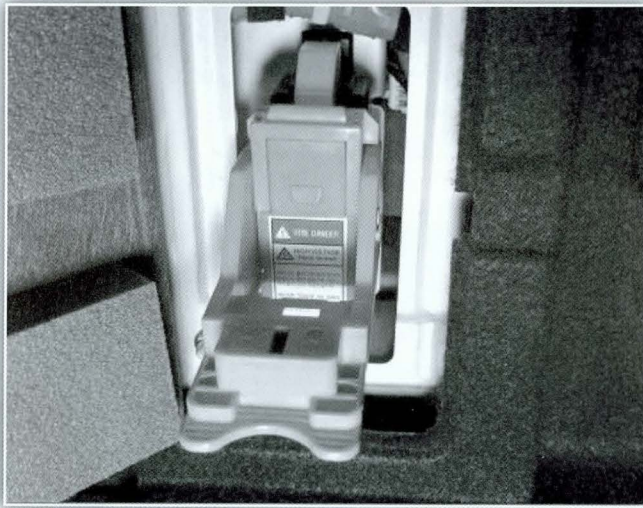
- Open the rear trunk and open the cover to the safety plug.

Put on insulation gloves and pull up on the black tab and pull out the safety plug.

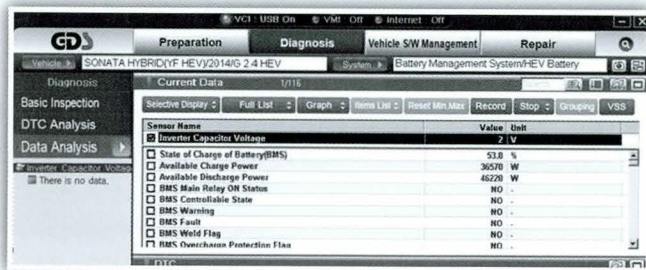
Attach a GDS and select BMS menu, Current Data and Inverter Capacitor Voltage. Confirm the Inverter Capacitor Voltage is less than 30V.

- If less than 30V, the system voltage is safe for the technician. Turn off the ignition and disconnect the negative battery cable in the trunk. Go to Step 5.
- If more than 30V, wait until the voltage is within specification before performing any repairs.

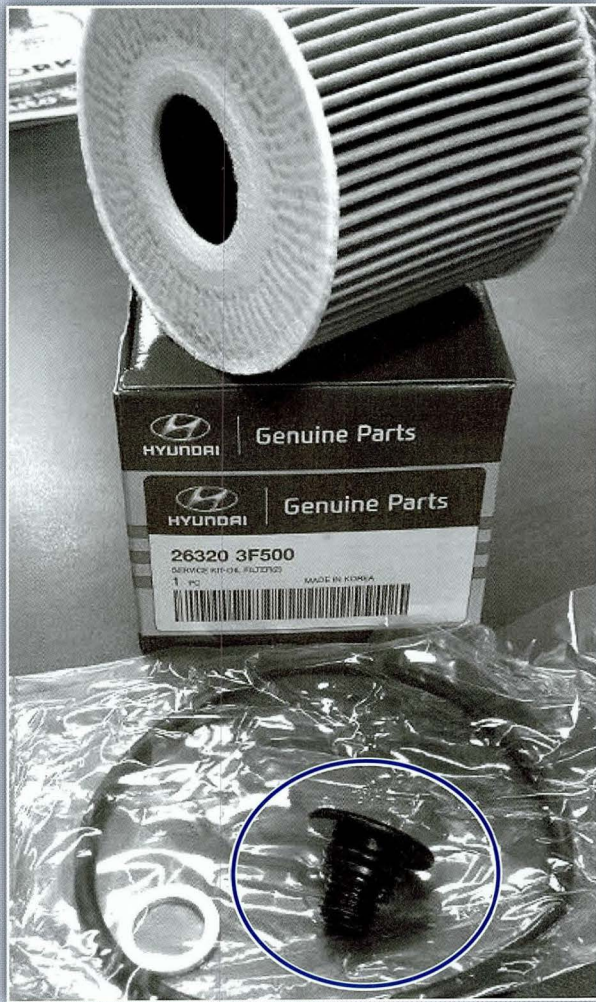
The oil filter for the 2015 5.0L equipped Genesis (P/N 26320-3F500) comes with a replacement drain plug for the canister filter housing

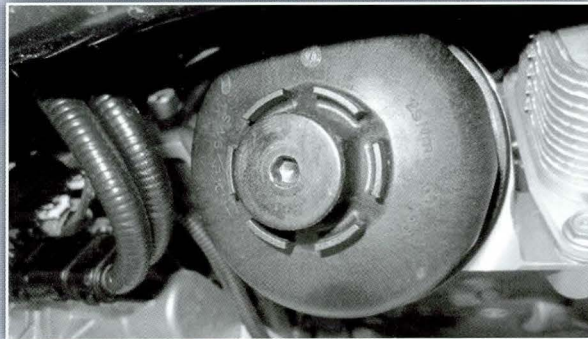
- 5.0 Includes filter housing drain bolt w/o-ring

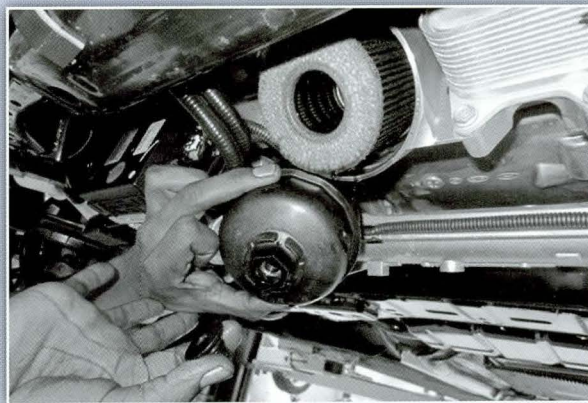
- Removing the plug allows the oil in the canister to drain before removing the filter.

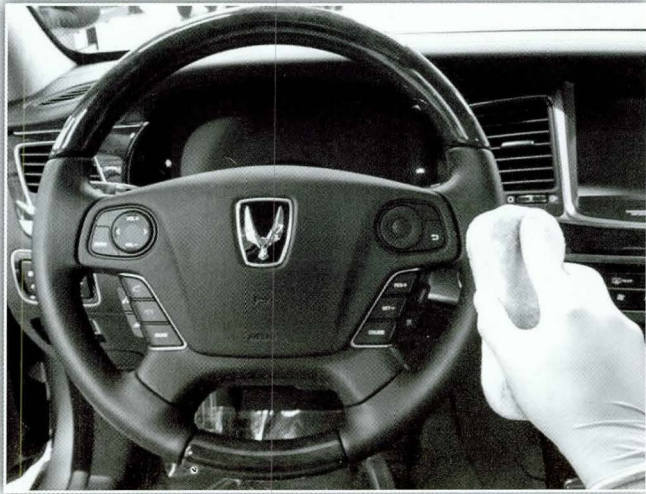
1. Spray the leather restorer onto the cleaning pad and scrub the steering wheel.

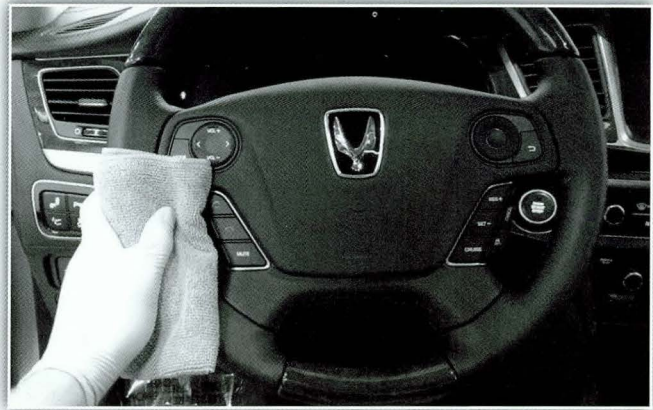
2. Using the microfiber cloth, wipe any leftover residue with a clean portion of the cloth.

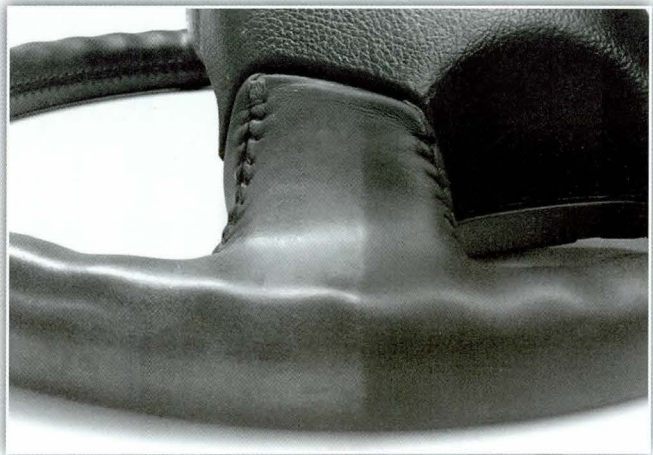
Steering wheel shown partially cleaned to demonstrate cleaning results.
