Clad Wheel (Chromtec) Servicing

14-15MY Tundra, Tacoma, Highlander/HV

2014-2015	Highlander	2014-2015	Tundra
2014-2015	Tacoma	2014-2015	Highlander HV

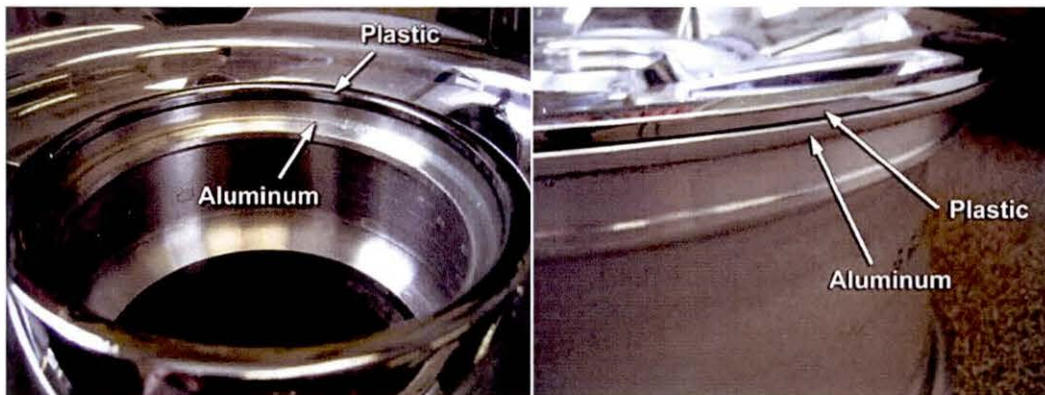
Chromtec (plastic clad) wheels are being damaged during mounting and dismounting of tires.

Refer to photos below for identifying plastic and aluminum portions of wheel:

When using a tapered cone on tire changer, the following precautions should be used to prevent damage or cracking to the plastic clad surface.

- Ensure mounting surface of cone and wheel is clean of dirt and debris
- Ensure wheel is perfectly centered on tire changer before tightening
- Use caution not to over-tighten cone or clamp
 - Over-tightening may cause plastic cladding to crack
- If further information is needed, refer to tire changer instruction or contact tire changer representative
-
