Subject NY Taxi vinyl cover installation CAUTION		Market USA
Service Category Vehicle Interior	Section Meter/Gauge/Display	
Applicability Prius V, Camry HV

APPLICABLE VEHICLES

2012-2015	Prius V	2011-2015	Camry HV
-----------	---------	-----------	----------

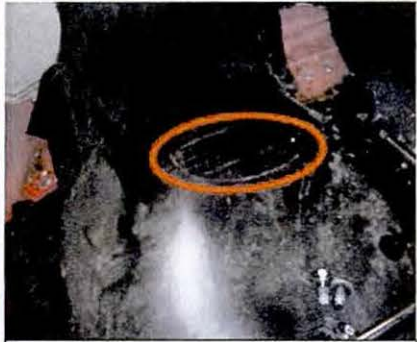
<p>Cooling fan inlet is covered by vinyl floor.</p>

<p>Cooling fan inlet is clogged or covered by dust, debris or additional seat cover.</p>

<p>Secure cooling fan inlet area by cutting off, cleaning or securely installing.</p>
<p>Camry HV</p> <p><TSB> Cooling fan maintenance T-SB-0087-13 Cooling fan Intake filter T-SB-0088-13</p>

Caution: Failure to cut out vinyl cover at HV Battery cooling system air inlet screen area will result in premature HV Battery damage
