S-SB-0023-14

Spring Spacer Removal During PDS

The 2015 model year FR-S has a new accessory package known as Release Series 1.0 that includes a suspension kit. To minimize vehicle damage during transportation, spacers have been installed on the front shock absorber piston shafts to hold the front of the vehicle up approximately two (2) inches over normal ride height. These spacers must be removed during Pre-Delivery Service (PDS).

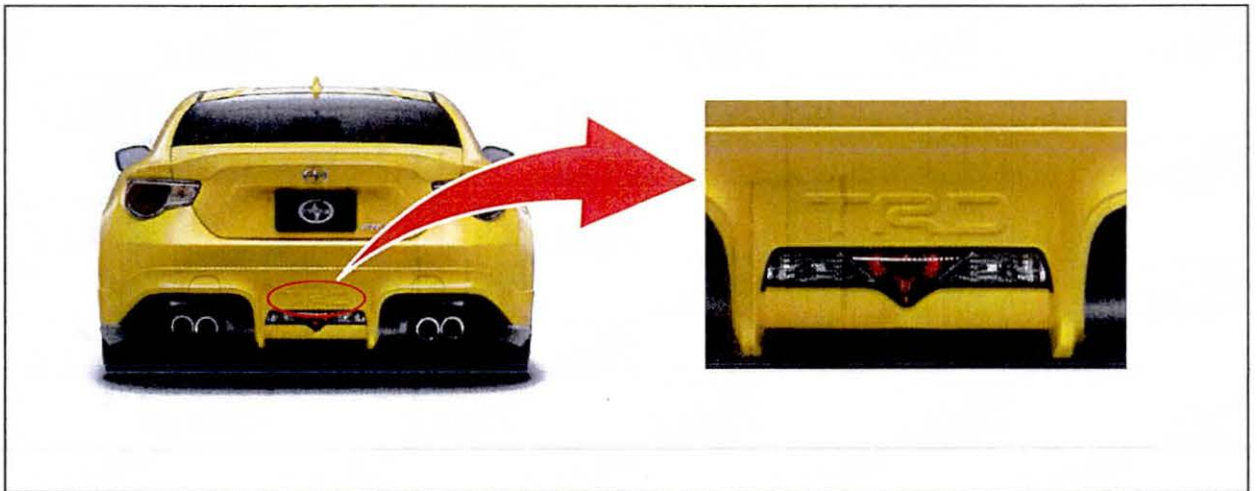
The Release Series 1.0 package can be identified by a number of ways, two of which are:

1. "Yuzu" vehicle paint.
2. Embossed TRD logo in the rear fascia.

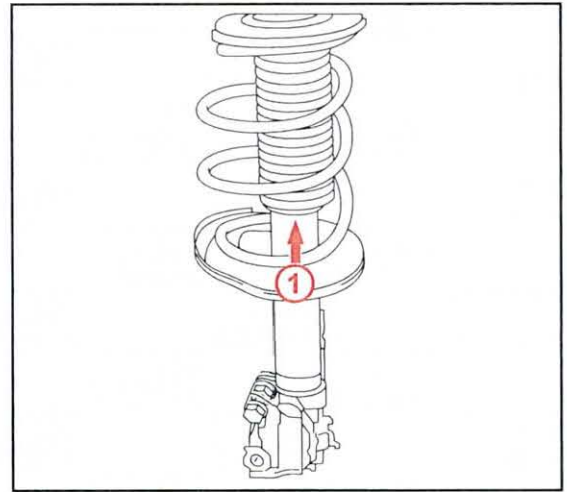
Figure 1.

1. Raise the vehicle on a hoist.
2. Lift corrugated dust boot on the front shock assembly.

1	Dust Boot
----------	-----------

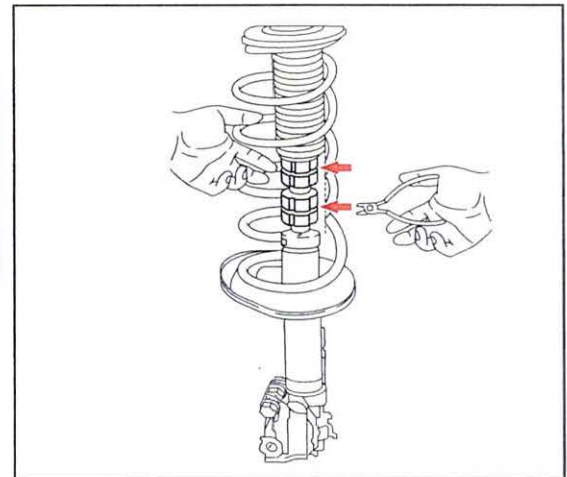
Figure 2.

3. Clip the nylon tie from the red spring spacer.
4. Remove the red spring spacers and nylon ties from the shock absorber and pull through the open spring coil.

- There are two spacers on each front shock absorber.
- Make sure the dust boot is properly in place when finished.
